**Report No. CDOT-DTD-R-2004-10
Final Report**

CABLE GUARDRAIL

**Interim Report
June 2004**

**COLORADO DEPARTMENT OF TRANSPORTATION
RESEARCH BRANCH**

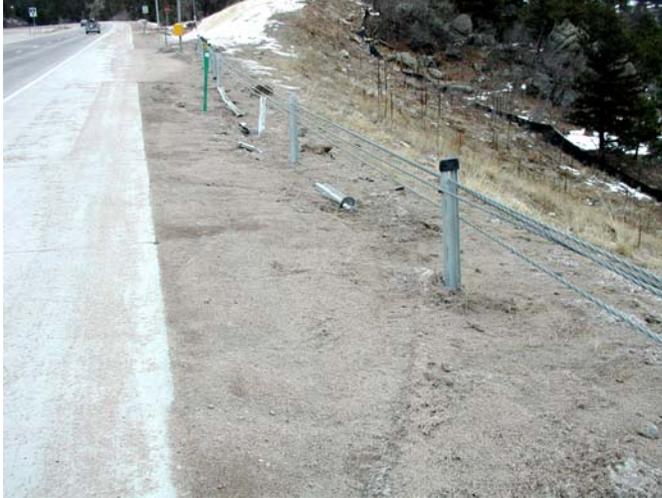
Figure 1. The most severe hit on the Windy Point systems damaged only six posts.

on US-285, Research was notified of four hits. Three of them were so minor that the impacting vehicles left without law enforcement being informed. One required replacement of 4 posts; the second, 2 posts; and the third, 3 posts. The fourth hit was more severe. It involved a CDOT engineer from Durango who credits the Brifen WRSF system with saving his life. This more severe accident required replacement of only 6 posts. None of the accidents required replacement or repair to anything other than posts and hardware such as cable locator pegs and post caps.

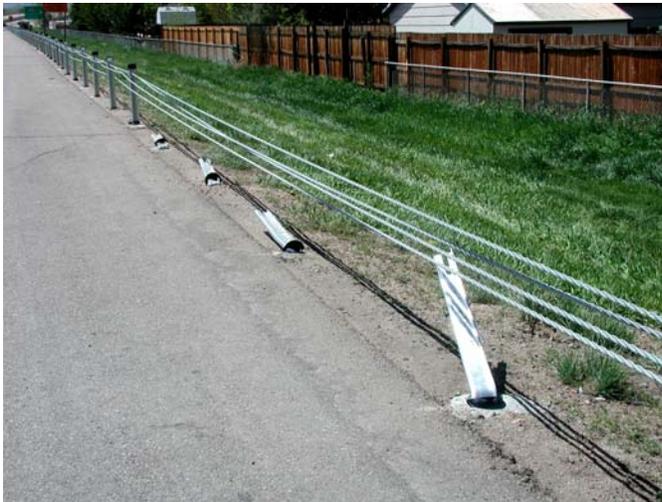
Figure 2. Only four posts were bent in this drive-away accident on US-285 at Kipling.

US-285 at Kipling Parkway: In early May of 2003, the system on southbound US-285 (**Figure 2**) was hit once requiring replacement of 4 posts. This appears to

have been another drive-away situation; there is no record of a report to law enforcement, and there have been no reports of any additional hits on the system.

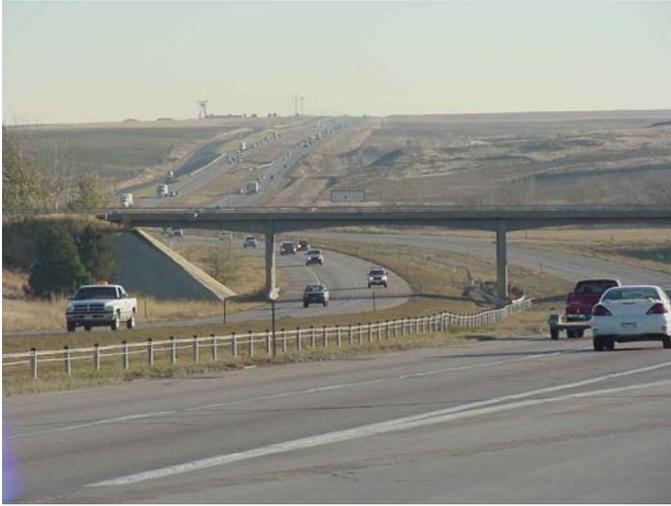
Figure 3. The I-25 – SH-56 interchange, looking south.

Three of the accidents occurred on the same day, November 22, 2003, in a period of about an hour, when the area was experiencing icy driving conditions. Two of the accidents were on the system north of SH-56 and one was to the south, beyond the overpass in **Figure 3**.

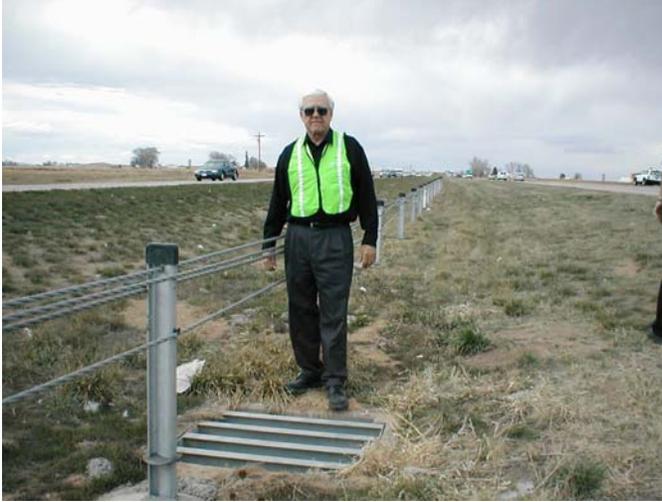
Figure 4. The cables over this drain inlet are much farther off the ground than the design specification.

According to the accident report, in addition to the side hit by the southbound vehicle, the Honda was damaged quite extensively on its top. It appears that the vehicle happened to penetrate the cable system at a drain inlet. The depression at the inlet appears to have allowed the vehicle to pass under the cables. The fact that, according to the accident report, there was considerable damage to the top of the vehicle, and that it did not roll, supports this theory. The accident report specifically mentions that there was no damage to the cables or support posts at the point of penetration.

Figure 4 shows the height of the cables at the drain inlet where it is believed the Honda went under the cable guardrail. About eight inches above the bottom of the post in the foreground there is a flange that is designed to keep debris out of the post socket – that flange should be at ground level. The tension of the woven cables is actually holding the post up partially out of the socket. On the near side of the post the cable can be seen below the locator peg. Normally the lowest cable should be 20 inches above the ground. Because of the depression around the inlet drain in the picture it is considerably higher – enough higher that the Honda mentioned above was able to pass under the entire system. A solution for this problem is discussed in the Recommendations section of this report.

From a design and construction standpoint, correct cable height along outside shoulders is usually easy to establish due to the constant slope of the shoulders. Correct cable height can be more easily established in median installations by running the cable guardrail system a set distance from the shoulder line of one side of the highway, rather than down the center of the median. (Brifen USA recommends 18 feet offset from the shoulder stripe if the median is wide enough, which should accommodate mowing operations.) By putting the cable in an area where the slope does not vary up and down in short distances, it is easier to maintain a uniform height for the cables above the surface thus preventing high or low areas where the barrier can be more easily under- or over-driven. A barrier that follows the smooth curves of the highway is also more aesthetically pleasing than one in the center of the median that has to wander from side to side to avoid passing directly over depressions at drain inlets.

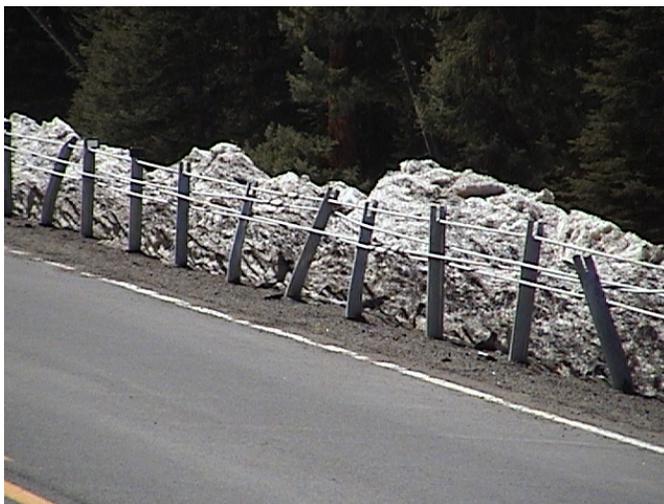
Figure 5. Posts on SH-65 are bent in all directions, suggesting that the damage is not all caused by snowplows.

snow. Accumulations of several feet hide the cable system from plow operators, making their jobs more difficult. Some posts are undoubtedly bent by plows. In addition, the weight of the accumulation of snow pushes against the posts, bending others. Many of the posts on SH-65 will need replacement when the snow melts. **Figure 5** shows that the damage to the system is not entirely from plow blades hitting the posts. The fact that some are curved rather than bent over at the base, and some are bent toward the highway suggest that the force of the snow and ice thrown by the plow blades and the weight of the snowbank behind the cables contribute significantly to the damage.

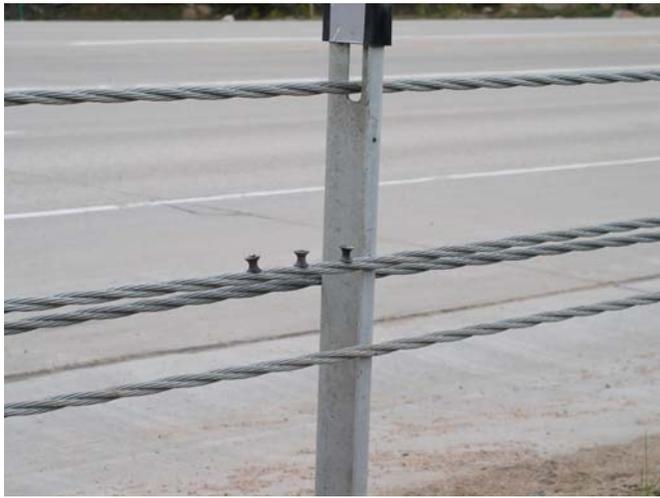
locater pegs to break or pop out of their holes for some distance from the point of impact, even on posts that have not been bent. Cables that are too low or too high are better than no barrier at all. However, as the penetration of the median system on I-25 demonstrates, their effectiveness is reduced.

Figure 6. Cables positioned lower than design height.

It is important to maintain the cables at the correct heights set by the locating pegs on the sides of the posts. In areas where heavy snow is thrown over and through the cable system by snowplows, the impact of the snow and ice on the cables and posts may be strong enough to break or pop out the locator pegs, allowing the cables to sag below the design height. It may be necessary to replace the pegs and reposition the cables to the proper height periodically. **Figure 6** shows cables that are lower on the post than the design heights. The three black pegs sitting on the cable in the picture had been broken from their mounting holes and were lying on the ground near the post. In the picture, a black dot can be seen on the side of the post just below the top cable. It is the hole for the upper cable locating peg for this side of the post. This is where the top pair of woven cables should be, with the lowest cable 6-1/2 farther down the post (about where the woven pair are in the picture).

It is very important that the cable height both sides of the impact point be checked whenever accident damage is being repaired. Movement of the cables during impact often causes the
