Ohio Department of Transportation

Re: Brifen Cable ISPE, Year 2 Report

Brifen WRSF In-Service Performance Evaluation
Year 2 Report - For the period from July 2004 to June 2005
Prepared by Dean Focke, Standards Engineer, ODOT
November 22, 2005

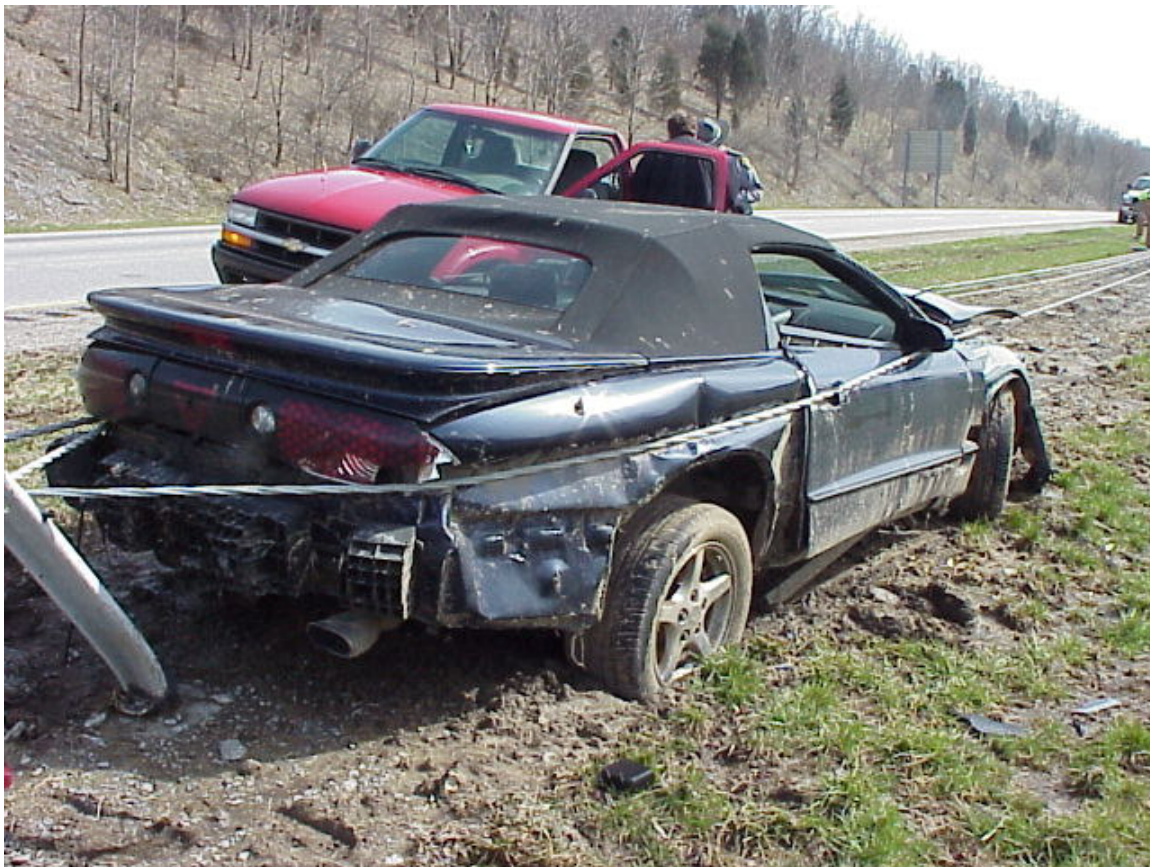
rotation may have led to the penetration of the cable.
1/5/05	2	25.4	Penetration: It appears the northbound vehicle lost control, spun around, went through the cable rail backwards, and entered the southbound lanes. The vehicle then struck a southbound vehicle, causing a sideswipe collision with a semi-truck that left the scene. This crash appears to have occurred near a turn buckle.
3/27/05	2	31.5	Entangled: According to the OH-1 report, the driver was heading northbound on IR-75, lost control due to excessive speed, and struck the cable. The vehicle then rotated around and became entangled in the cables. The vehicle was a Pontiac Trans Am that has a steeply sloped nose. This nose may have split the cables causing one cable to slide over top of the vehicle.

In the 3/27/05 accident, the vehicle became totally entangled in the cable as is shown in the following photo. One of the difficulties in analyzing accidents after the fact is to determine exactly what happened in the crash sequence. Exactly how the vehicle ended in this position is unknown.

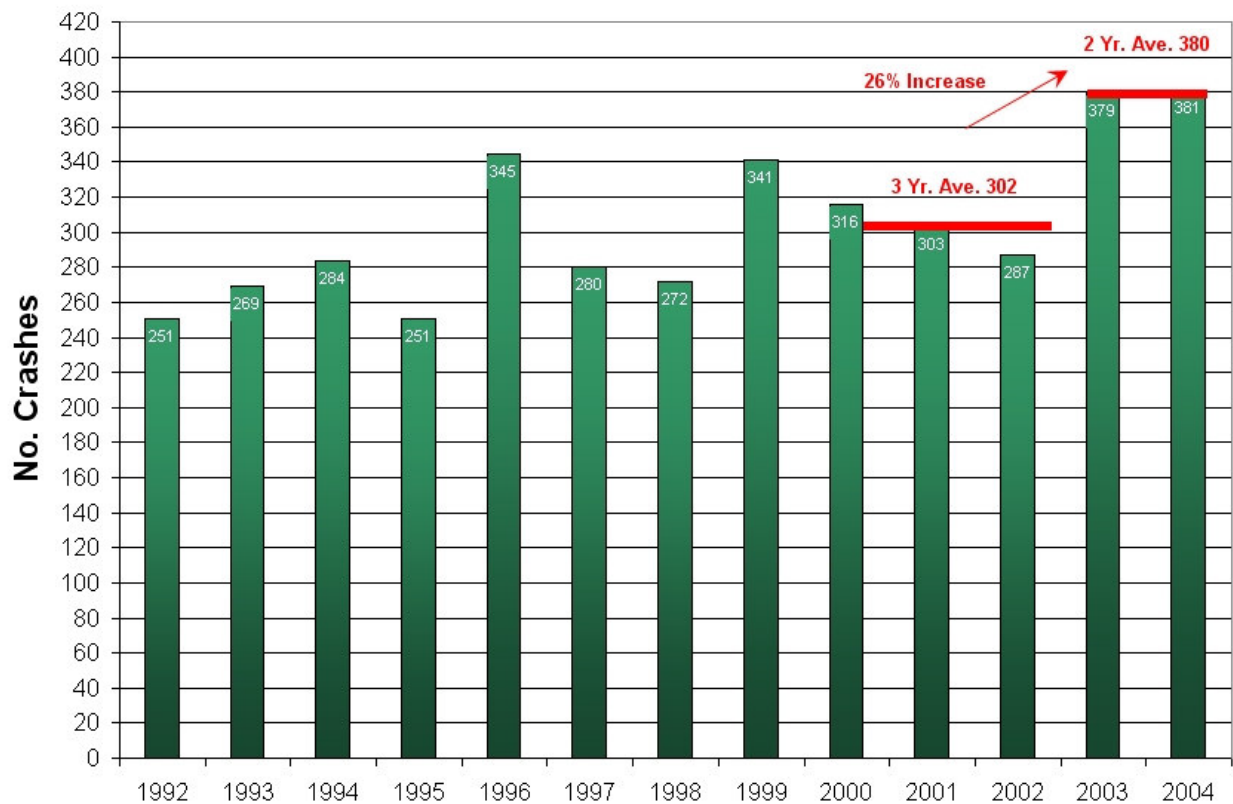
WAR / BUT - IR.75 Crash History

One of the reasons transportation departments nationwide have against installing cable is that the introduction of an object in the roadway's clear zone will increase the overall number of accidents. This department has previously heard estimates of 200 to 1000 percent more crashes. The graph below shows accidents for 2003 and 2004 (the last data available) averaged 380 per year in the area the cable is located. In the same locations in the three years prior to the cable, accidents averaged 302 per year. This modest 26 percent increase can generally be contributed to the presence of the cable. However, even with an increase in accidents, a review of Figure 3 shows the number and types of accidents to be mostly PDO and minor injury.

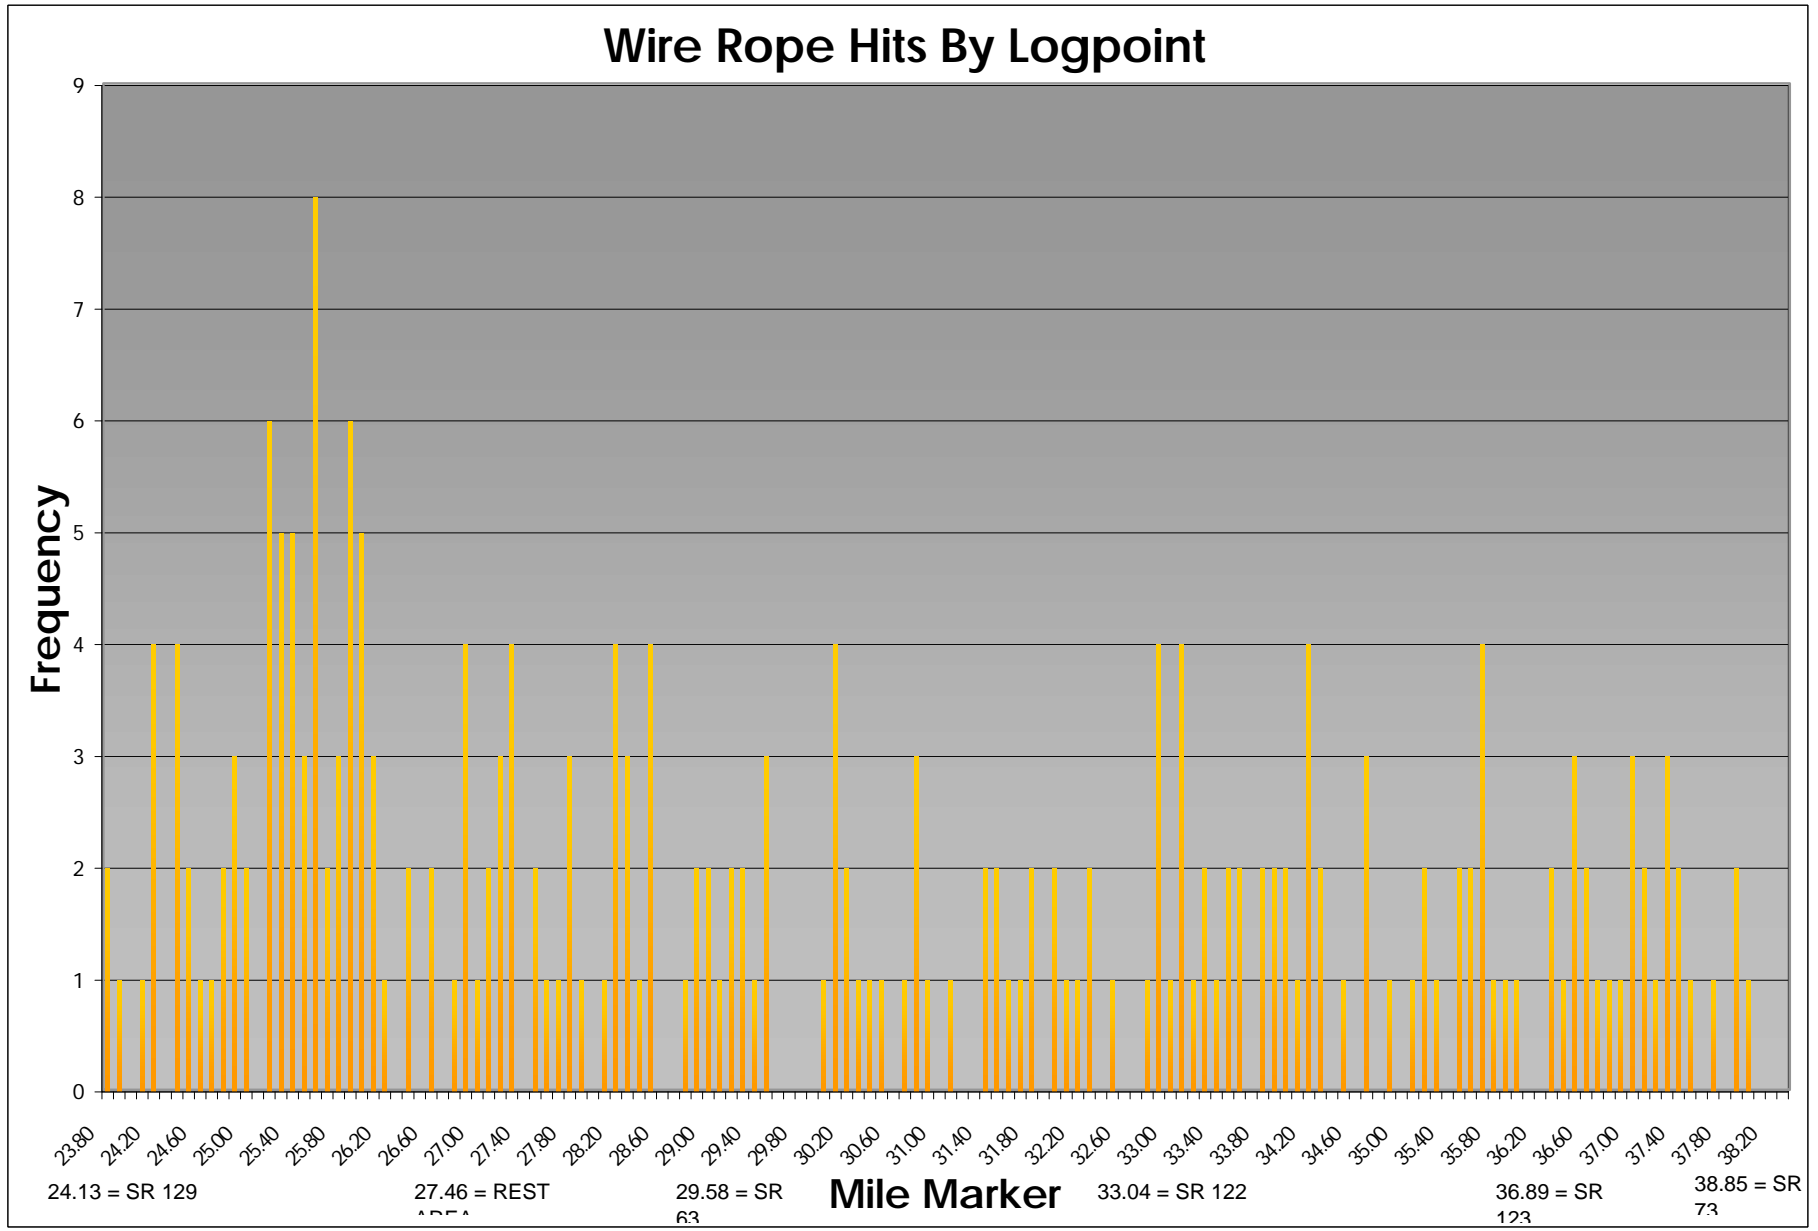
FIGURE 4

A graph showing the frequency of crash by location is shown in Figure 4 "Wire Rope Hits by Logpoint". A greater frequency of accidents occurs in the southern end of the installation, as shown by lower Mile Markers. This is consistent with the higher ADT, and thus congestion, in that area of the installation location.
