Evaluation of Brifen's Wire  
Rope Safety Fence

By  
Dave Ward, PE

Indiana Department  
Of  
Transportation

Interim Report

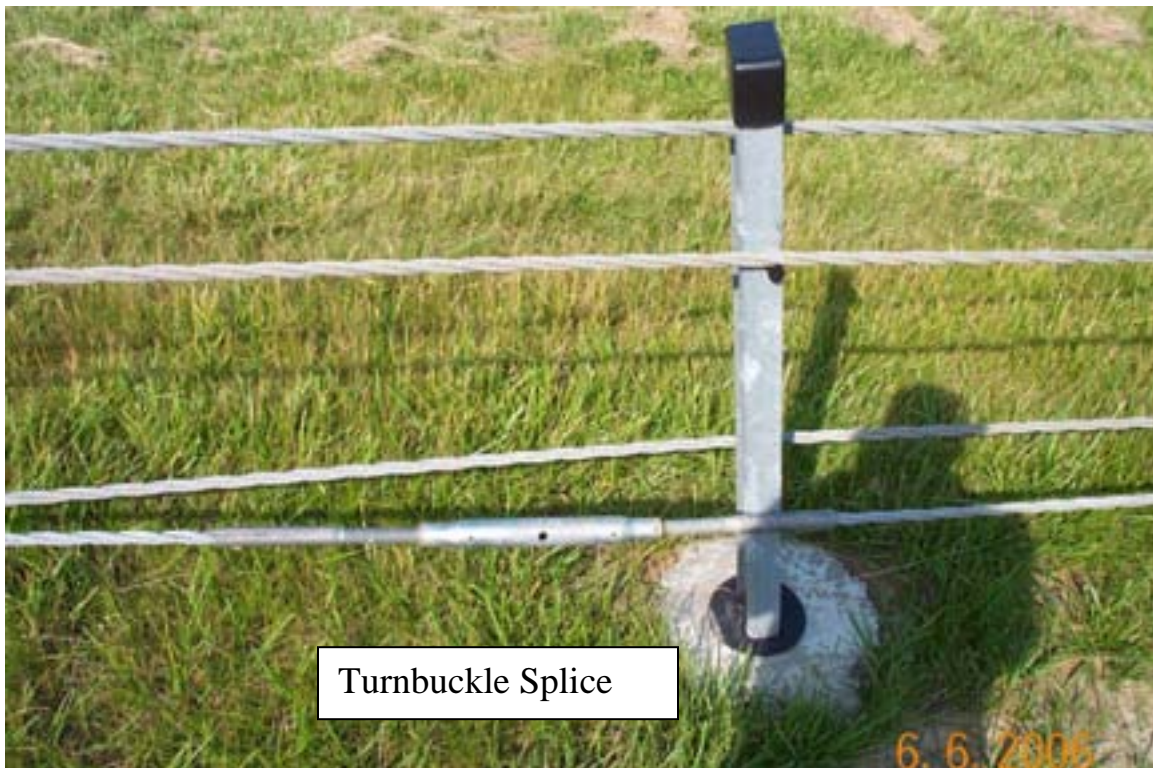
CTECH began the installation of the WRSF on I-65 in December 05. The first step in the installation was to locate the beginning and end points of each run and offset them 16 feet from the inside edge of the passing lane. This was done using surveying equipment to set the control points for each run. Some of the control points were set for runs that were more than a mile long. These sections would require turnbuckle splicing every 1000 feet. See the picture below which shows a typical splice.

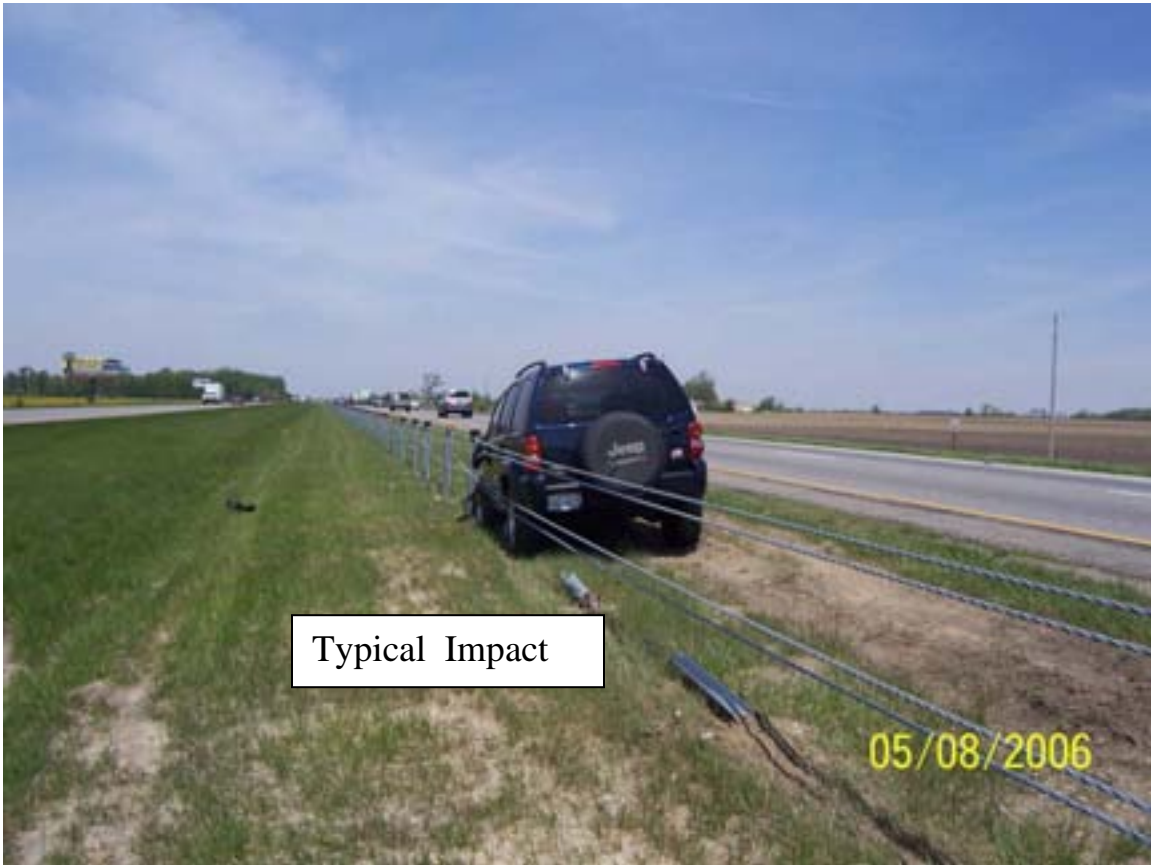
A typical vehicle impact of the WRSF involved about six posts that were bent over at the top of the socket. See the picture below. Some of the wire ropes occasionally passed over the vehicles bumper and ended up on the top half of the vehicle or on the windshield.

This usually was true for smaller vehicles or bullet nose mini vans. For larger vehicles the wire ropes usually tended to stay low on the vehicle and ended up lodged against a quarter panel of the vehicle or bumper. Four vehicles penetrated the WRSF and came to rest partially beyond the wire rope in the grass median. These vehicles passed through the wire ropes with some of the ropes passing over and some passing under the vehicle. None of the wire ropes were severed and no vehicle was in danger of reaching the opposing lanes. Vehicles that hit the WRSF, for the most part, sustained moderate damage of about \$5,000.

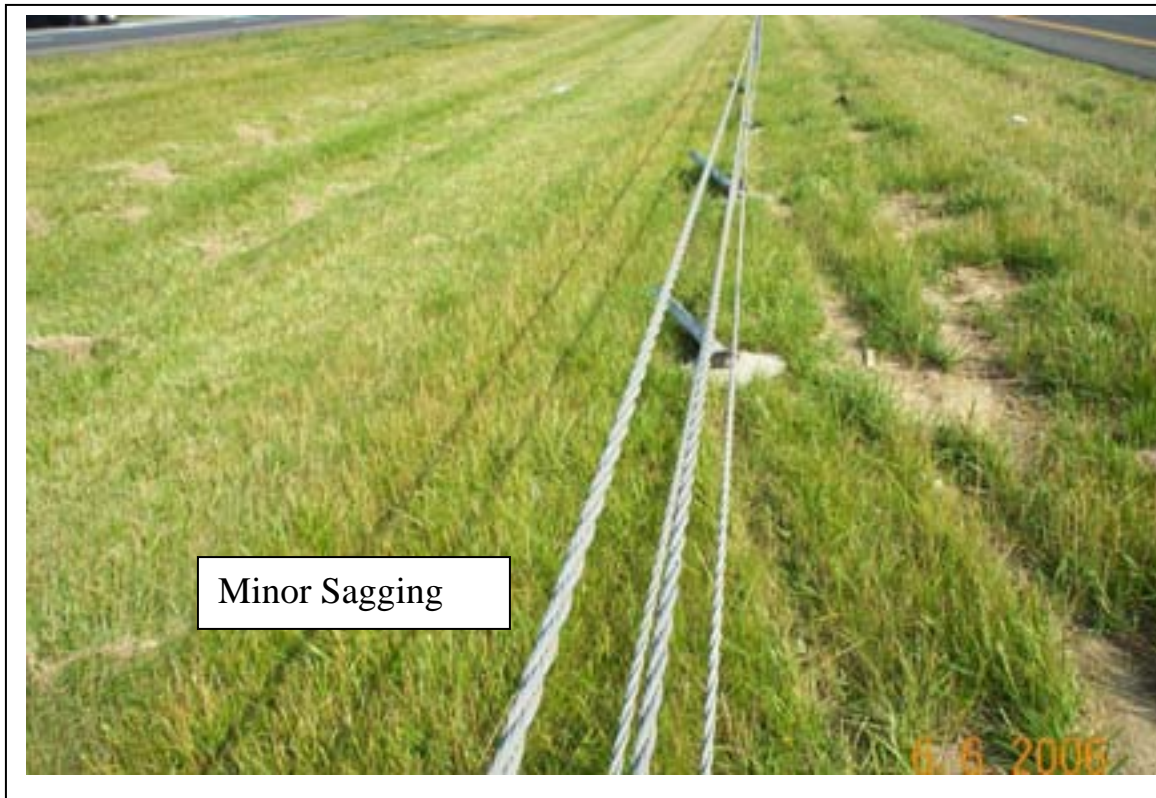
After a vehicle is removed from the WRSF the wire ropes return to their original alignment because they are under high tension. They are no longer attached to the posts that are bent over. Although the posts are bent over, the wire ropes can still “capture” a vehicle. If more than about 10 posts are bent over there is some minor sagging. See the picture on page 19. One hit involved a semi that bent over 31 line posts. Although the wire rope did sag it appeared that it could still stop a smaller vehicle. There were not many hits that bent over more than 15 posts.

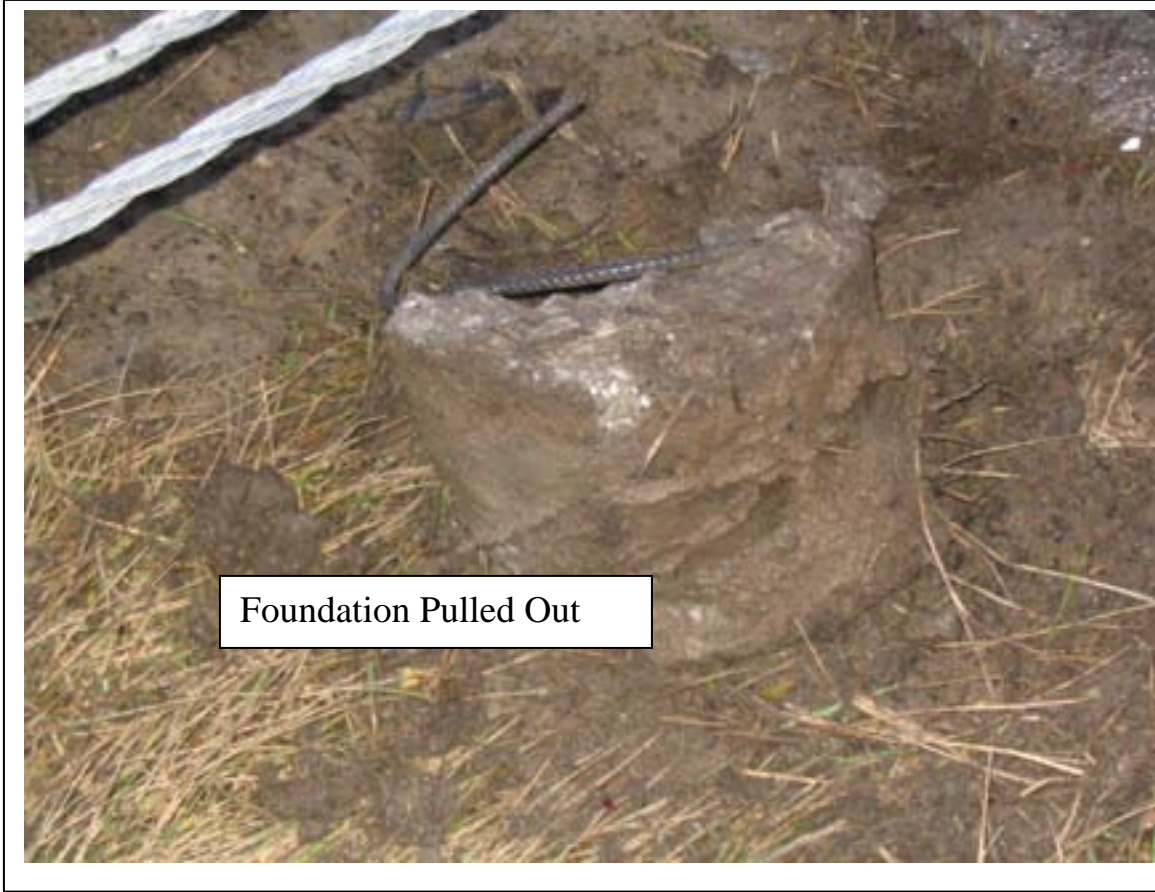
Foundation Pulled Out

At the time of this report, the WRSF on I-65 has been hit about 69 times. Some of these hits resulted in socket foundations being pulled completely out of the ground. See picture on page 21.

This problem was likely due to soft soil and foundations not being cored deep enough. It should be noted that to date that only 13 line foundations have pulled out of the ground, however, there have been a significantly number that were cracked. There is no way to determine how many foundations will exhibit pullout and cracking problems because it only occurs when the WRSF is hit. To date there has been no backside hits to the WRSF. It was also noted that some socket concrete foundations were cracked but had not been pulled out of the ground. See picture below..

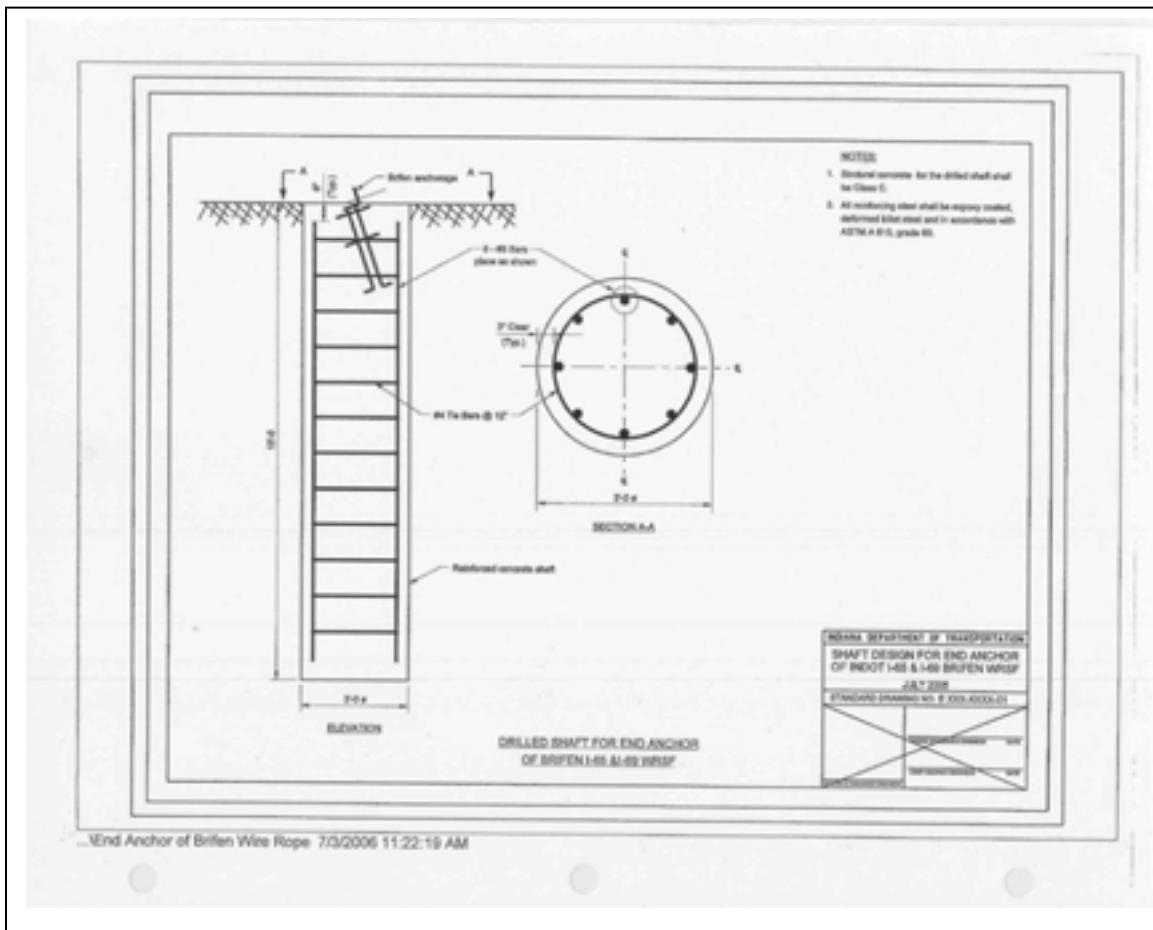
## NEW FOUNDATION DESIGN

As indicated, several end anchors failed under dead load. As a result of these failures, it was decided to use the results of the geotechnical investigation to design a new end

anchor foundation. The redesigned foundation was substantially deeper than the original but smaller in diameter (36 inches in diameter and 13 feet deep, see the picture below). The redesign also specified that the foundation be steel reinforced throughout its entire depth. Since the new foundation was smaller in diameter, Brifen was asked to verify that the end anchor bracket design would work with a smaller diameter foundation.
