Proprietary Tensioned Cable System:

Results of a Three Year In Service
Evaluation

Ohio Department of Transportation

District 8

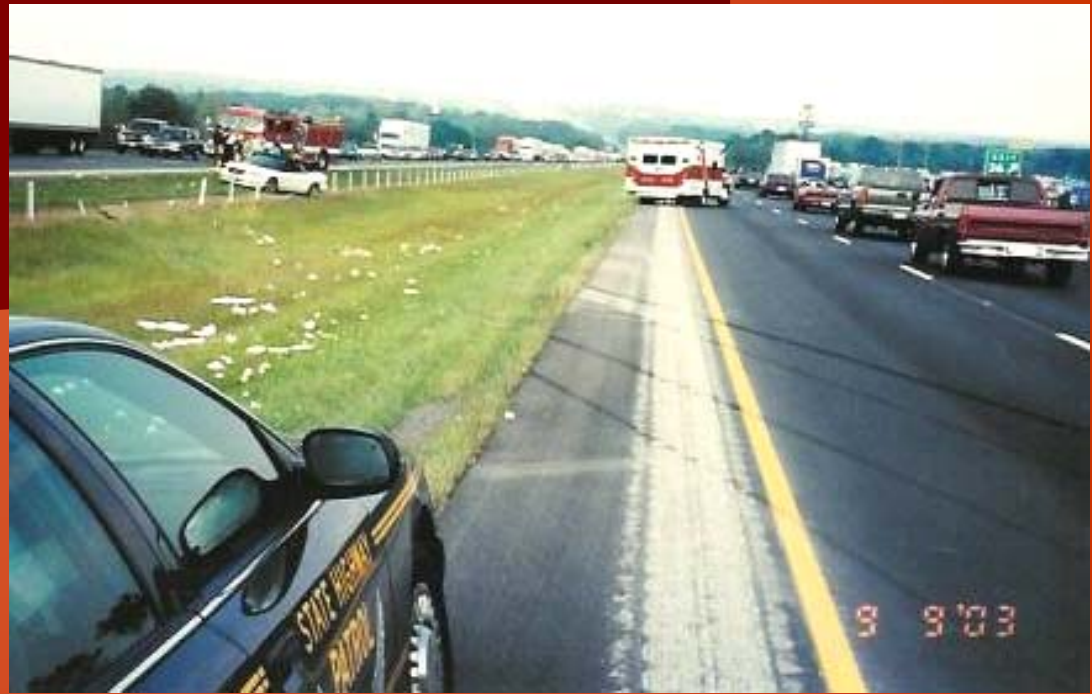
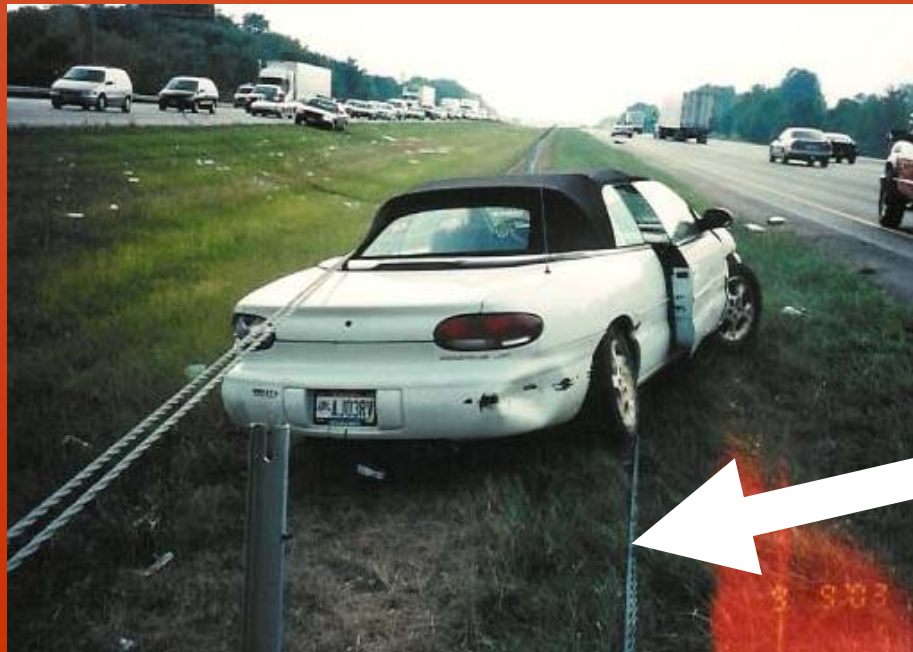
Penetration

- Approx. 4 per year
- No discernable trends

- Only 3 out of 13 were back-side hits

Two ropes did maintain contact with this vehicle

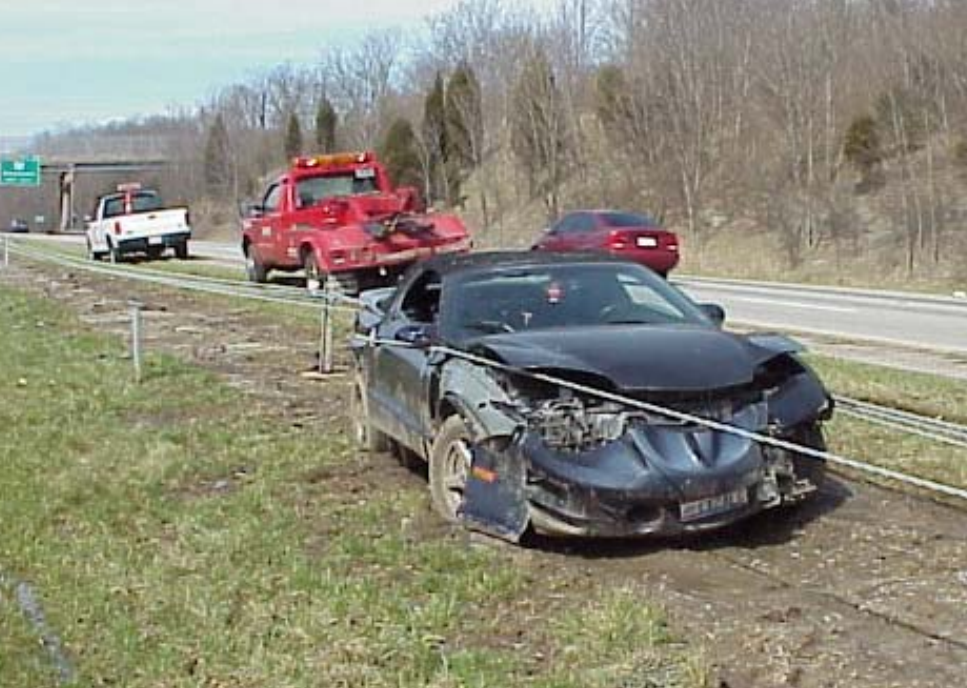
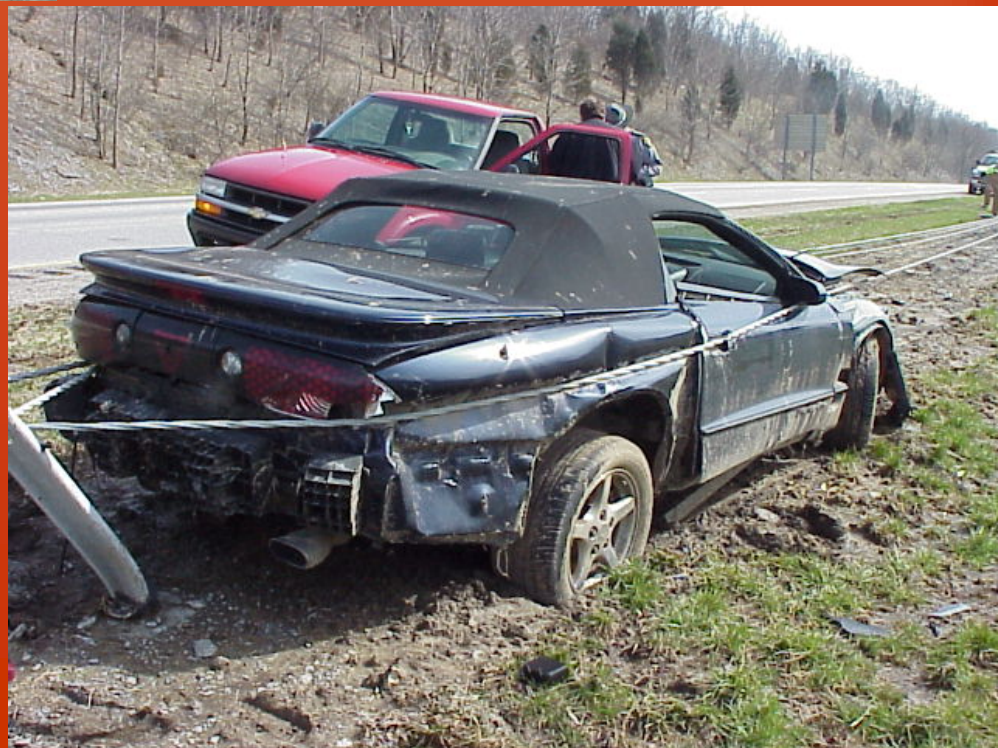
Entanglement

- Only 1 crash observed from July 2003 – June 2006

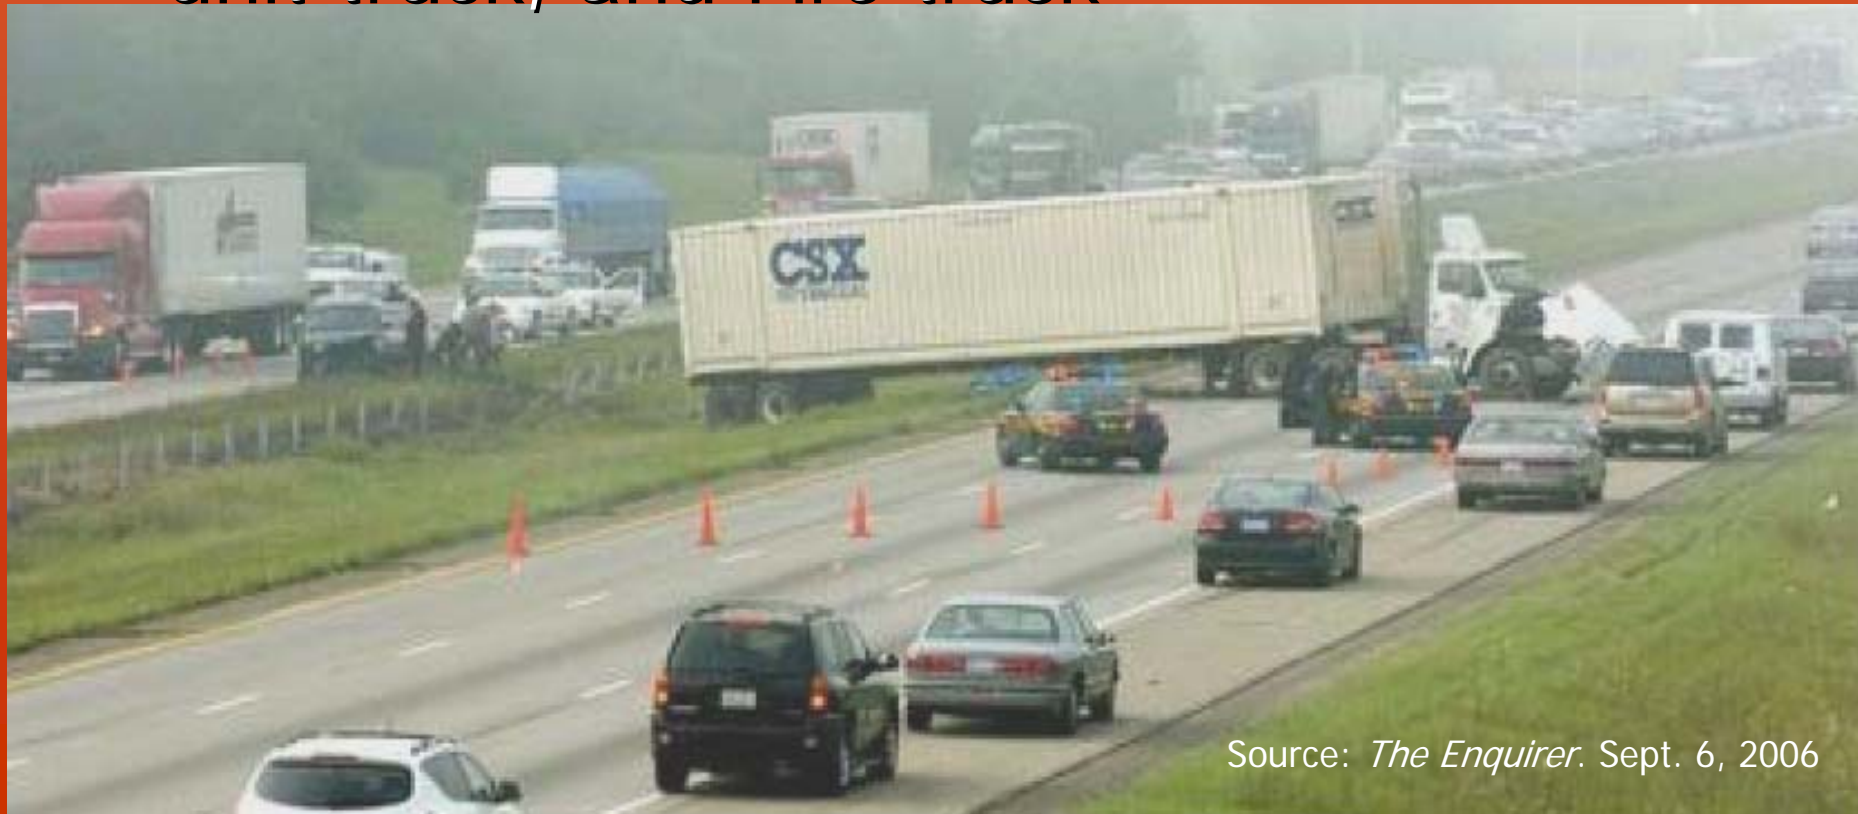
Vehicles Exceeding Design Criteria

- September 6, 2006 Semi-truck hit
- Other crashes included Mac truck, single unit truck, and Fire truck

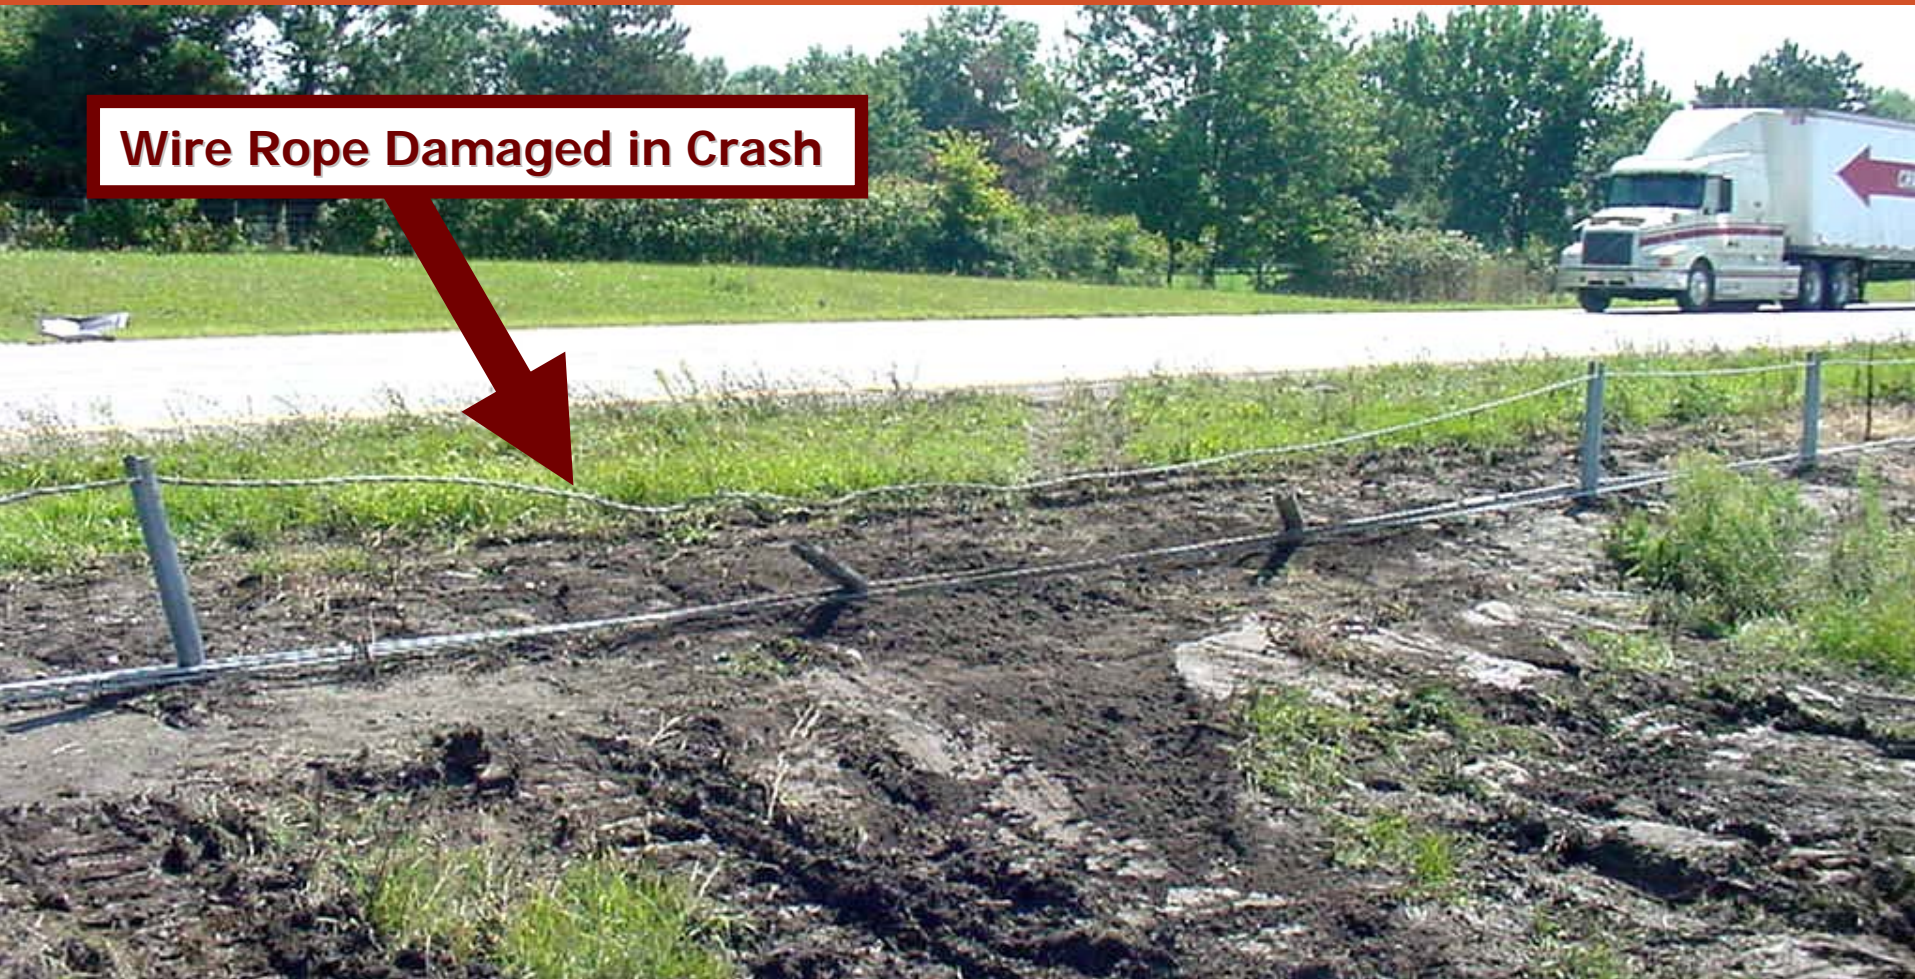
Wire Rope Damaged in Crash

- Only 1 resulted in penetration
