**THREE-CABLE
MEDIAN BARRIER
FINAL REPORT**

#OR-RD-99-03

Oregon Department of Transportation
Research Unit
200 Hawthorne SE, Suite B-240
Salem, OR 97310

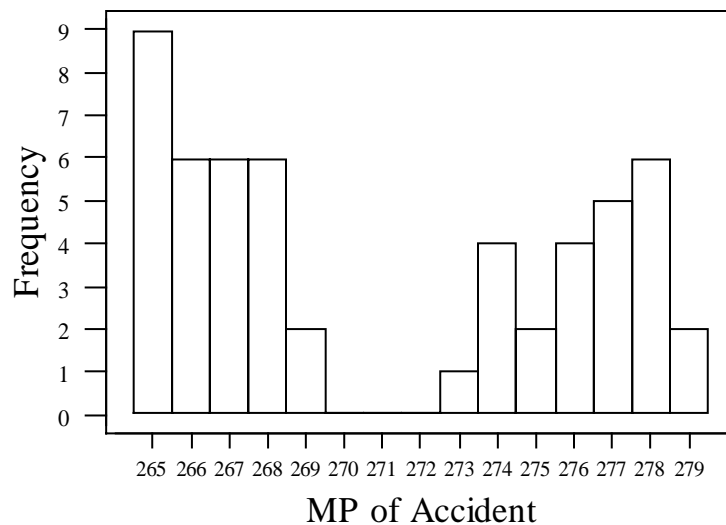
Figure 3.1: Impacts on the cable median barrier by MP

The cable median barrier has been hit 53 times from December 1996 through March 1998, or about once every nine days, based on the repair records. The frequency and location of the impacts are shown in Figure 3.1. No cable barrier was installed between MP 268.81 and 273.21. The accident rate for the cable barrier, 40 per year, is much higher than the historical accident rate of 1.0 per year. The most likely explanation for the increase in accidents is vehicles that drove into the median prior to the barrier installation, and reentered the roadway without incident, are now impacting the cable system. So, the total number of vehicles entering the median was not captured in previous accident history.

Once the system is installed, repair locations should be tracked as per Figure 3.1 in order to identify possible roadway design problems.

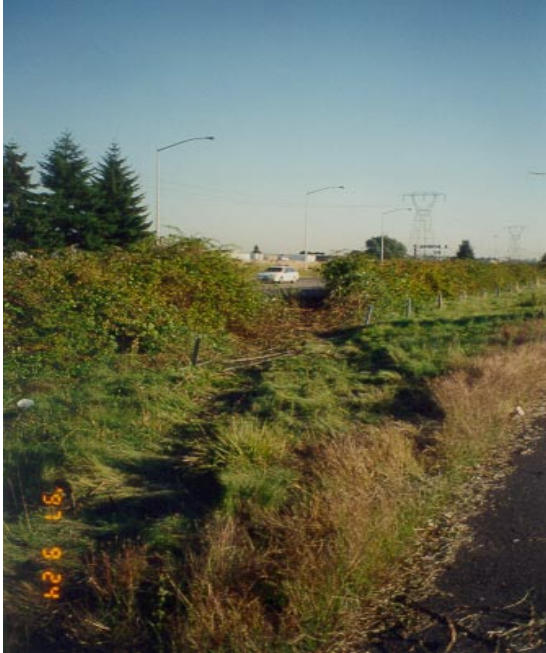
On September 23, 1997, the only median crossover impacting the barrier occurred. A semi-truck went through the median barrier, dragged the cables across the opposing traffic lanes, hitting a GMC Yukon. The driver of the Yukon suffered minor injuries. The semi-truck driver suffered from a seizure before crossing through the median. As stated in Section 2.3, none of the barrier options are designed to stop these larger vehicles, as it is not cost effective.

Figure 3.2: Semi-truck crossover through cable median barrier

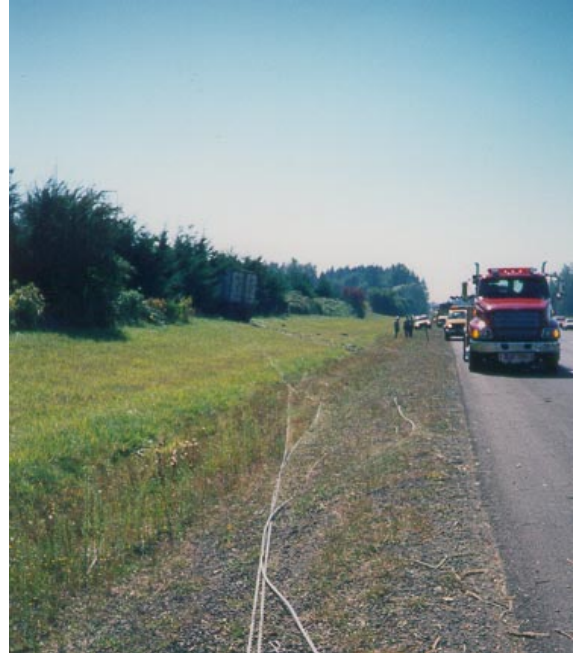
Figure 3.3: Semi-truck pulled barrier cables across northbound lanes

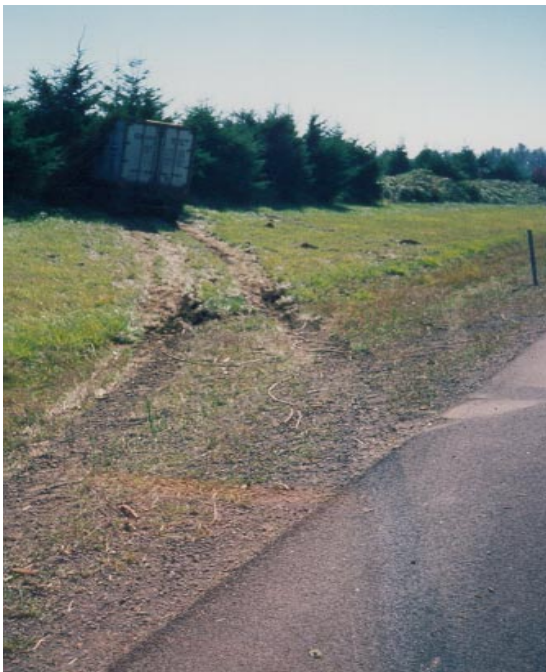
Figure 3.4: Semi-truck stopping location after crossover

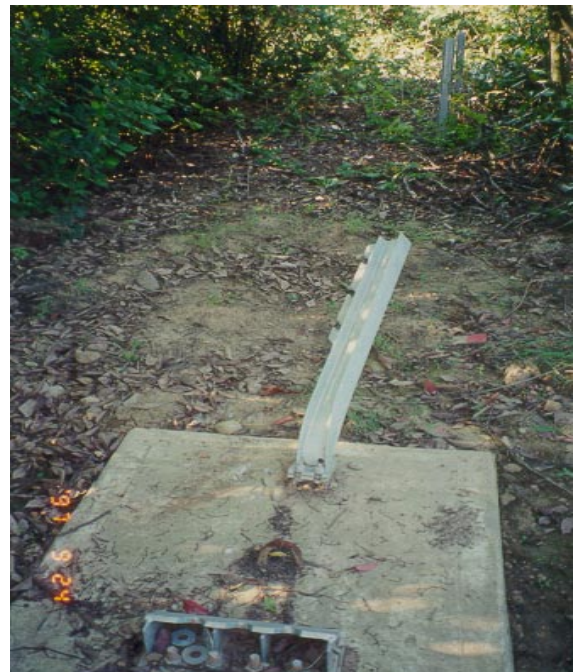
Figure 3.5: Energy dissipation-cable release from breakaway anchor angle and anchor post bracket (north end)

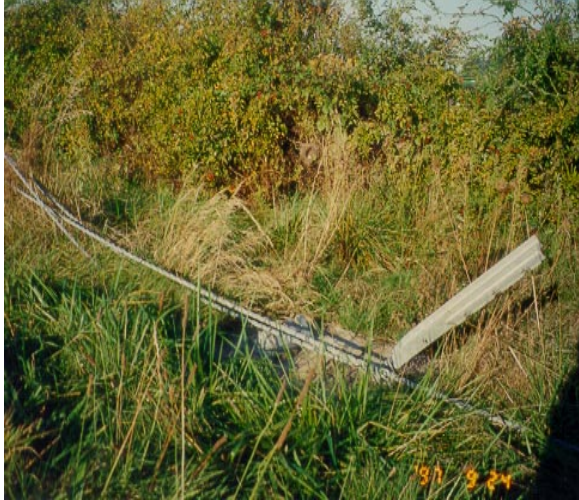
Figure 3.6: Energy dissipation-cable release from breakaway anchor angle and anchor post bracket (south end)

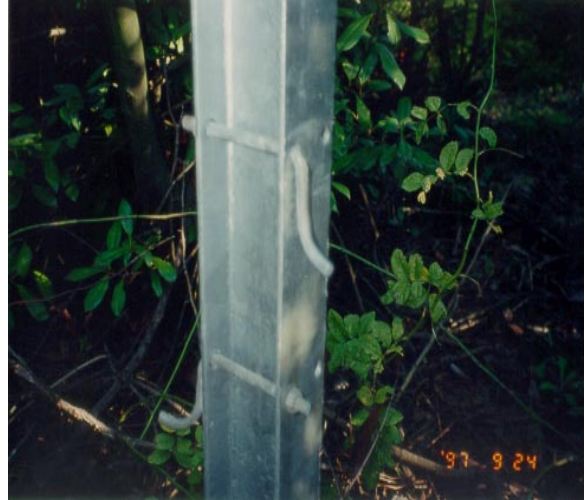
Figure 3.7: Energy dissipation-cable release from round bend hook bolts

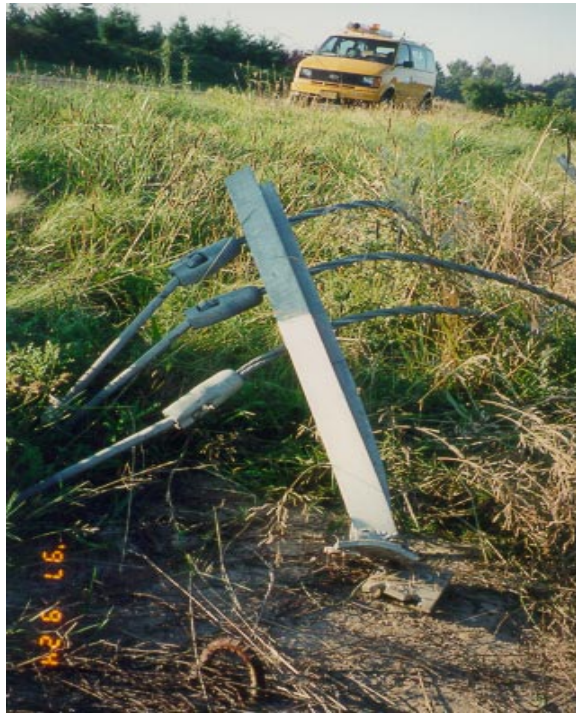
Figure 3.8: Energy dissipation-cable release from breakaway anchor angle and anchor post slip base failure

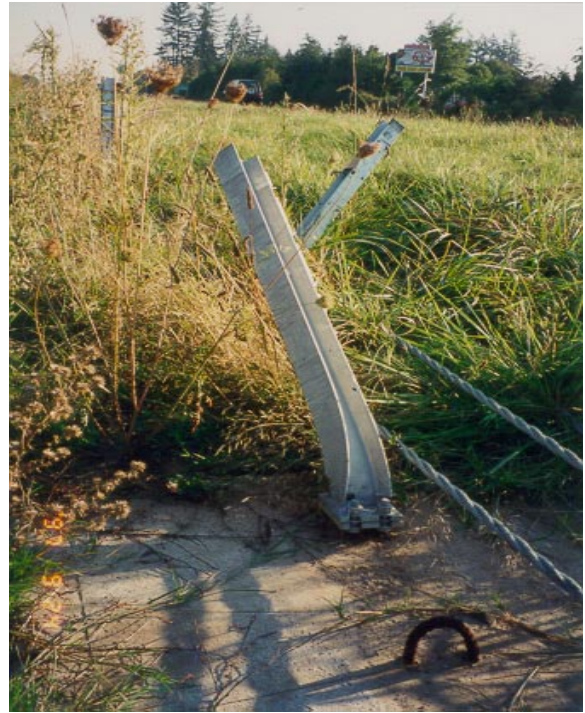
Figure 3.9: Energy dissipation-weak-post bending

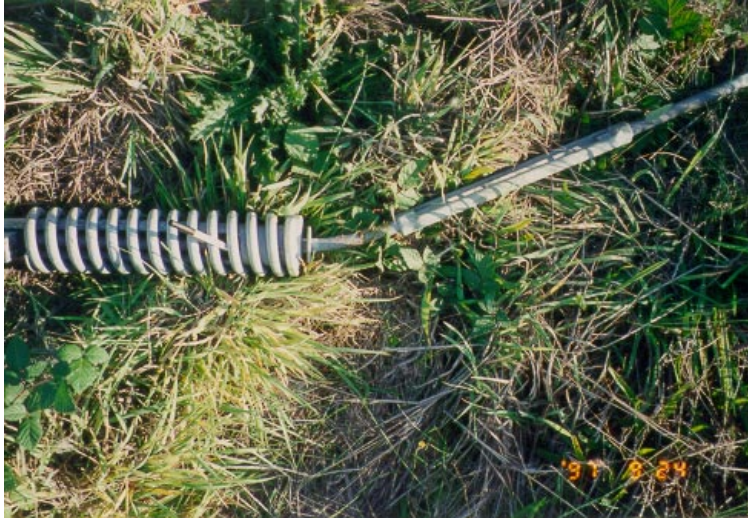
Figure 3.10: Energy dissipation-spring cable turnbuckle deformation

As shown in Figures 3.2-3.10, significant barrier damage may occur with any single hit. So far, there has not been a cross-median accident in a location where the barrier needs repair work. Even so, consideration should be given to the risk of cross-median accidents where the barrier is damaged.
