Caltrans First Repair Was A Half Collapse

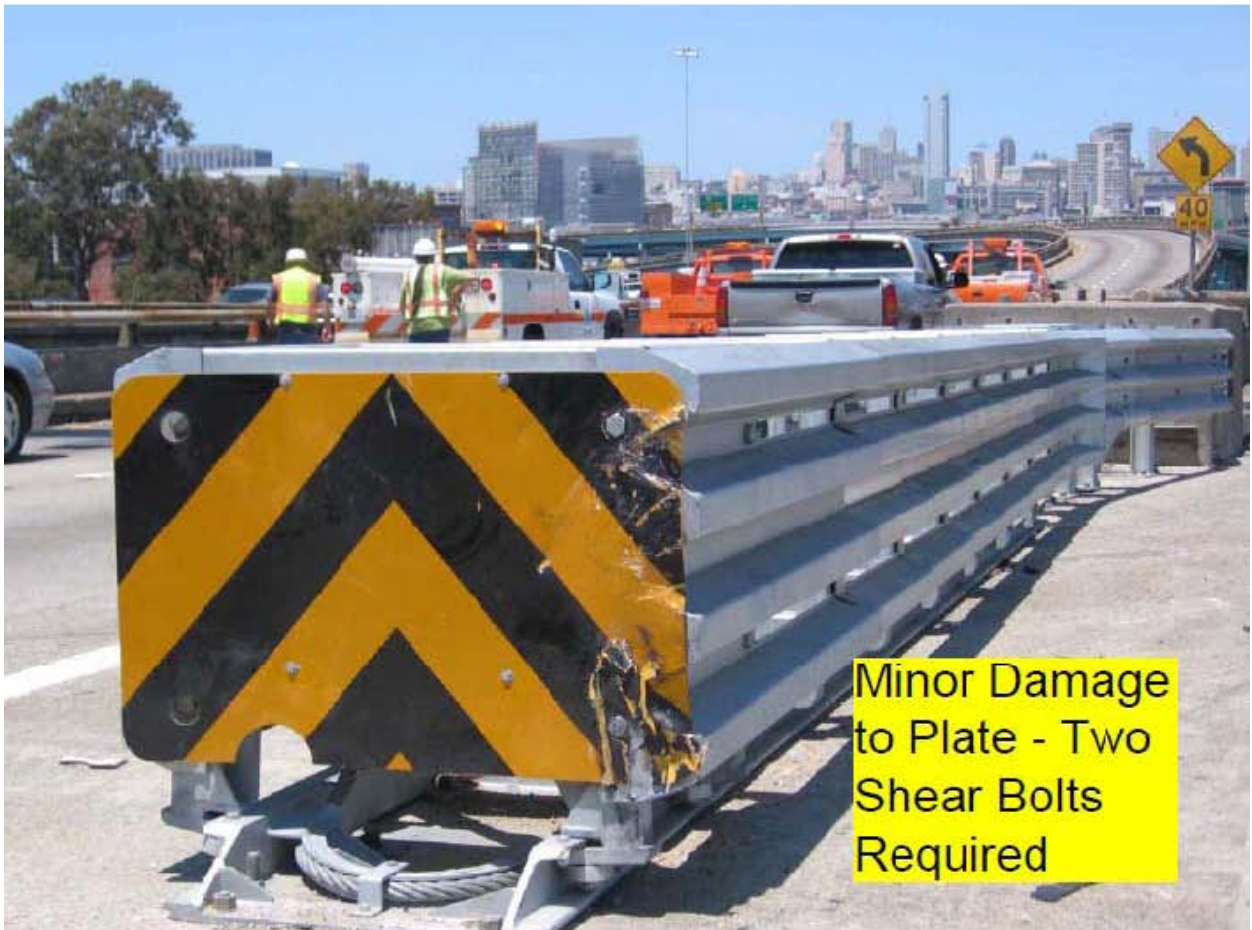
Minor Damage to Plate - Two Shear Bolts Required

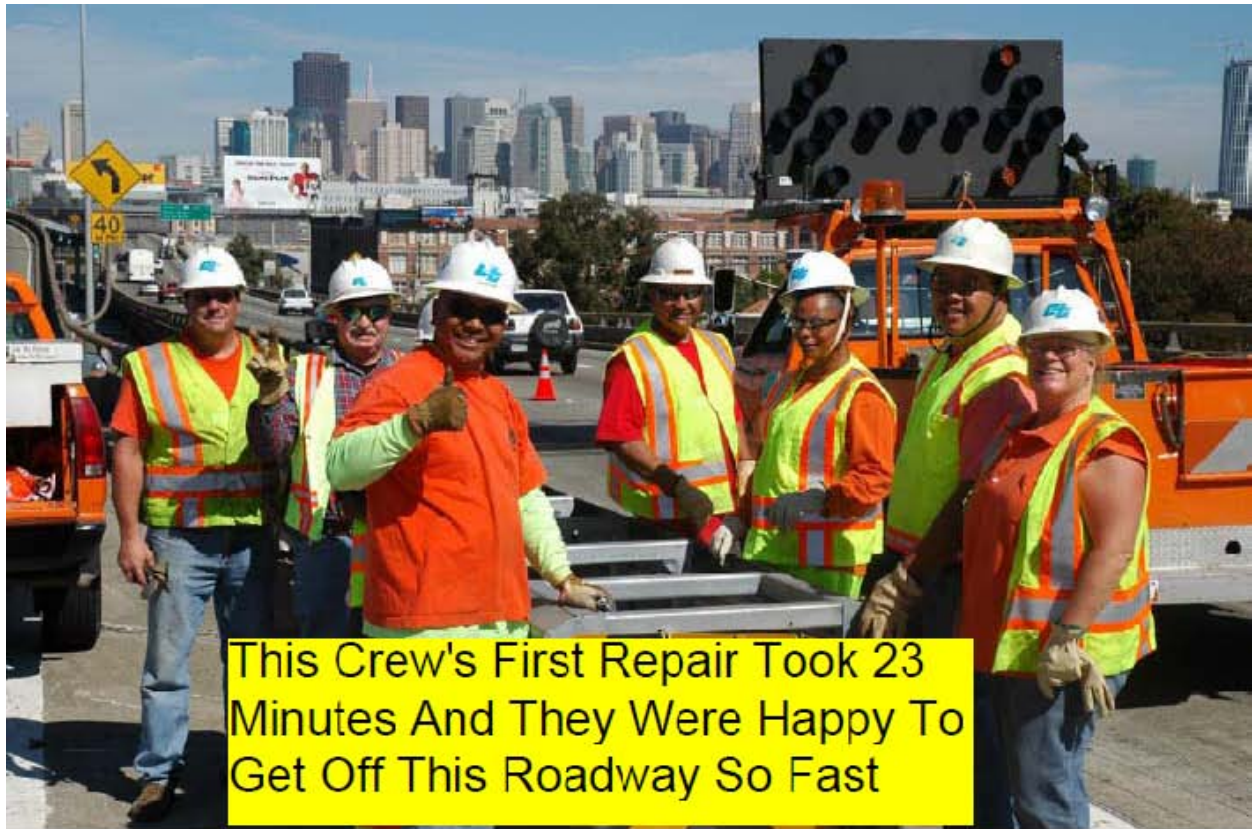
This Crew's First Repair Took 23 Minutes And They Were Happy To Get Off This Roadway So Fast
