BRIDGE EXPANSION JOINT SYSTEMS

AASHTO Innovation Initiative (A.I.I.)

JOINT MAINTENANCE WATERPROOF WITHOUT REPLACEMENT

Presenter – Mark Croarkin, MoDOT

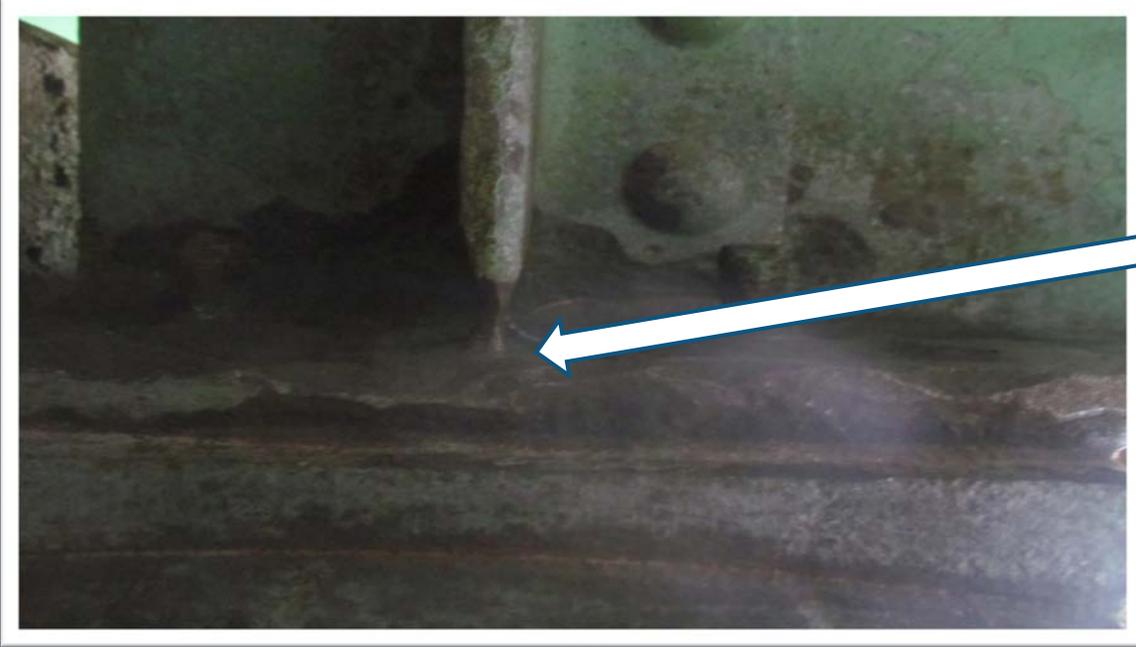
VERTICAL STIFFENER
SECTION LOSS

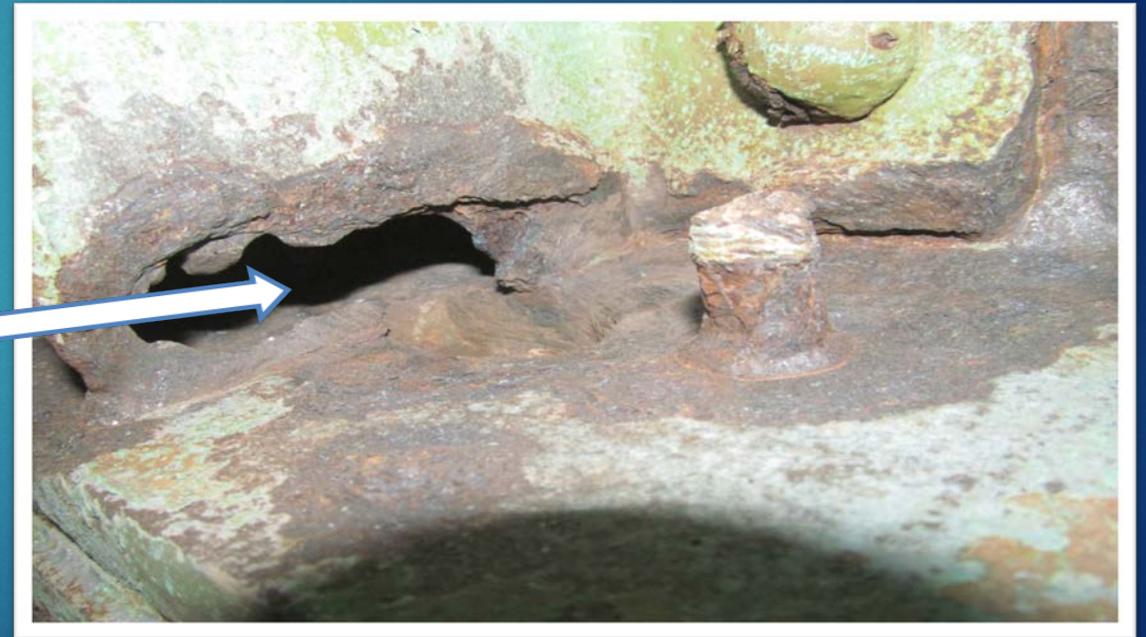
HOLE IN WEB
OVER BEARING

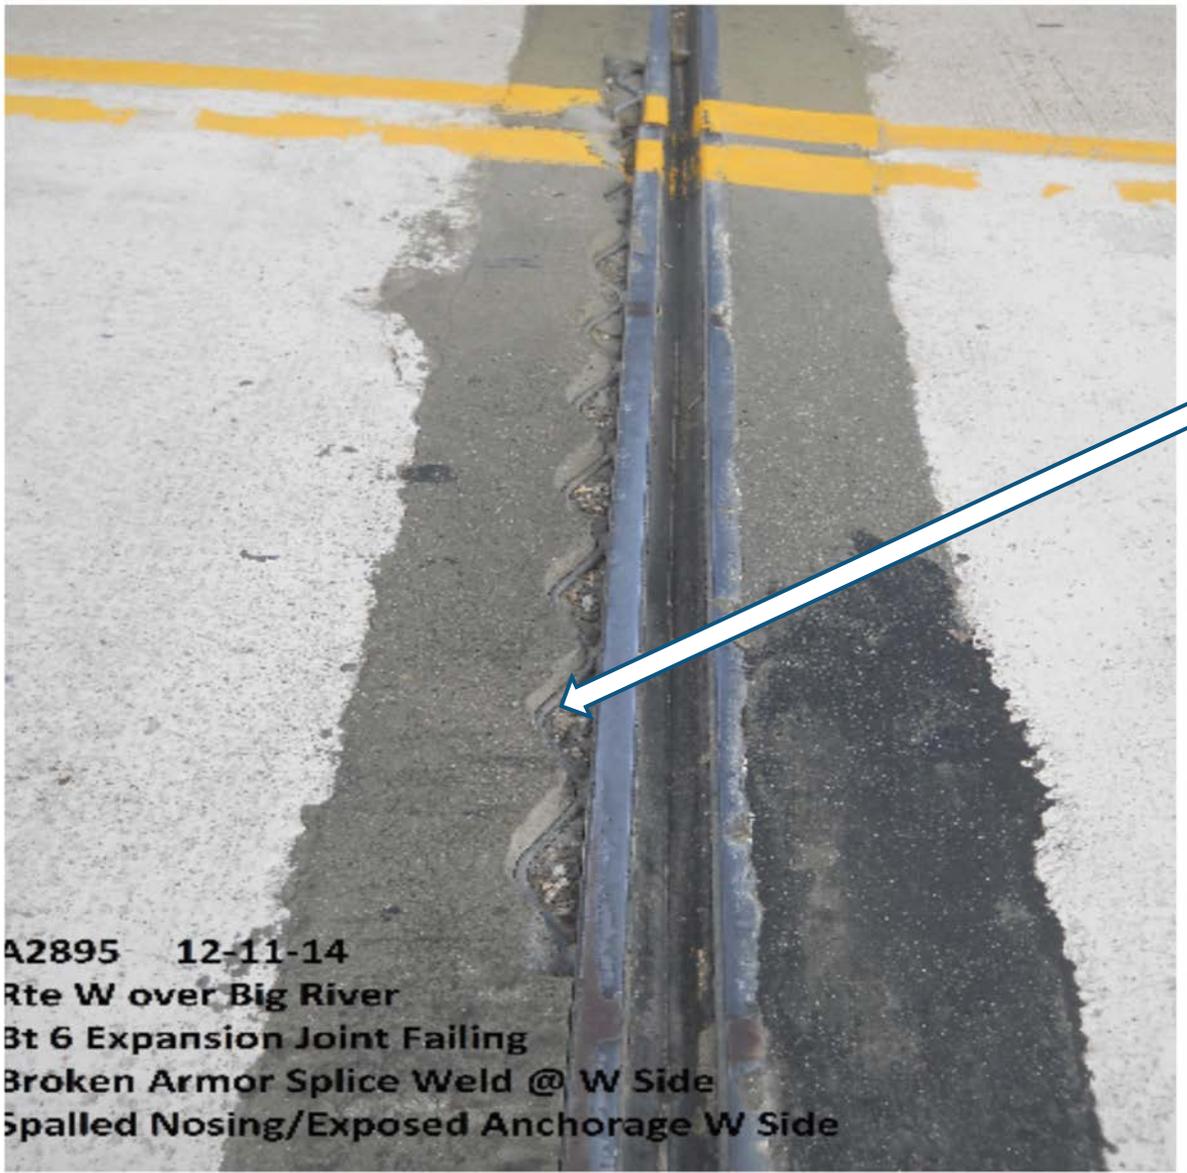
A2895 12-11-14
Rte W over Big River
Bt 6 Expansion Joint Failing
Broken Armor Splice Weld @ W Side
Spalled Nosing/Exposed Anchorage W Side

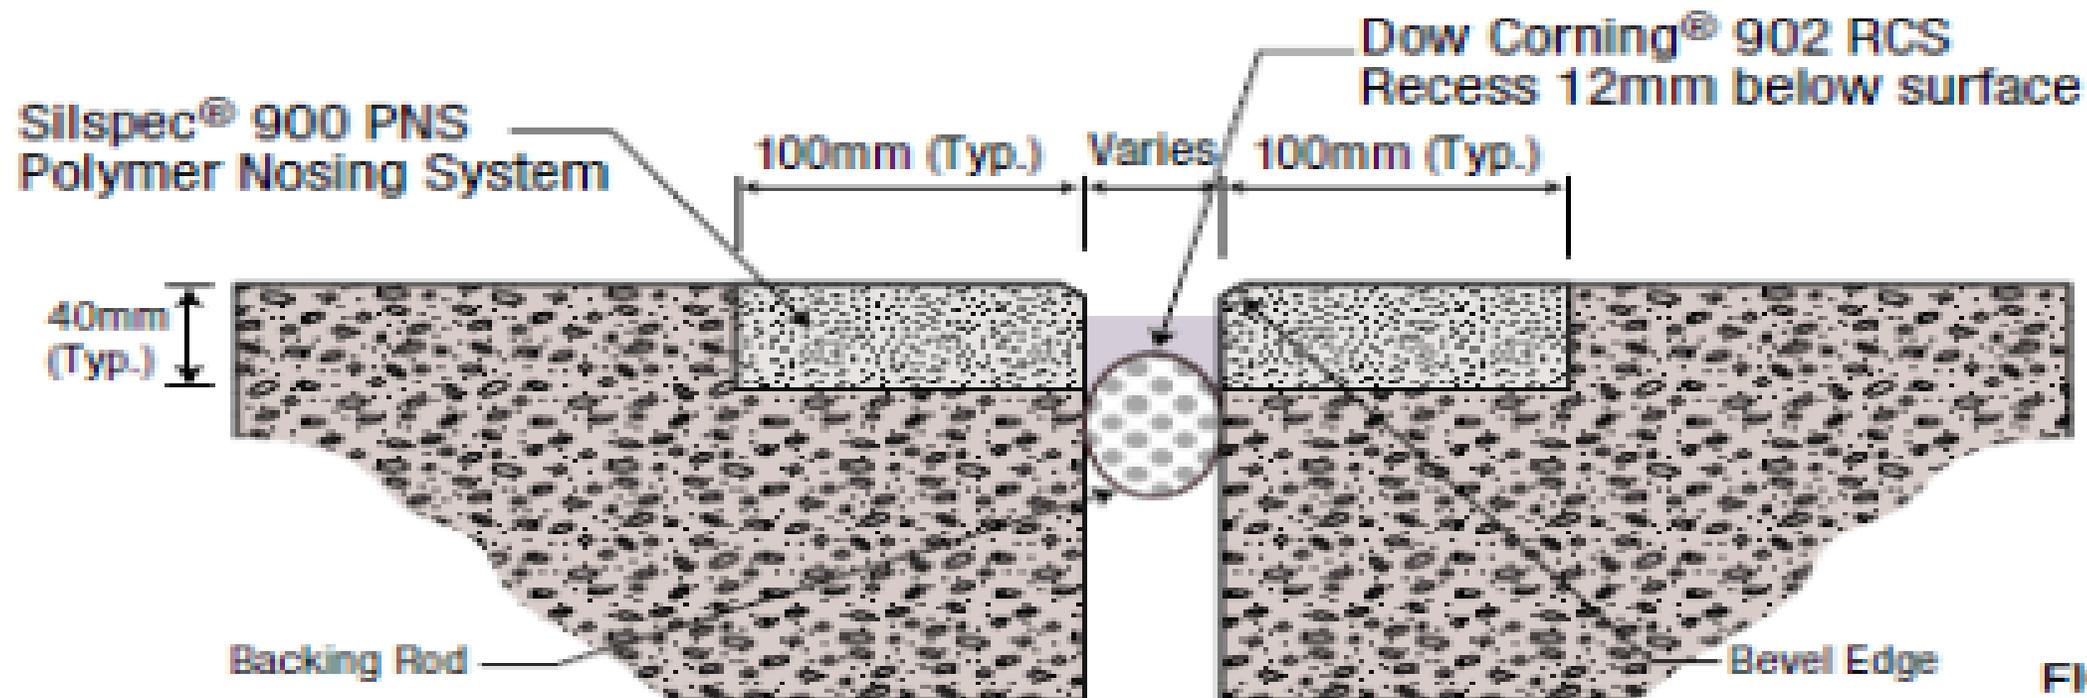
FIG 1

XJS® STANDARD DRAWING FOR NEW WORK INTO CONCRETE DECK

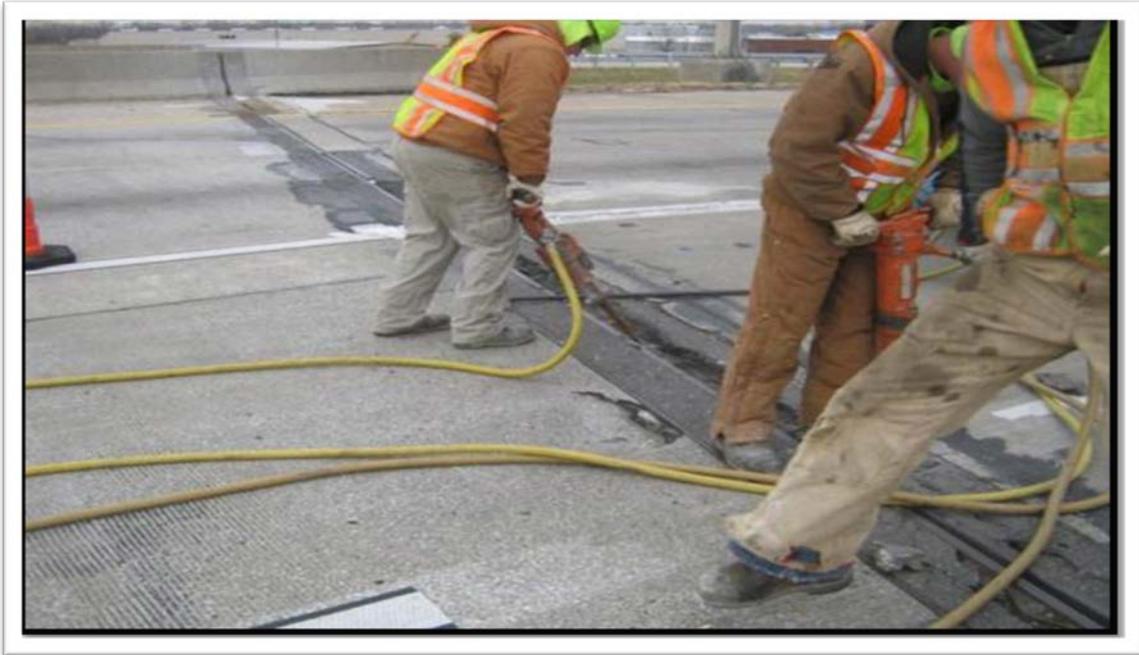
REMOVAL

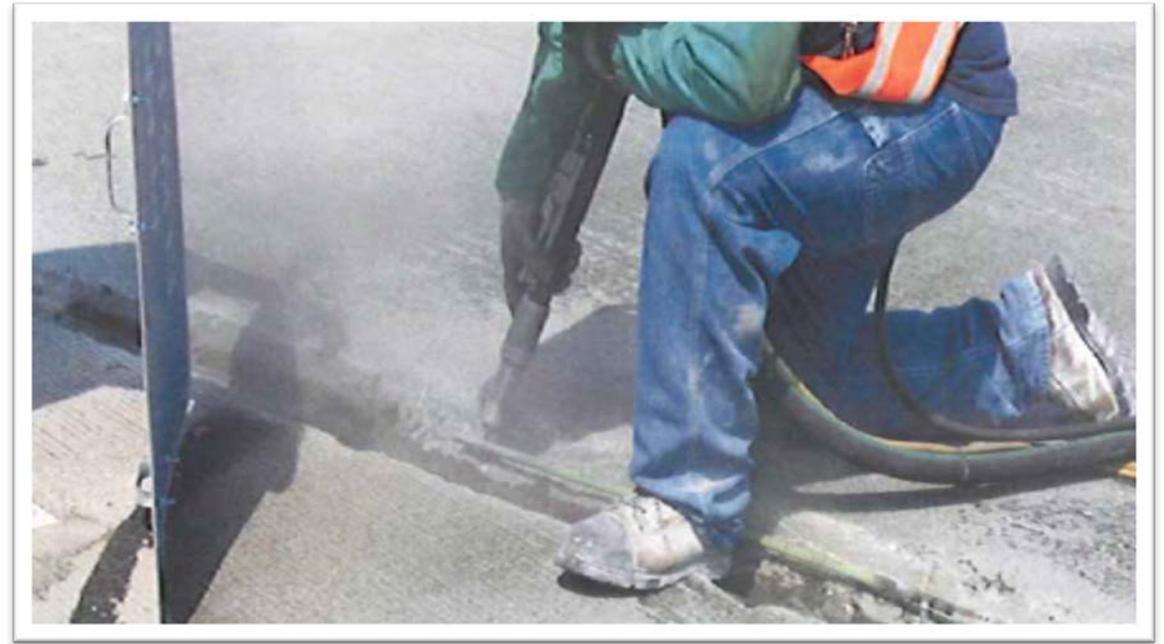
SANDBLAST PREP

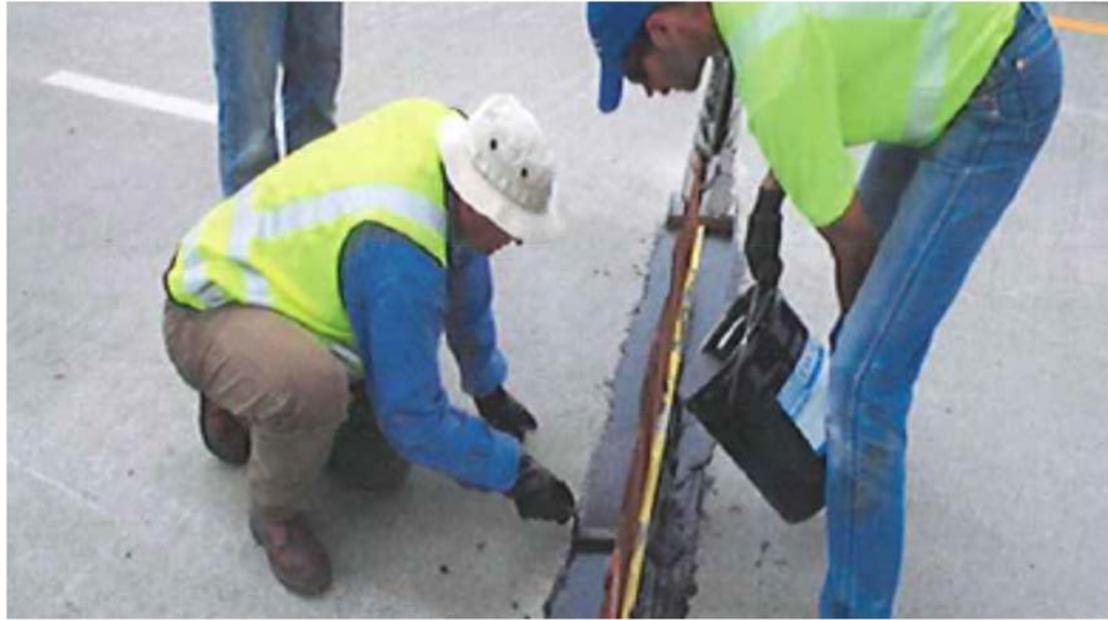
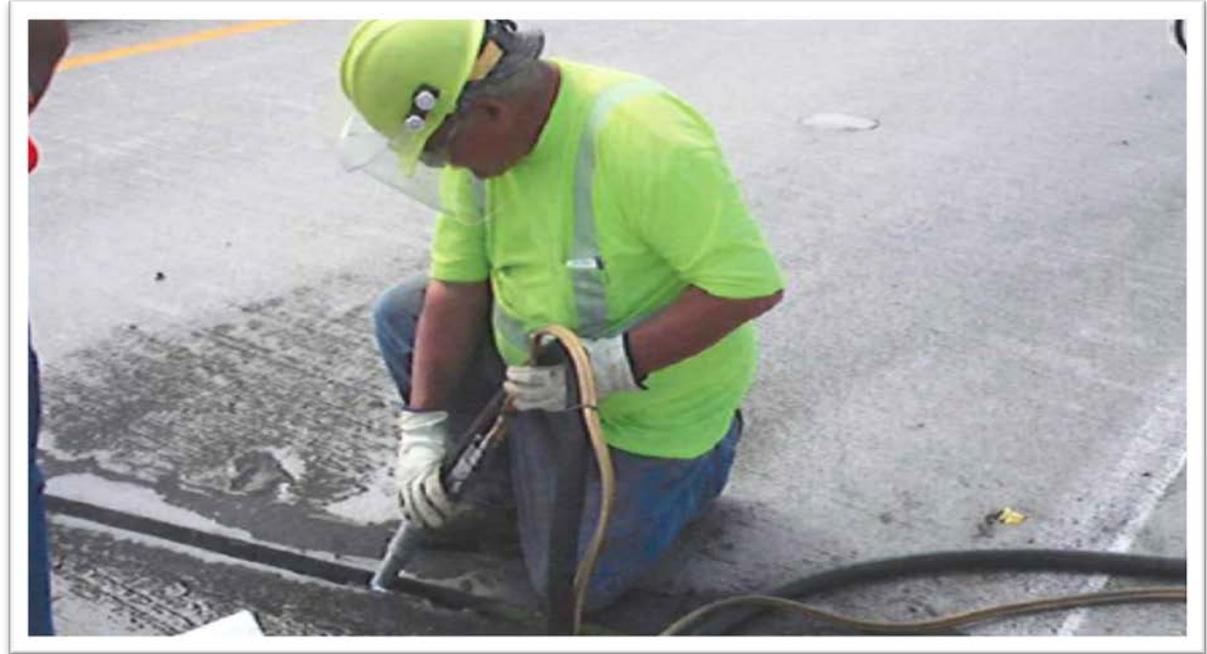
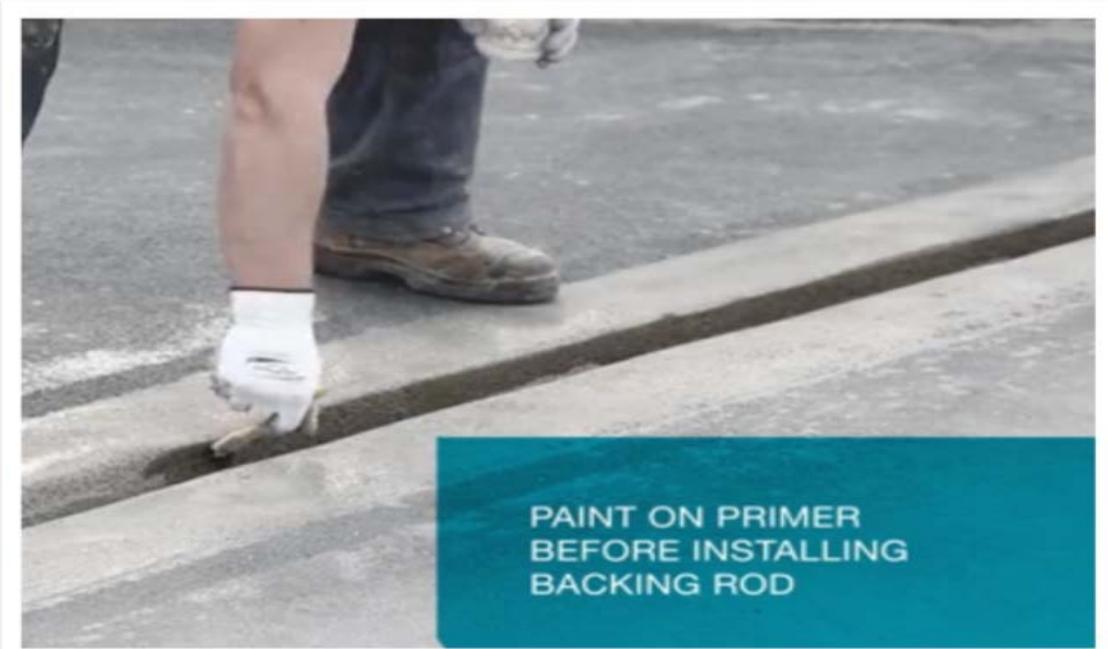
NOSING
SANDBLAST FOAM
PRIMER

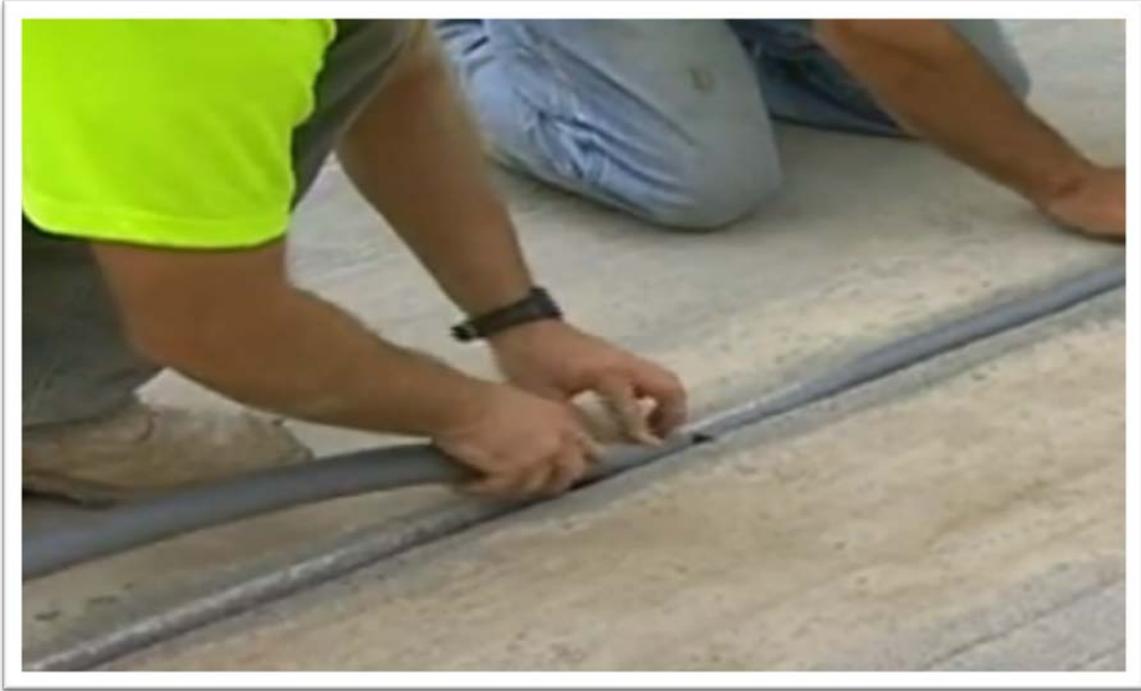
BACKER ROD

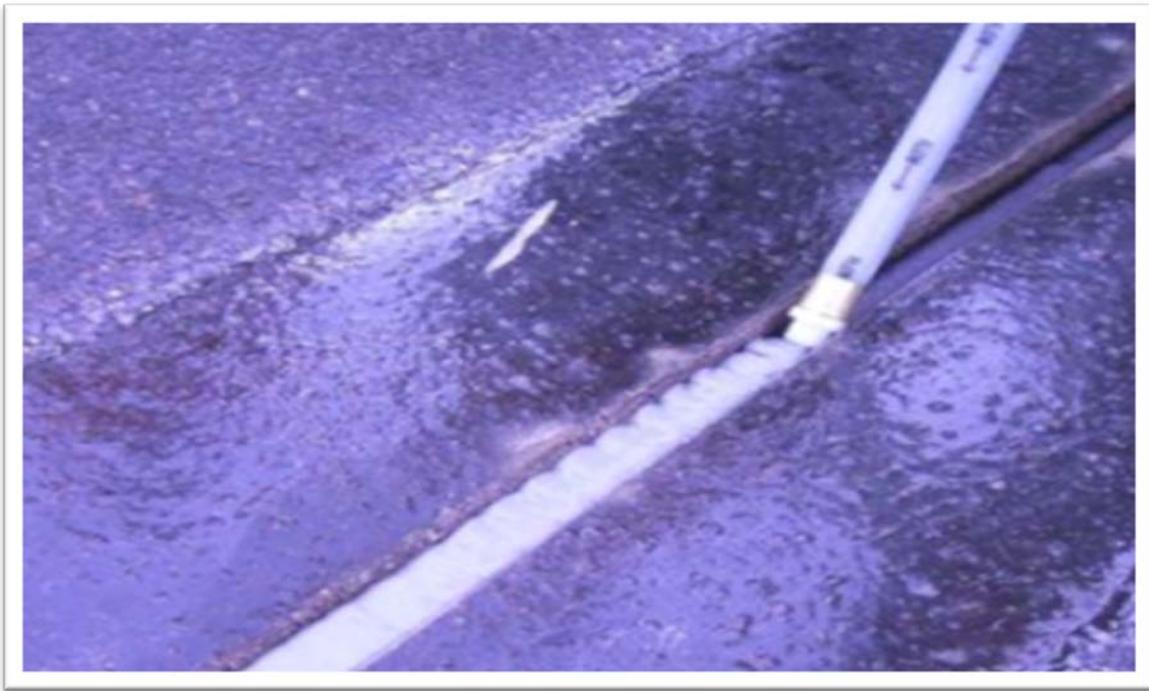
SILICONE

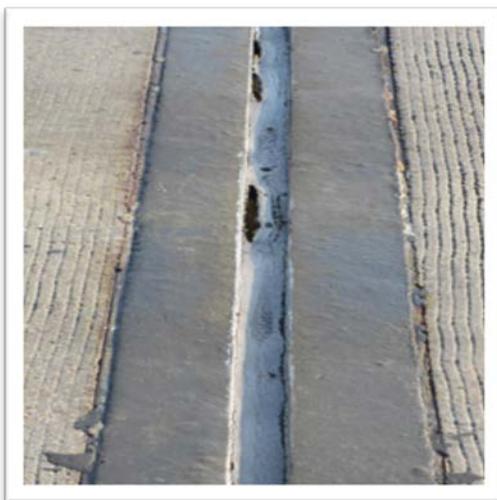
A4640 St. Louis Co. I-270 4-21-11
Silicon debonded in east joint.

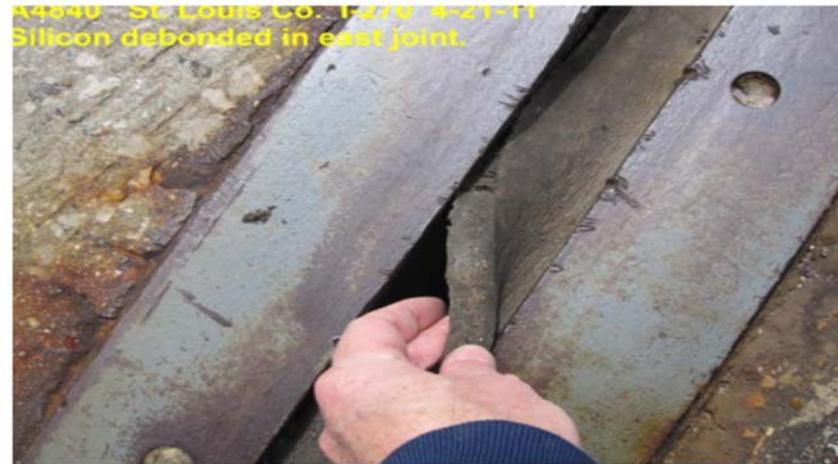
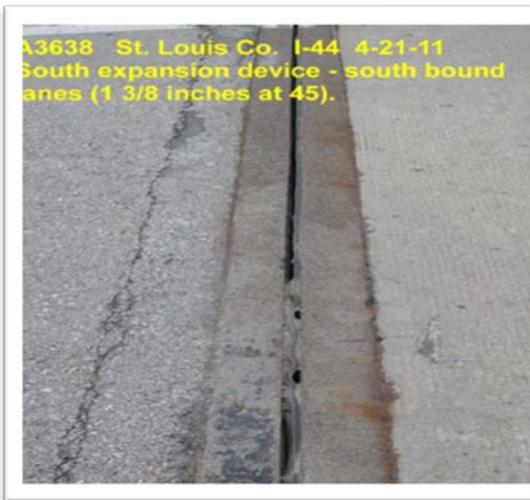
A3638 St. Louis Co. I-44 4-21-11
South expansion device - south bound
lanes (1 3/8 inches at 45).

A3638 St. Louis Co. I-44 4-21-11
South expansion device - south bound
lanes - silicon to narrow.

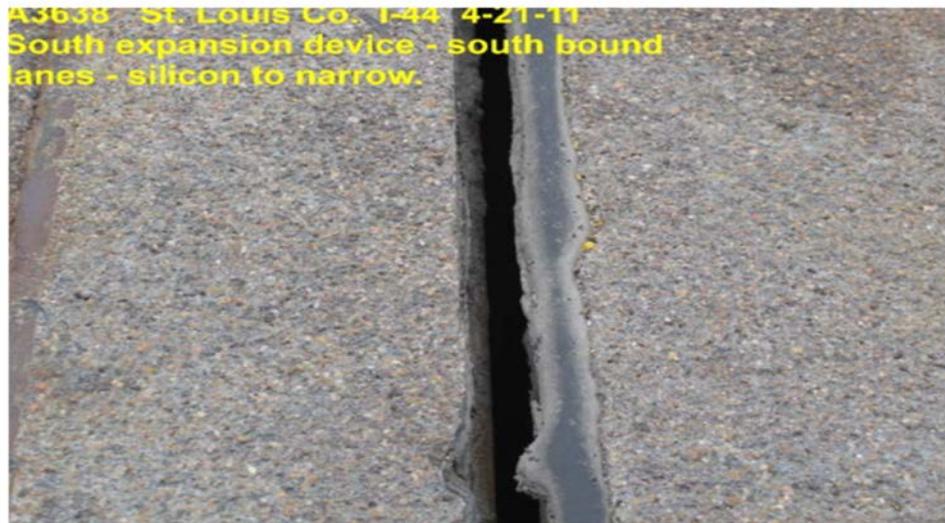
A4629 Jefferson Co 1/18/12
MO 30 E @ BIG RVR
Bent 4 Exp. joint failing
Repair expansion joint

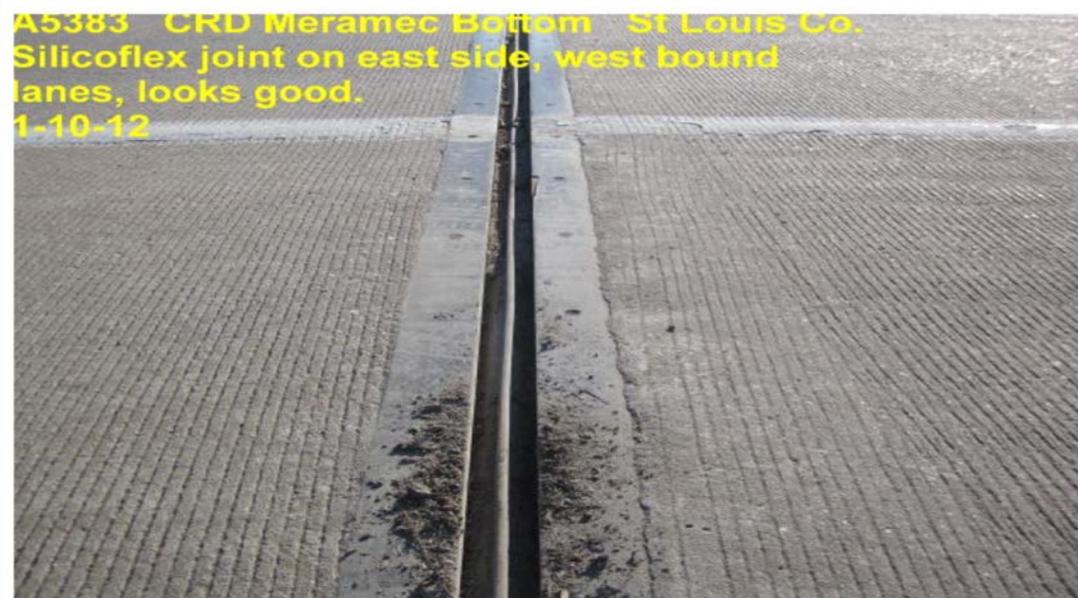
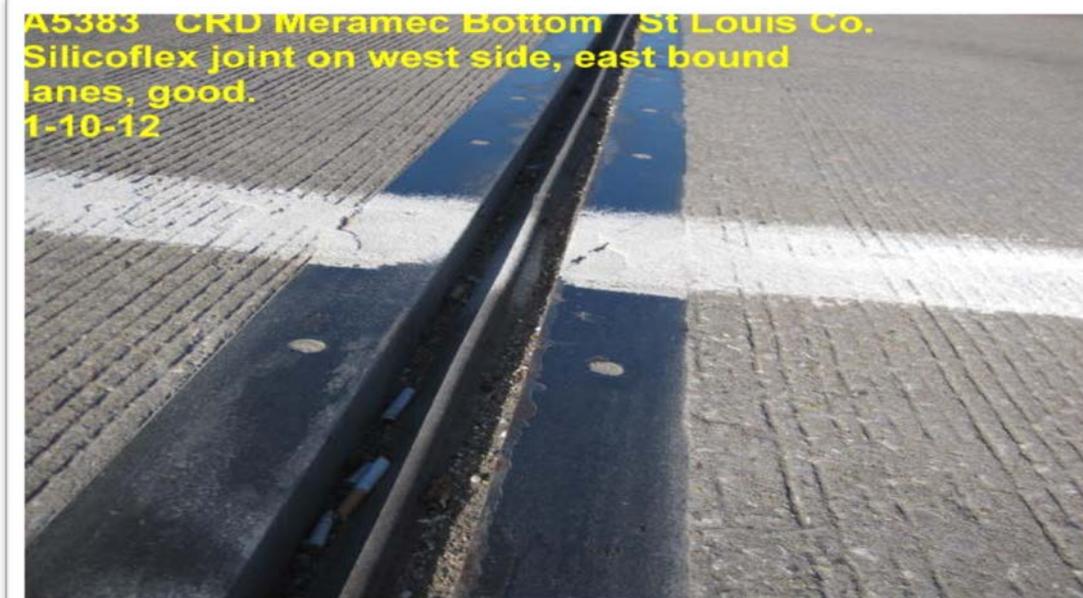
IT STILL LOOKS GOOD

EXCESSIVE GLUE

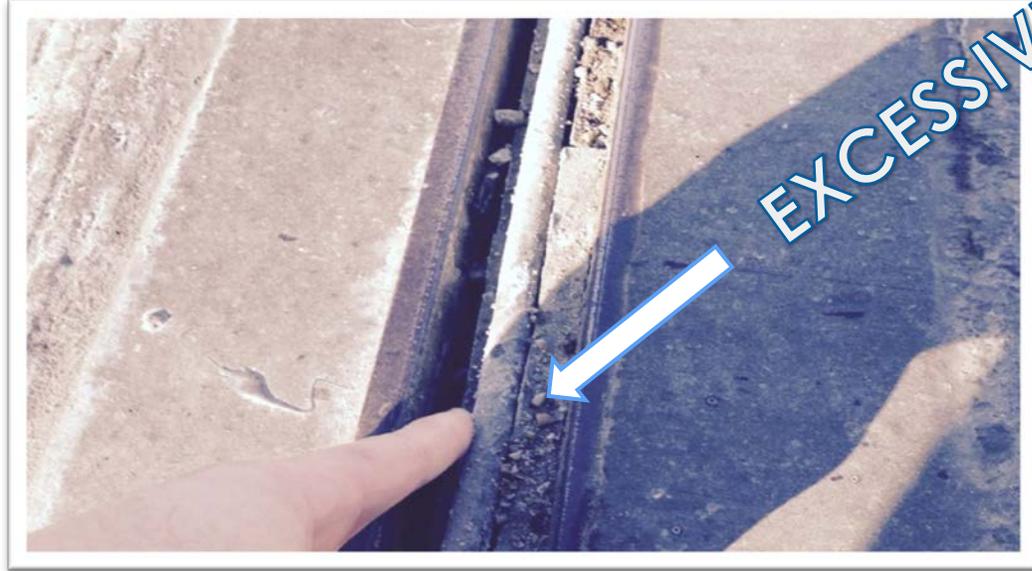
CANNOT TRIM

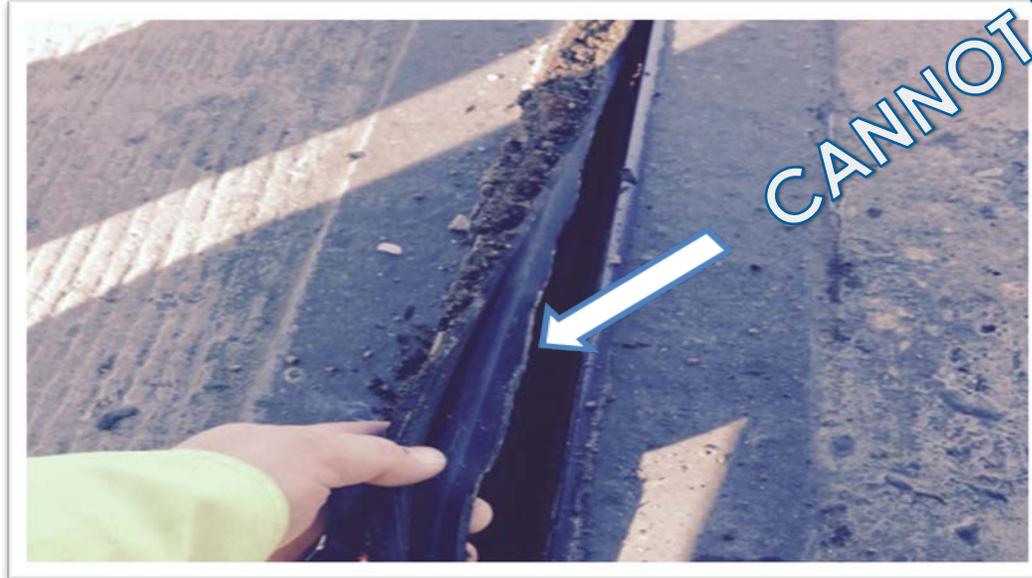
GLAND FAILURE

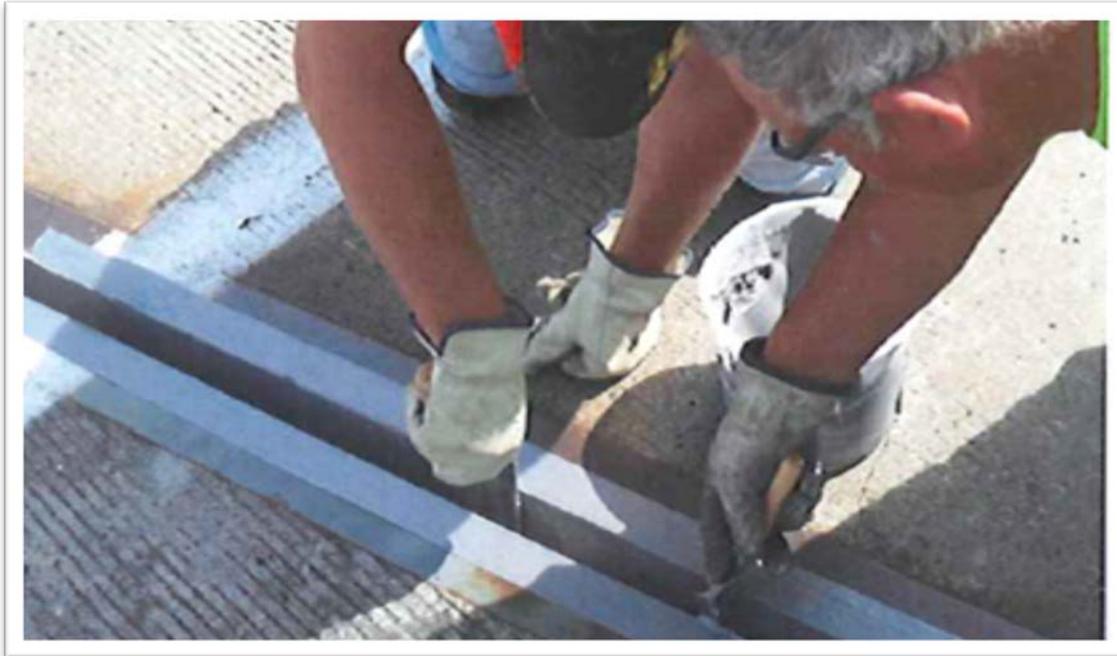
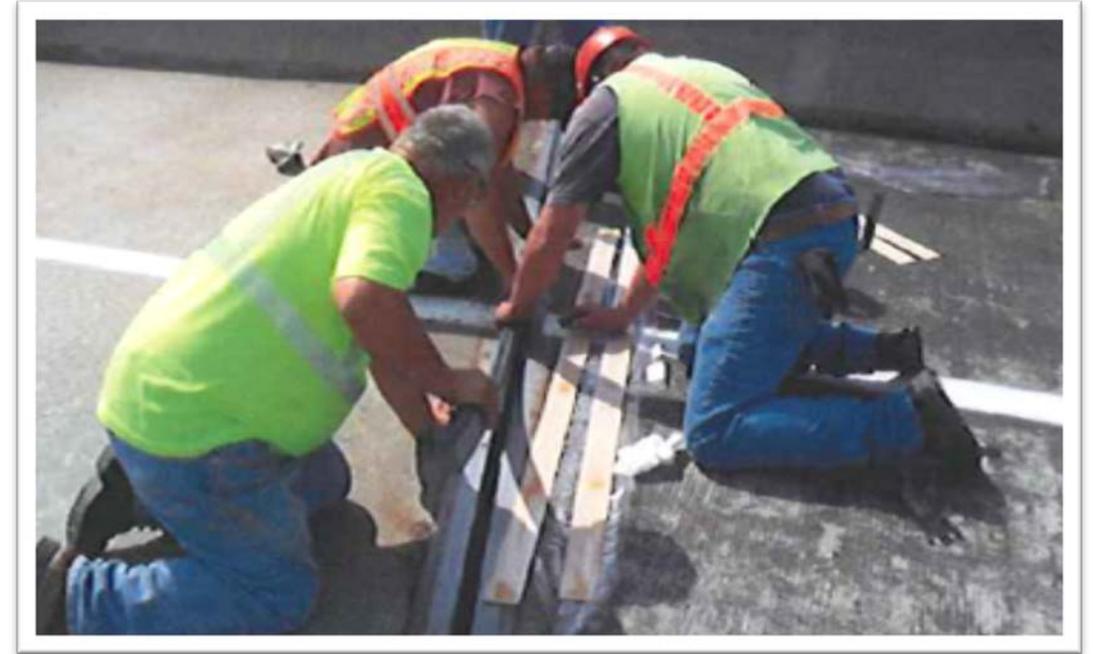
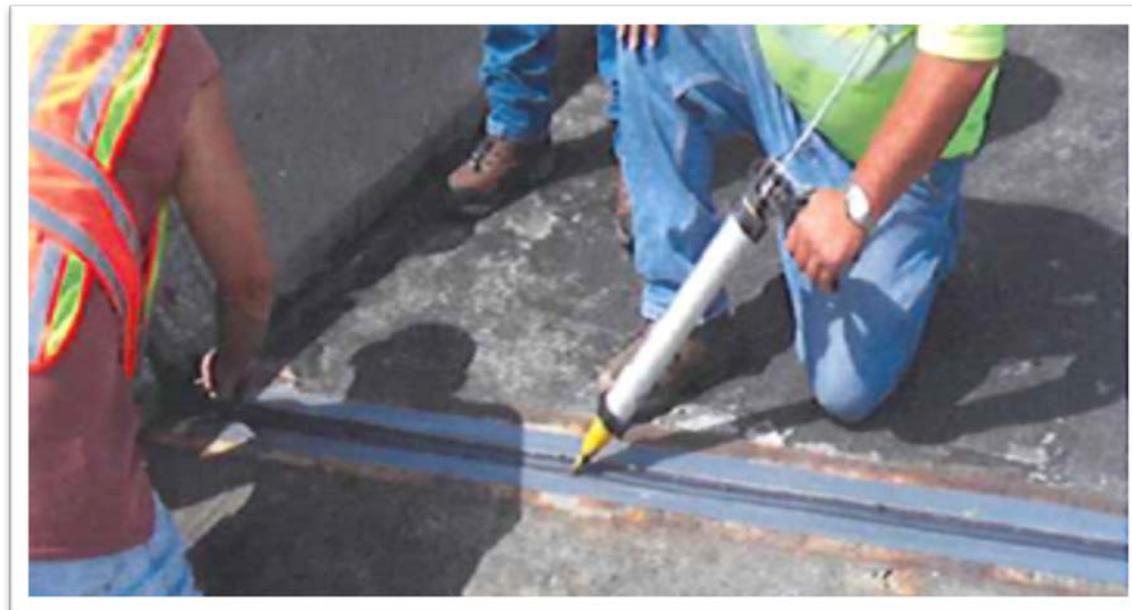
EPOXY
INSERT GLAND
SILICONE ADHESIVE

COMPLETED

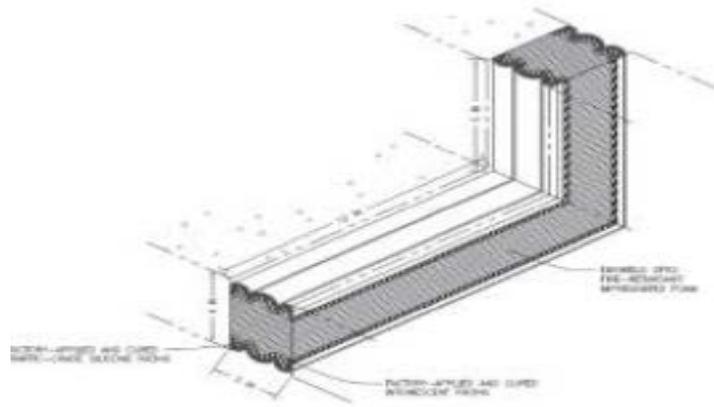
Universal-90 Upturn Transition

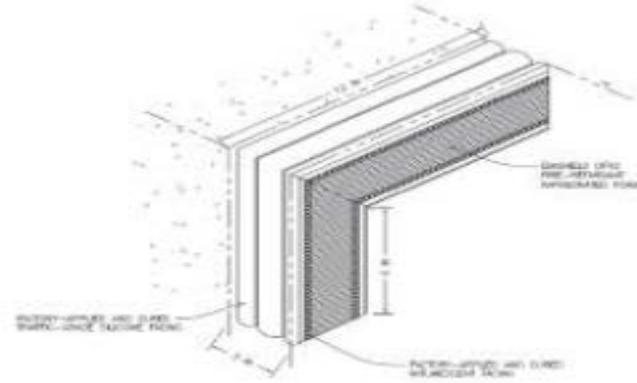
Universal-90 Flipped-Over as Downturn Transition

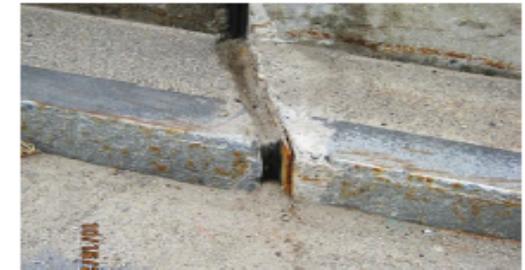
The joint seal splices (left photo) seem to be holding up well. The seal is supplied in 6.56 LF (2 m) lengths and is bonded end to end in the field with a silicone adhesive prior to insertion into the joint. The silicone sealant bead that runs the length of the seal and bonds to the steel is still holding up well for the most part.

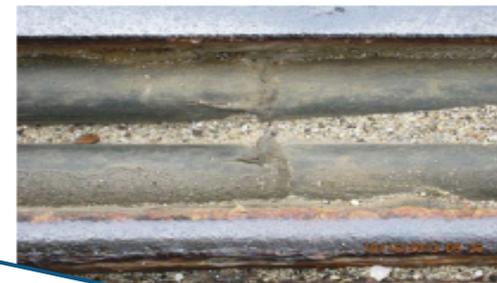
It was noted that in some areas the bond has begun to weaken on the seal side of the bead and has caused some separation. It is unclear to what depth the debondment extends to. See photo below.

Overall, the joint seal is performing well. Bridge Maintenance noted that they have seen no evidence of leakage underneath the deck.

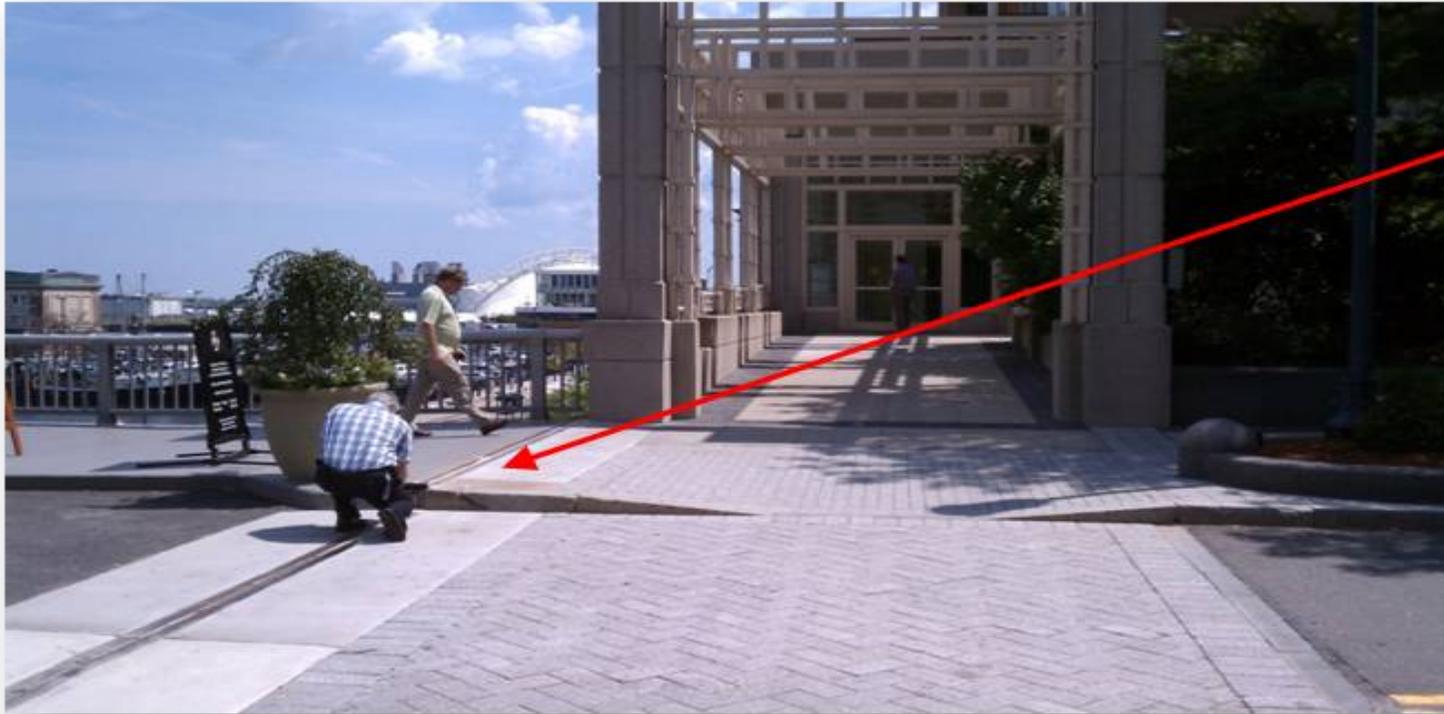
Expansion joint was installed in spring of 2011.

During the first hot spell of the summer the joint closed down and wax oozed onto the walkway as well as dripped below.

Results are dripping wax which contaminated the brick and was tracked into interior of the Seaport Hotel.

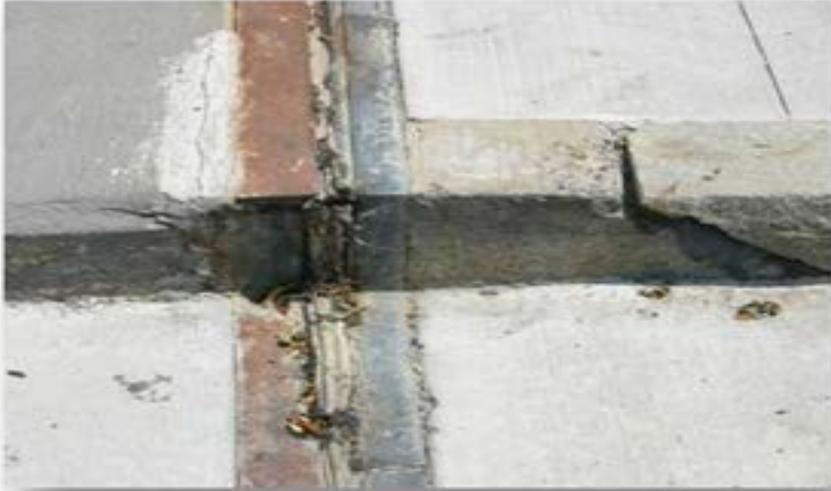
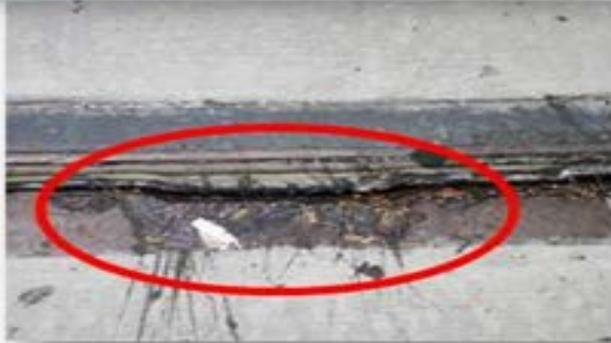
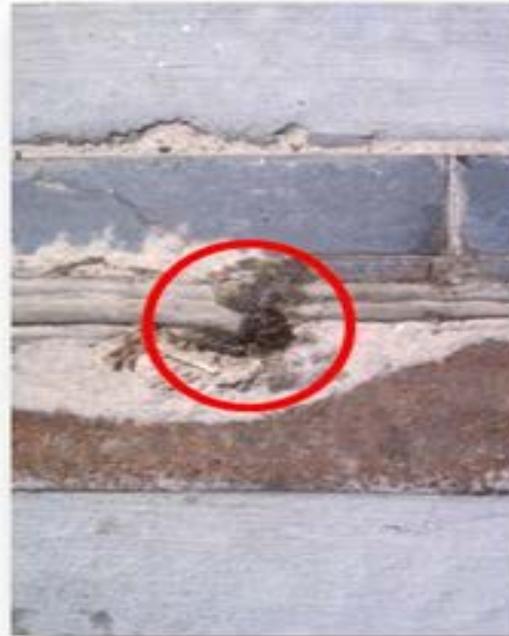
Examples of **the melted wax** on the top of the bridge-walkway during summer

Once the wax has been expelled from the foam during warm weather the product fails to expand as the joint opens during cold weather.

Gap forms and joint
leaks below

Require all products to **be certified in writing to be free of wax** according to independent testing using FTIR and DSC

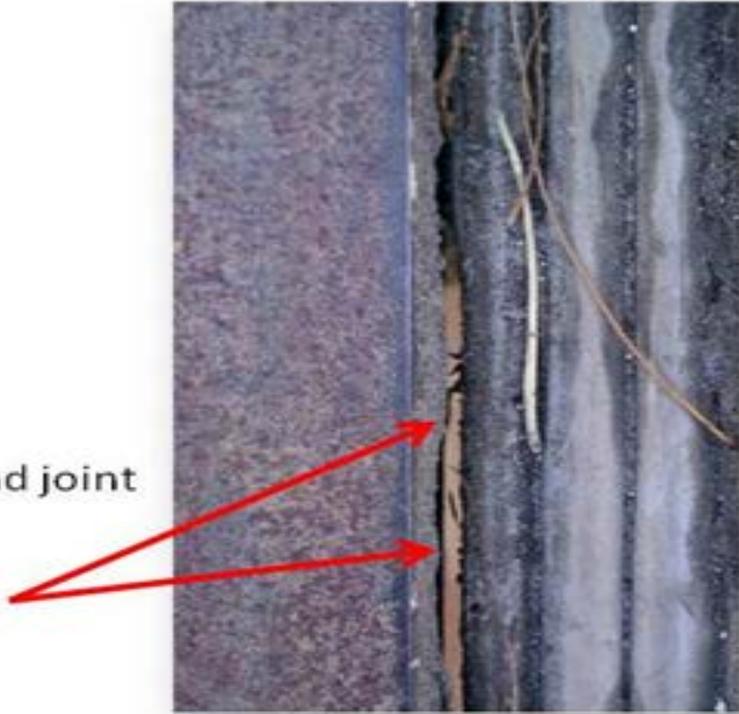
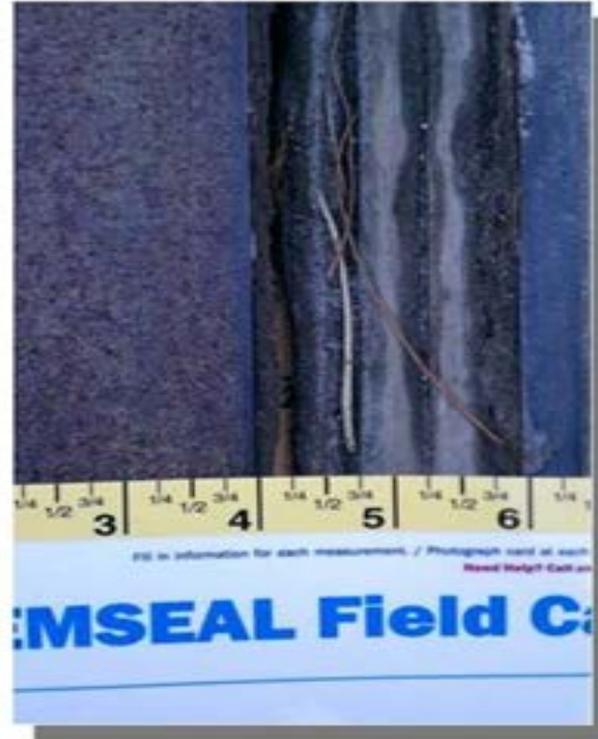
Photos were taken on 50 degree day (same location as previous)
