Beam End Repair with Ultra-High Performance Concrete Webinar

February 17, 2023 10:30 a.m. EST

Beam End Repair Using UHPC An Introduction

Beam End Repair Using UHPC Connecticut DOT's Implementation Experience

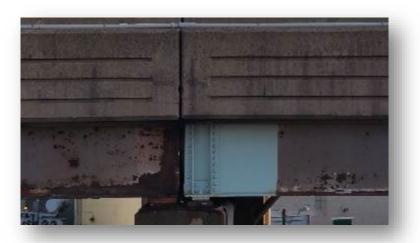
Conventional Repair Method

- Conventional repair method using new steel plates is still susceptible to future corrosion.
- Jacking is sometimes required to minimize in-situ member stress:
 - Costly
 - Disruptive to traffic
- Surface Preparation: extensive surface prep and lead paint removal may be required

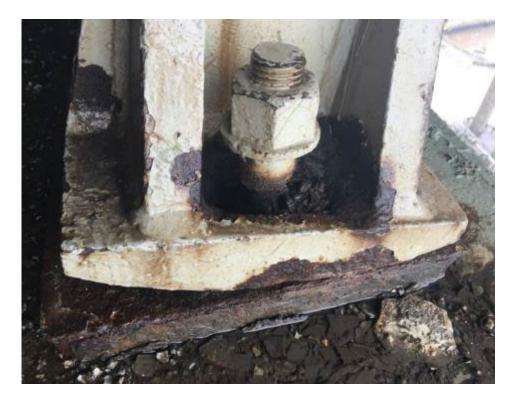
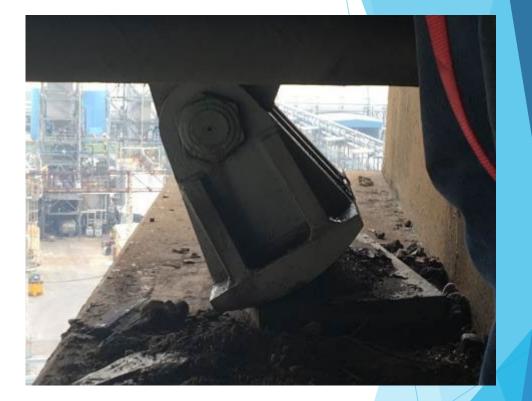
Problems: Rocker Bearing Deterioration

Corrosion of Steel Plates and Bolts

Large Rocker Rotation. Base Plate Movement. Anchor Bolt Shear-off.

(The rocker condition was most severe at Bent 45, Girder 6, and moderate at other locations.)

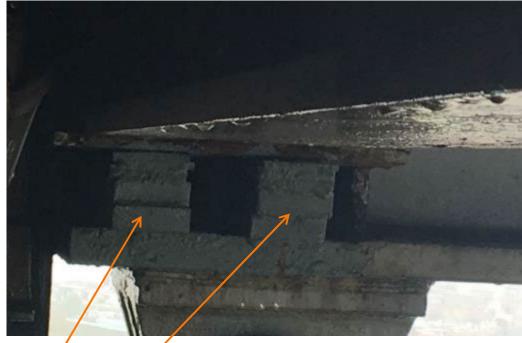
Temporary Repair (December 2018)

Shim Plates Installed (All Bearings)

At B45G6: Base Plate Extended

Stiffening Plates Welded (At Some Bearings)

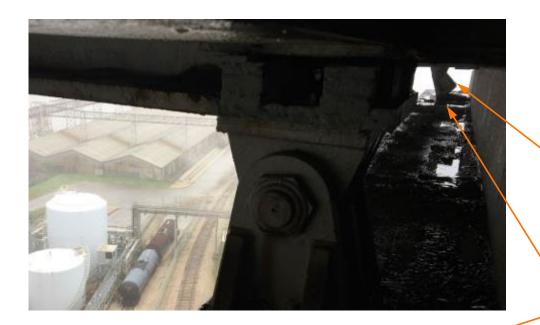
Permanent Repair Scope: Rocker Bearings

Urgent Repair--- Bearings at Bent 45:

Girder 6 rocker position must be corrected.

Deteriorated bearing base plates and anchor bolts under 4 girders at Bent 45 must be replaced.

→ Girder Jacking Is Needed at Bent 45

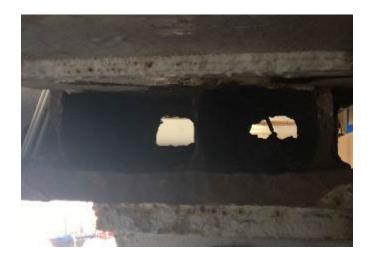
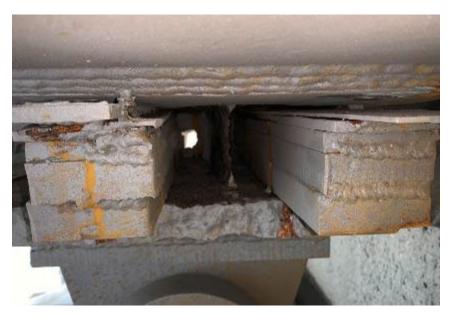
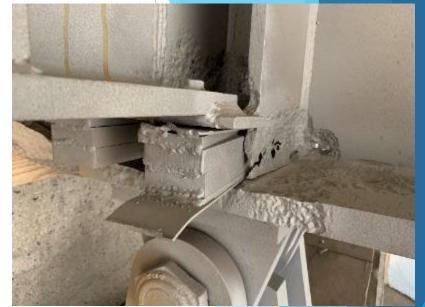
Permanent Repair Scope: Girders and Diaphragms

Repair the corroded and damaged plates to restore the load paths for DL and LL.

Provide a safe load path for jacking the girders to perform bearing repairs.

Improve details to minimize future corrosion.

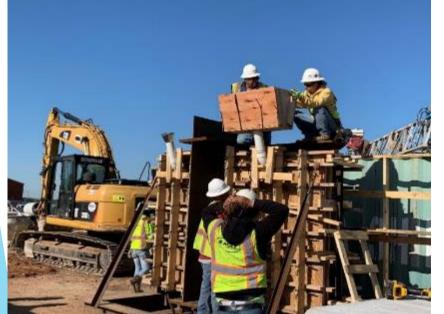
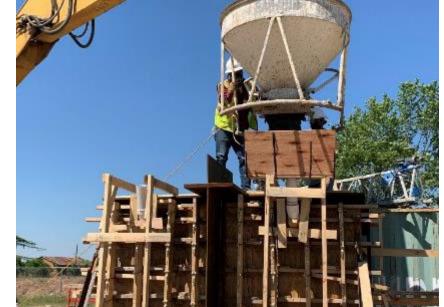
Mock-Up

□ Mock-up UHPC pour with real size prototype in April 2020.

Major leak occurred, indicating challenges on forming tightly around steel with high hydrostatic pressure.

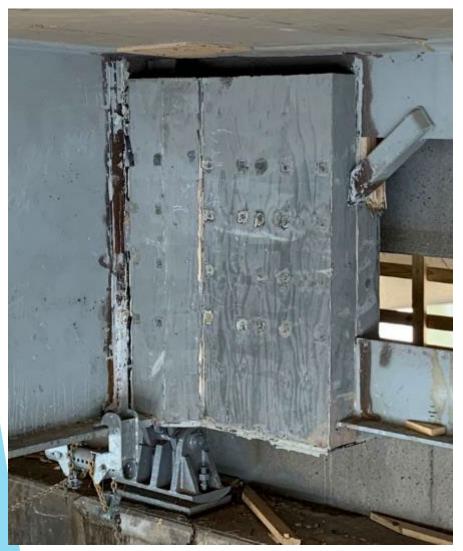
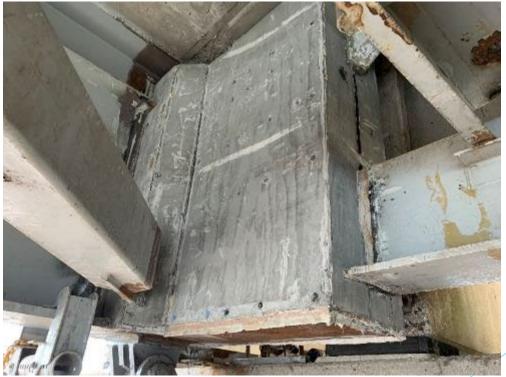
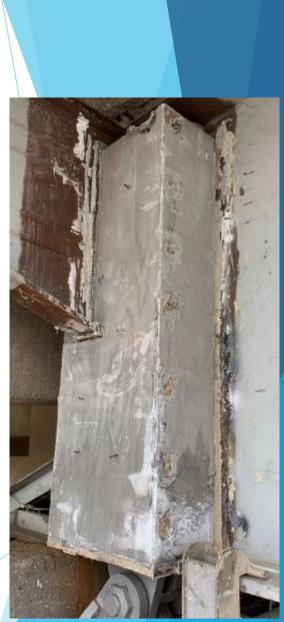
UHPC Form Removed

UHPC filled all the intended space! Solid load path established.

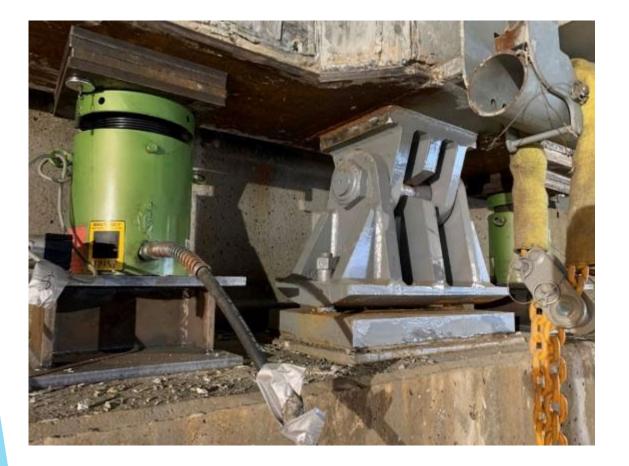
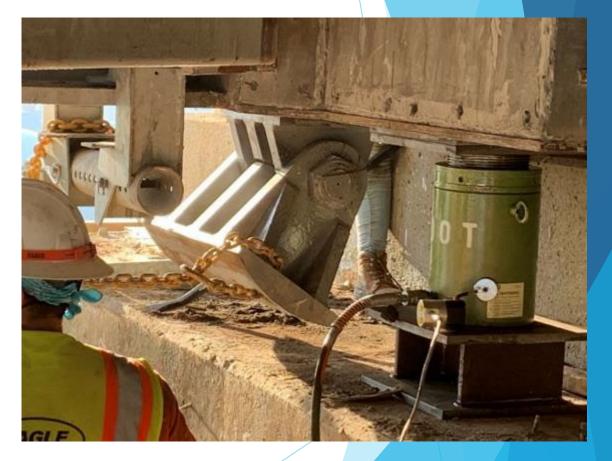
Jacking and Bearing Repair

Encasements performed very well during jacking operation.

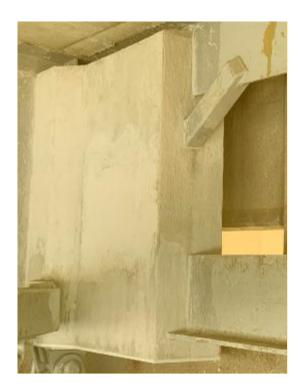
Superior UHPC Properties Used

- High Strength
 - Strengthening and confining the corroded steel joints.
- High Ductility and Reliable Tensile Strength
 - Preventing/minimizing cracking in varying stresses by live and jacking loads.
- High Flowability
 - Filling the small spaces around the corroded steel and the shim plates.
- Low Permeability
 - Improving corrosion resistance in future service.
