Automated Cross-Slope and Drainage Path Method

- Multi-Purpose Survey Vehicle (MPSV) to collect pavement data, and
- Automated Cross-Slope Analysis Program (ACAP) to analyze data

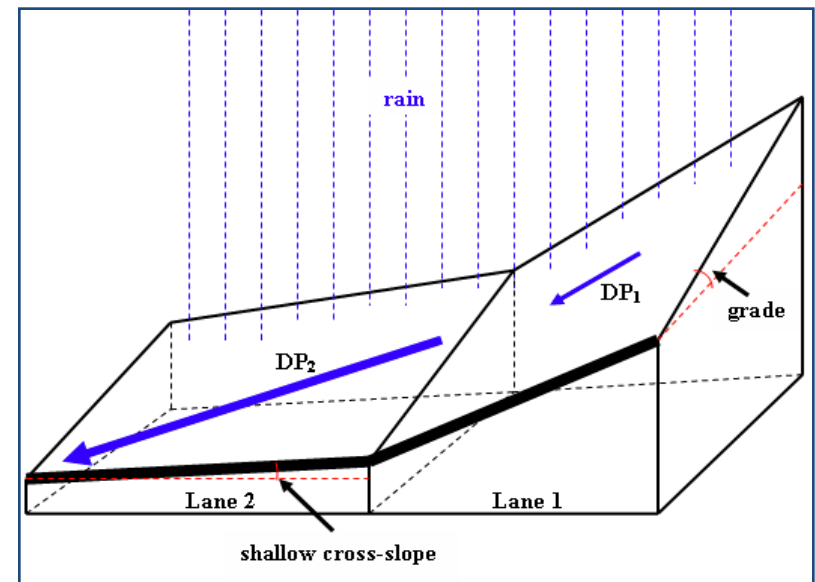
Pavement

- **Cross-slope**
Facilitates/hampers drainage
- **Grade**
Affects drainage path (DP)
- **Rutting**
Increases water retention

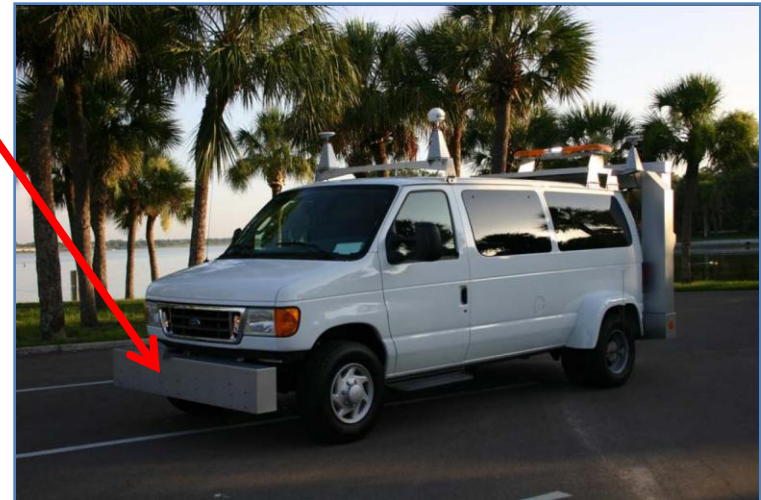
Multi-Purpose Survey Vehicle (MPSV)

- Inertial Profiling System
- Position and Orientation System (POS)

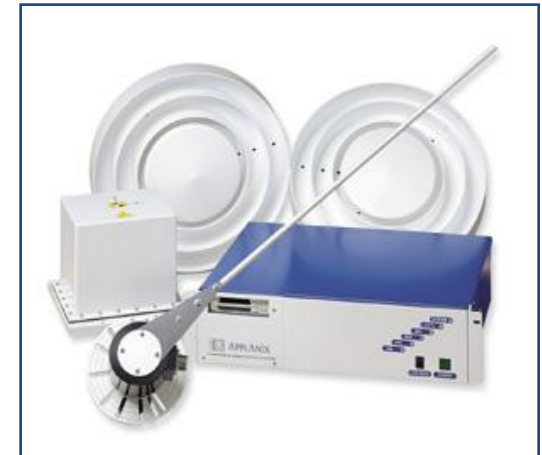
Position and Orientation System (POS)

- Differential Global Positioning System (DGPS)
- Inertial Measurement Unit (IMU)
- Distance Measurement Indicator (DMI)
- POS Computer

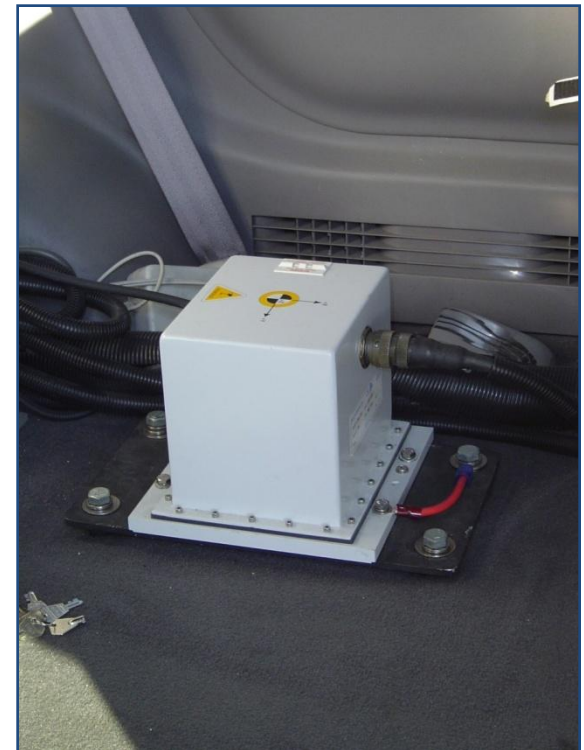
Inertial Measurement Unit (IMU)

- Generates tilt, roll and yaw data
- 3 accelerometers
- 3 gyroscopes

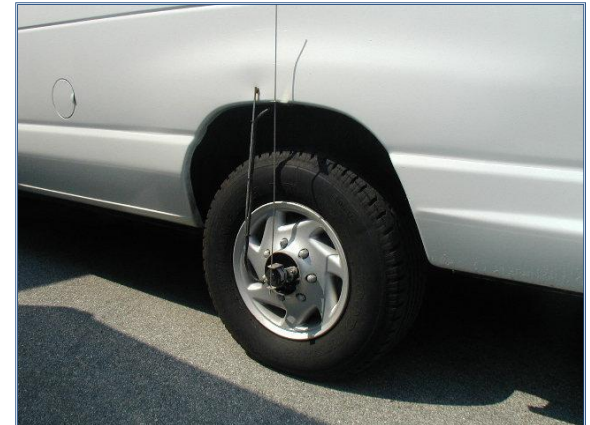
Distance Measuring Indicator (DMI)

- Linear distance referencing

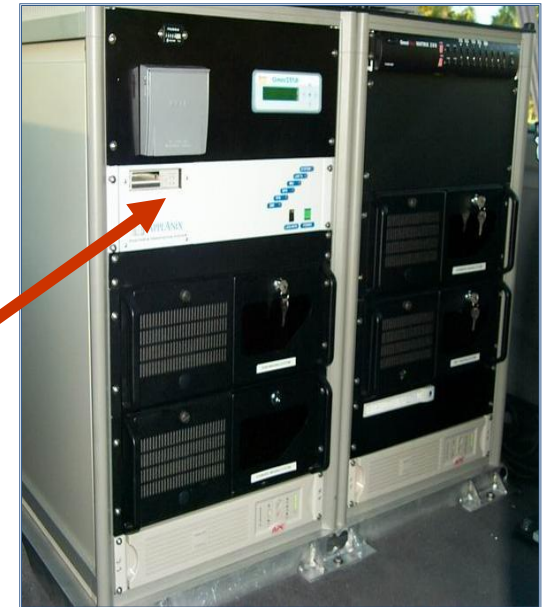
**POS
Computer**

POS Computer

- Data storage and processing

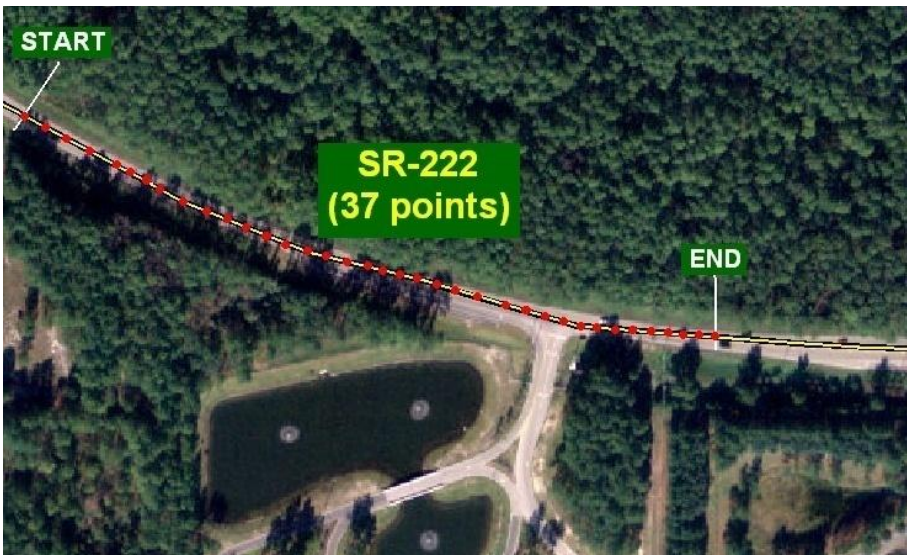
Field Validation

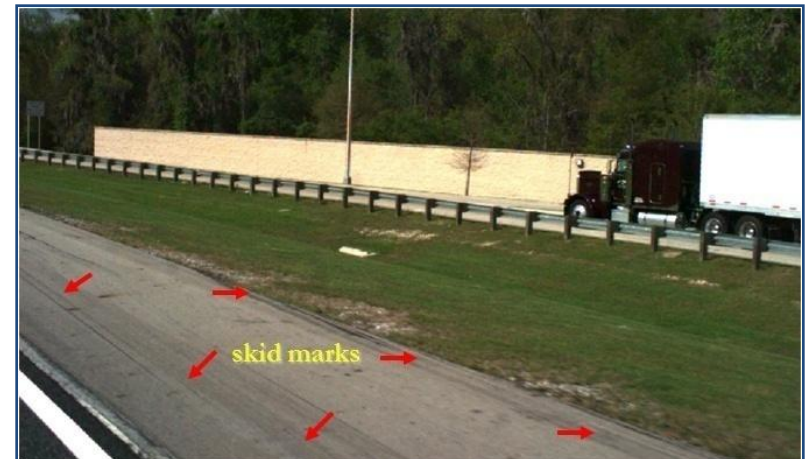
Case Example 2

Poor pavement drainage reported on 6-lane rural interstate

Roadway departures reported

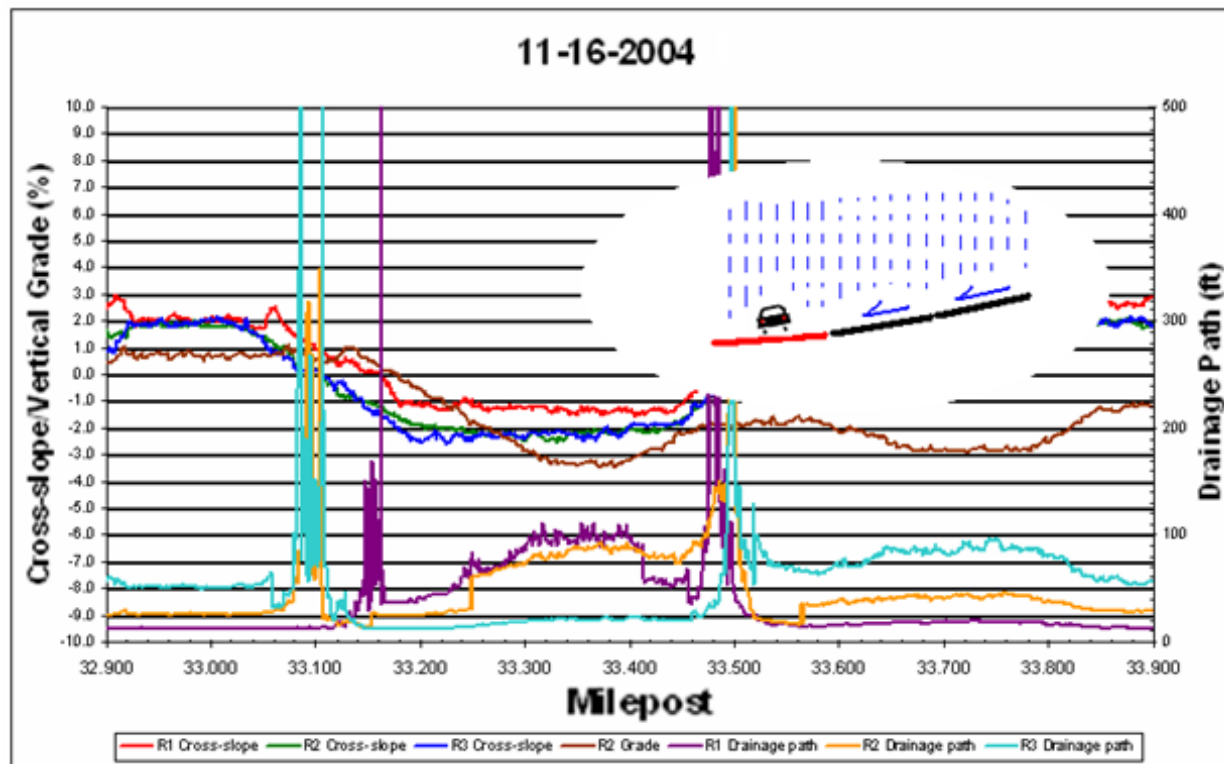
Before Corrective Action

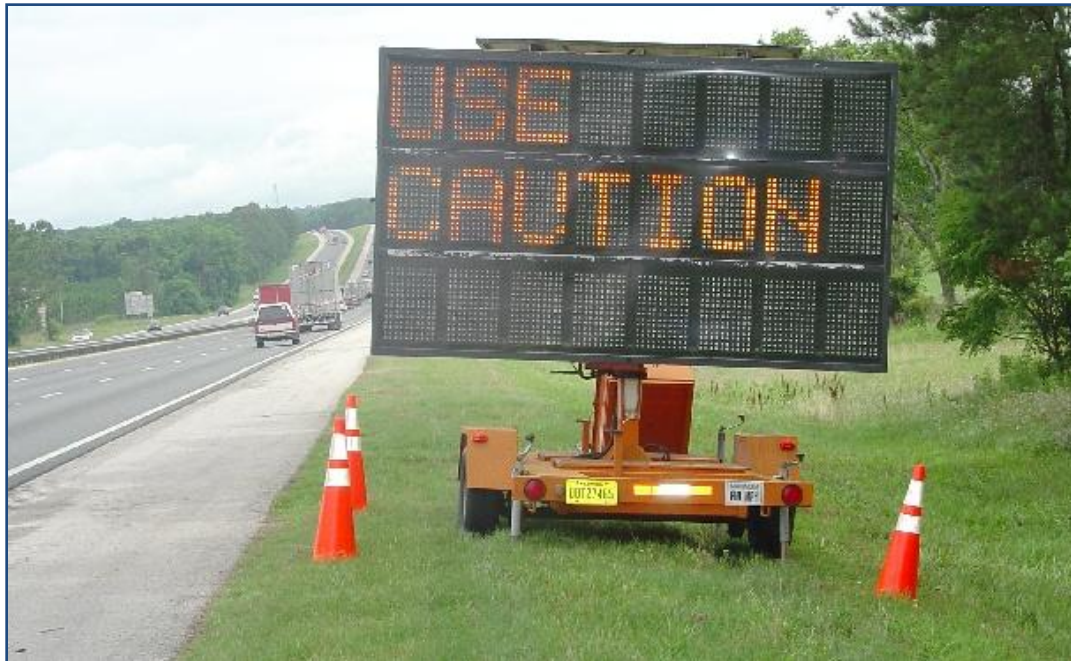
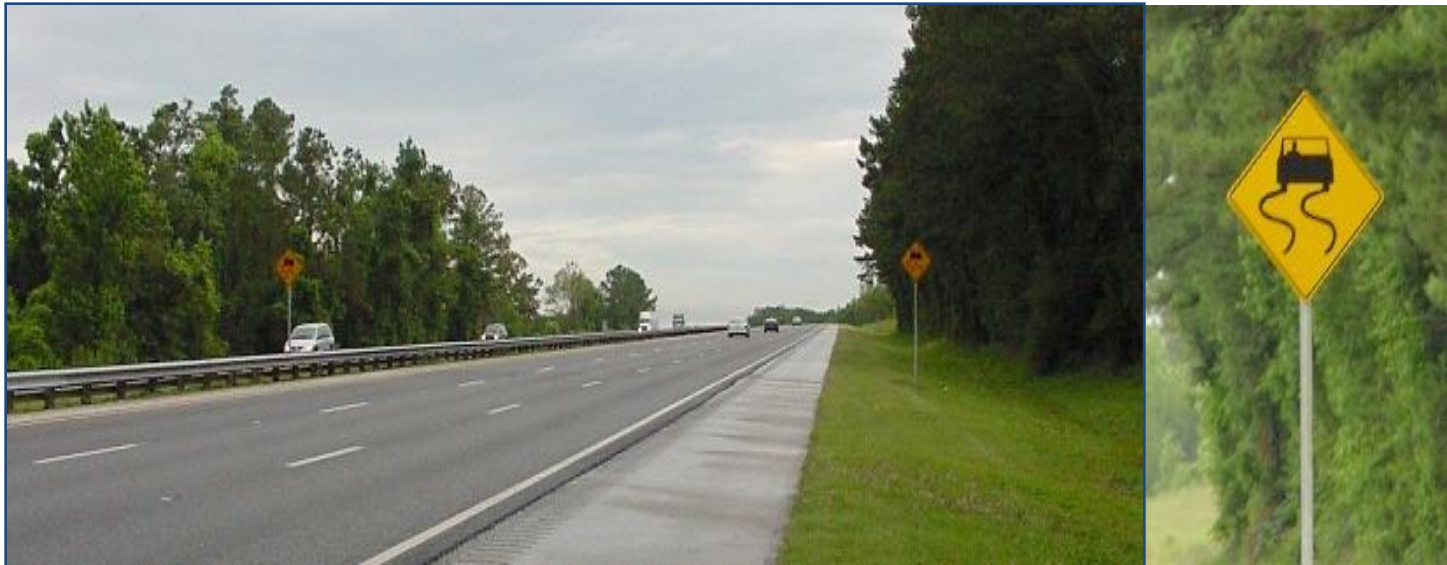
Short-Term Preventive Action

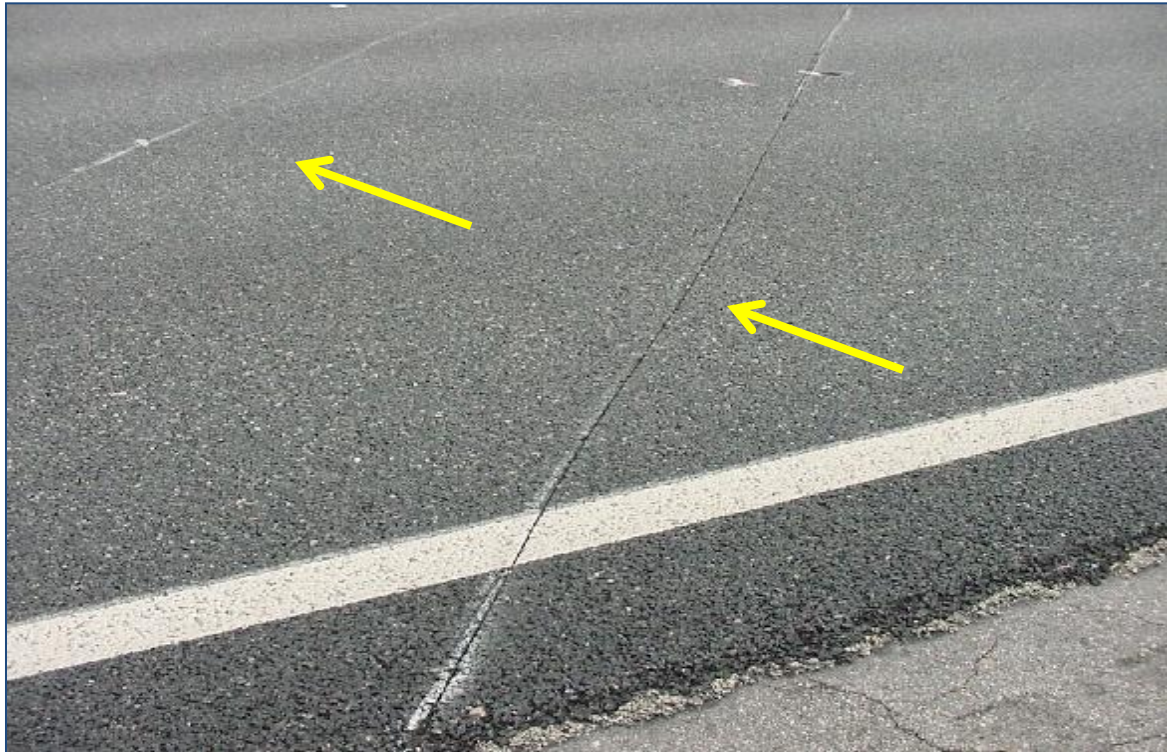
Short-Term Solution
