Road Safety Audits (Reviews)

G. Stuart Thompson

Locals RSA

Case Study – 3800 S & 3900 S @ Wasatch Blvd.

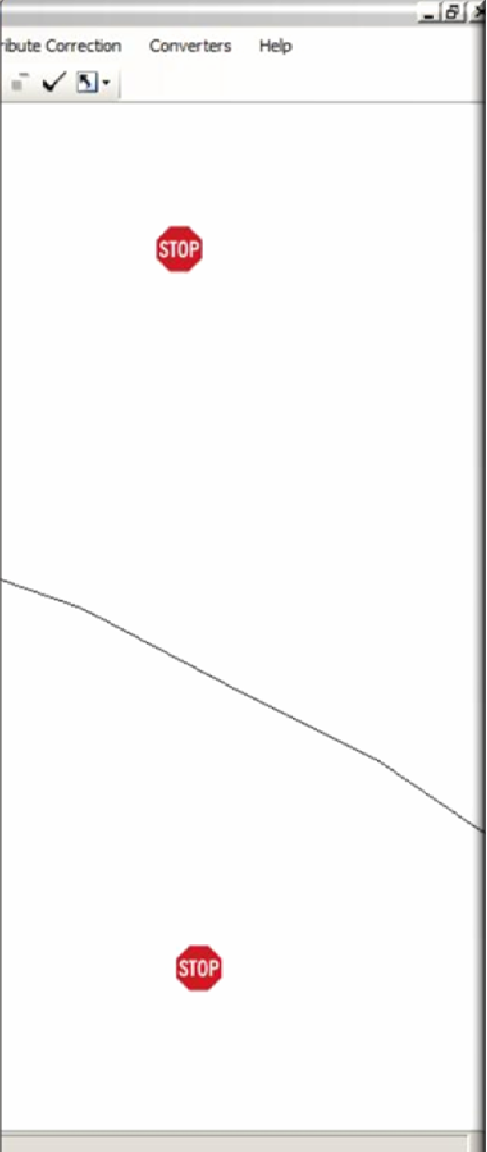
Issues

sight distance

cut scrubs

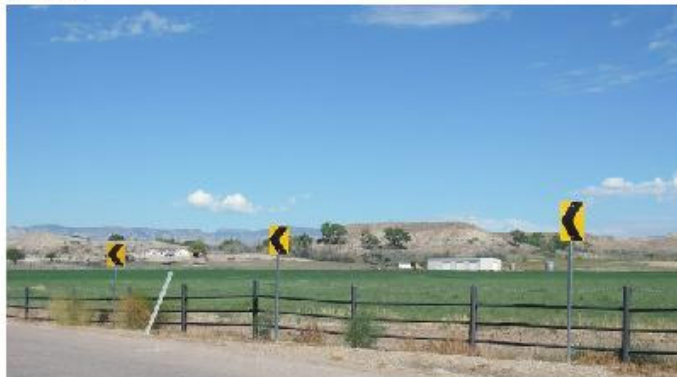
Location: east leg (1825075, 7027423) 1550 W 1.07856350178555

Description of Safety Issue: sight distance

Exposure: Low, Probability: Very Low, Consequence: Medium, Safety Risk: Medium

Recommendation: cut scrubs

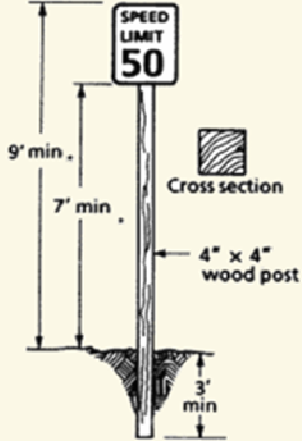
Diagram showing a speed limit sign (SPEED LIMIT 50) mounted on a 4" x 4" wood post. The sign is 9' min. high from the base, and the post is 7' min. high to the top of the sign. The base is 3' min. high.

Diagram showing a cross-section of the sign post base. The wood post is 14" high, and the styrofoam base is 4" high. The direction of travel is indicated by an arrow.

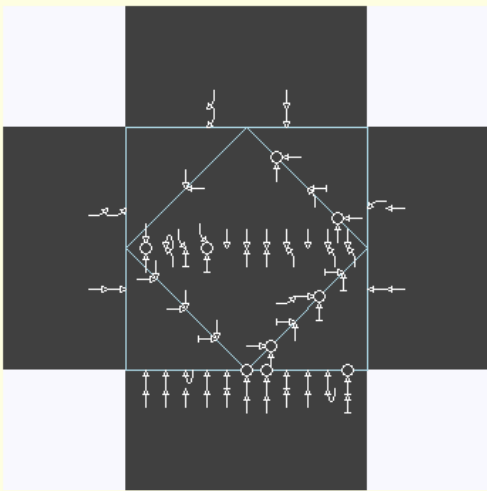
Intersection of 3500 E AND 3935 S

Collision Legend

Collision Injury Severity		
none	○ injury	⊕ fatality

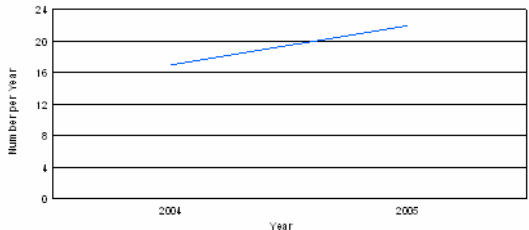
Collisions Near 3500 E AND 3935 S

Yearly Collision Trends

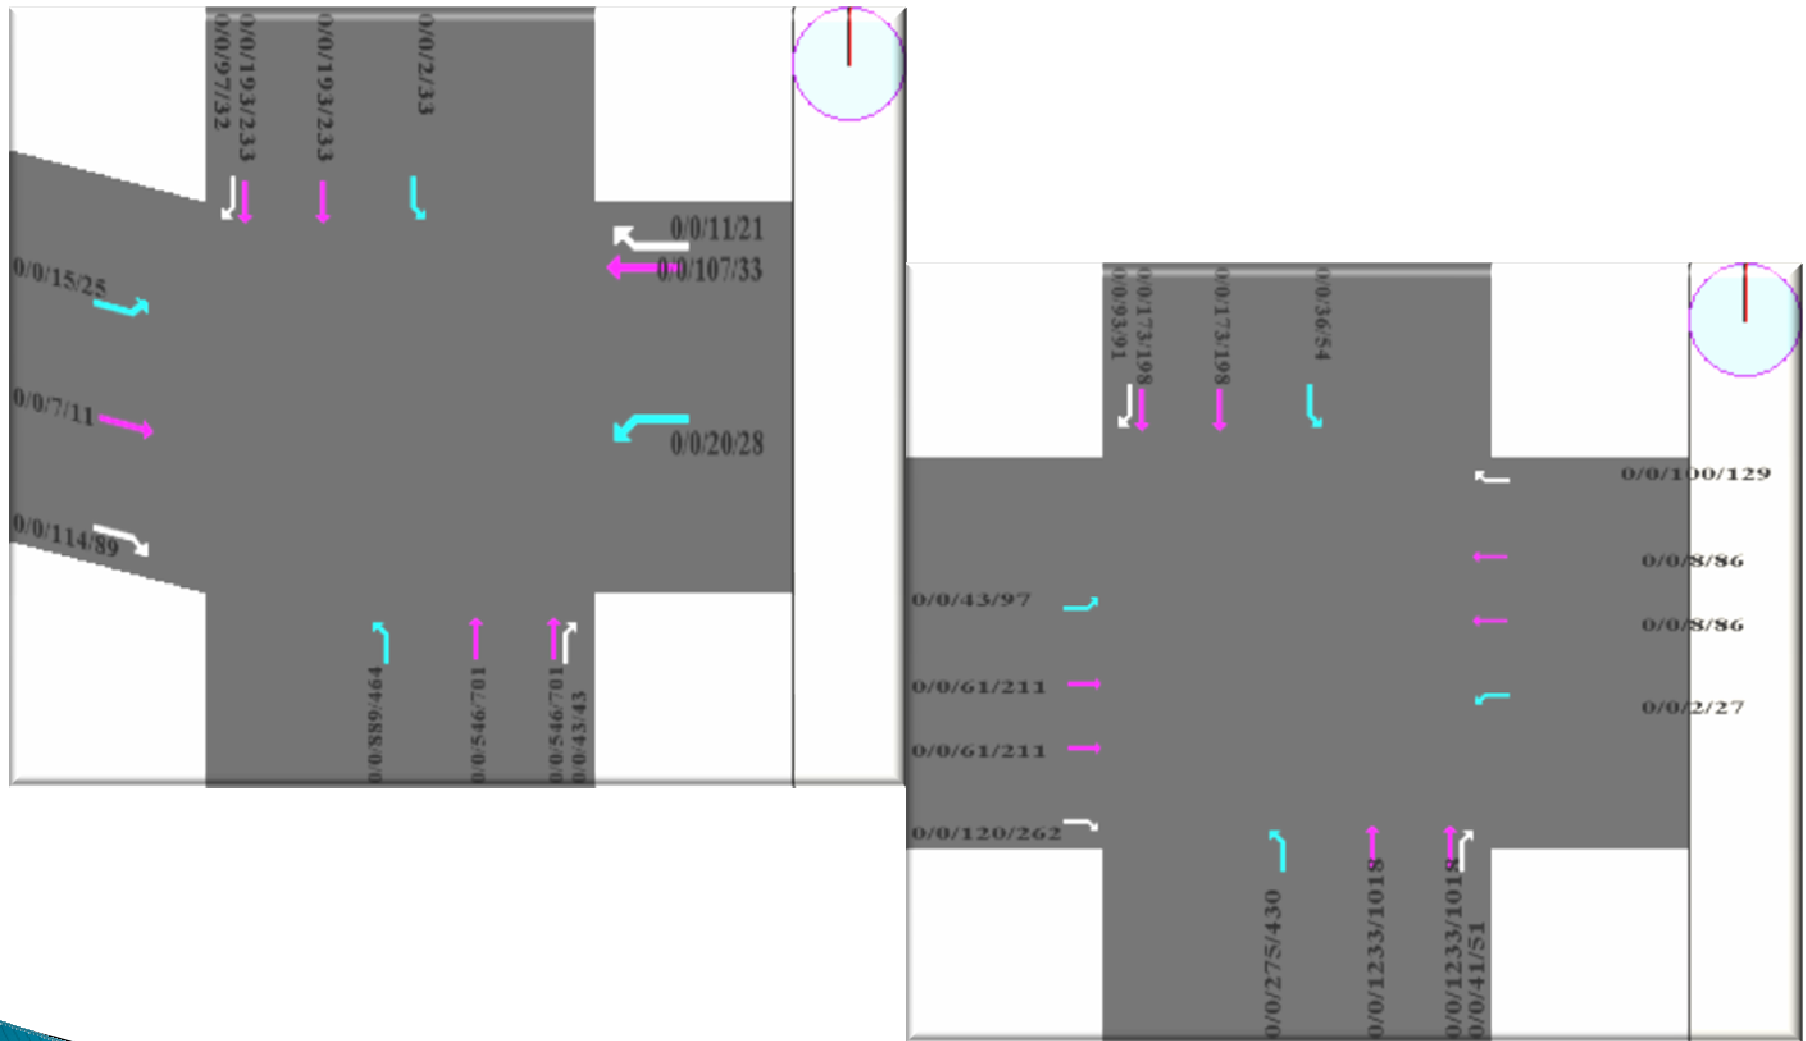
3800 S & 3900 S @ Wasatch Blvd. – Operations

8 hour/24 hour/AM Peak/PM Peak
