Roadway Safety Assessments (RSA): The Cornerstone of Virginia's Strategic Highway Safety Plan

Highway Safety Improvement Program (HSIP)

Traffic Engineering Division

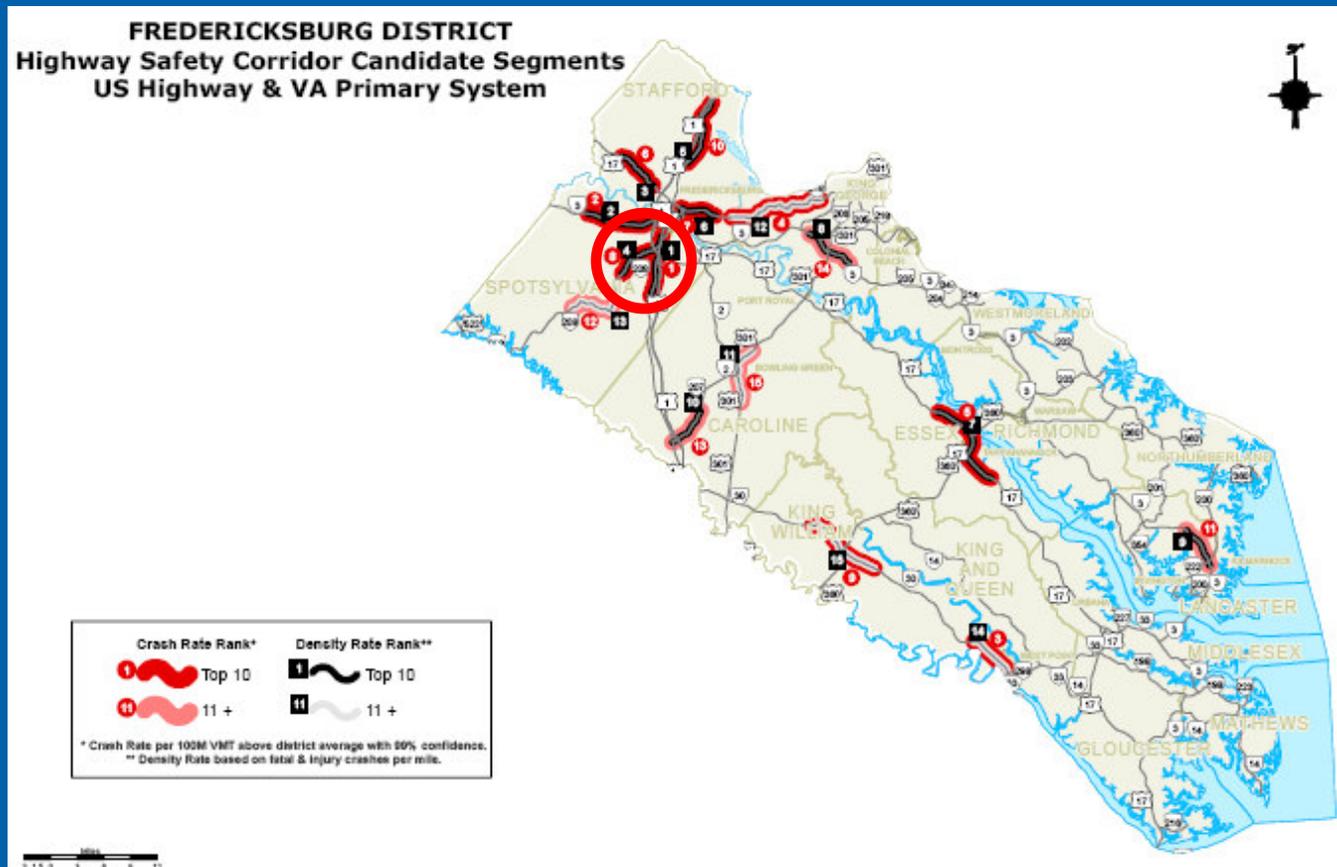
Prioritize High Crash Corridors

- Use candidate Interstate and Primary system Highway Safety Corridors
- Focus on corridors with highest death + injury densities

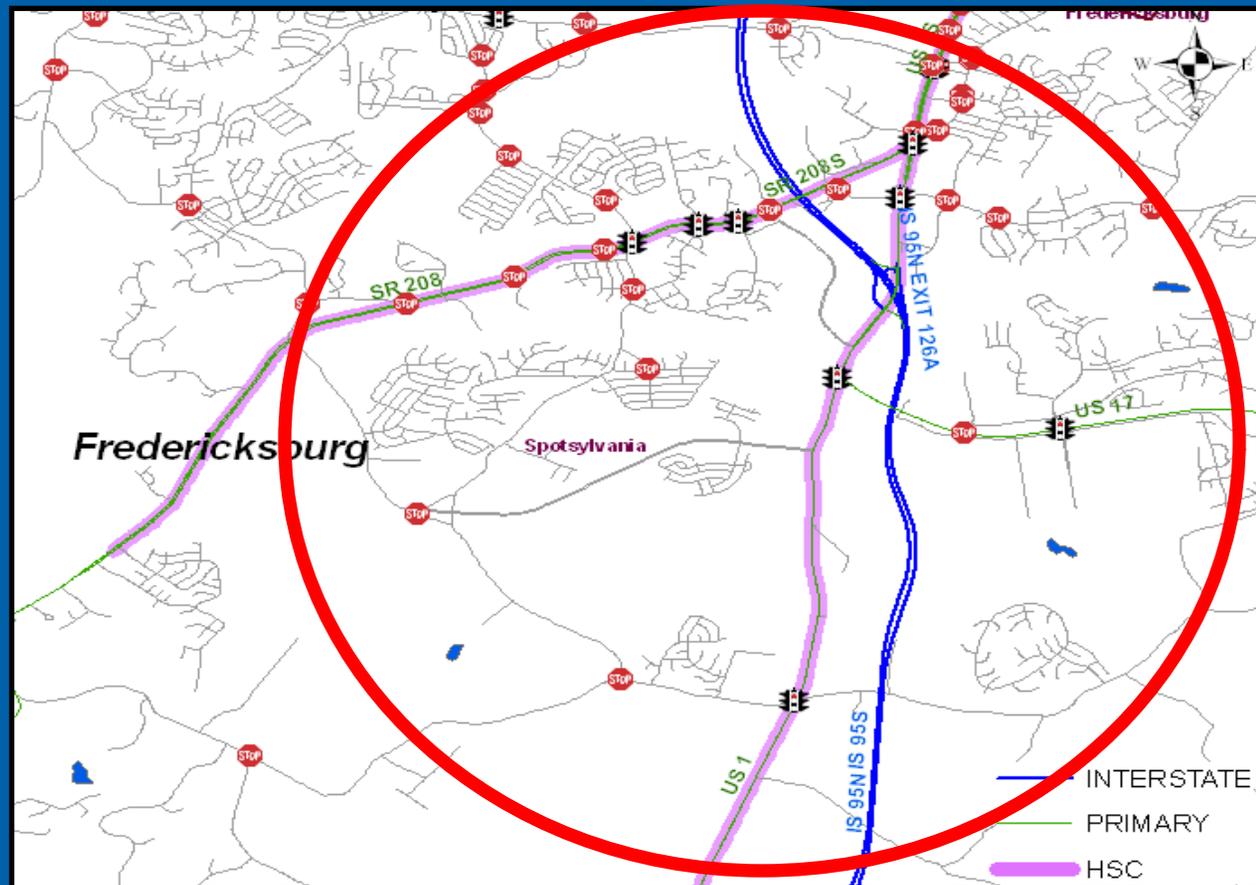
High Crash Sig/Unsig Intersections in Spotsylvania County, Fredericksburg District

Prioritize High Crash Locations

- Use annual “critical rate” intersection and segment listing to target review locations
- District maps of high crash intersections are being prepared

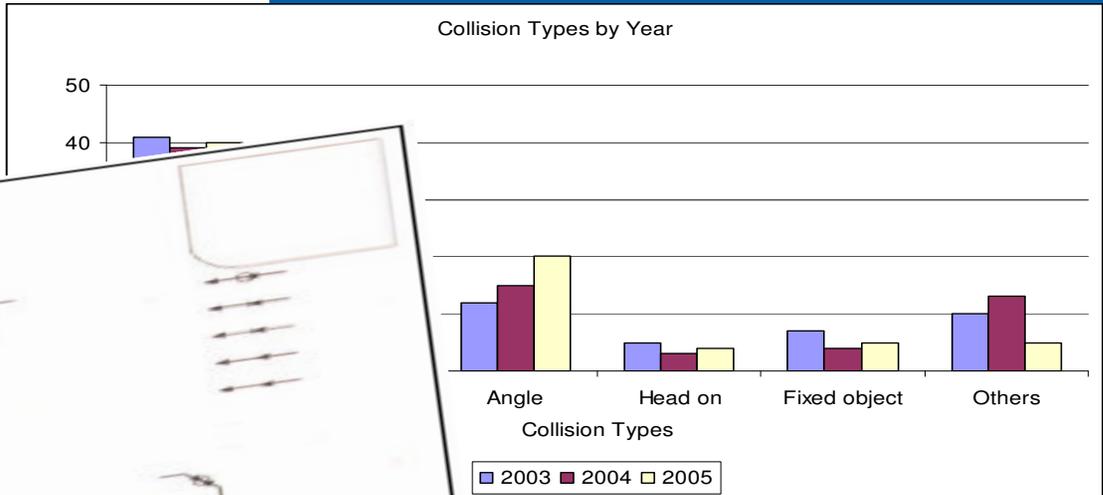
Collision Types by Year

Focus on:

- Crash Factors
- Human Factors
- Weather Influence

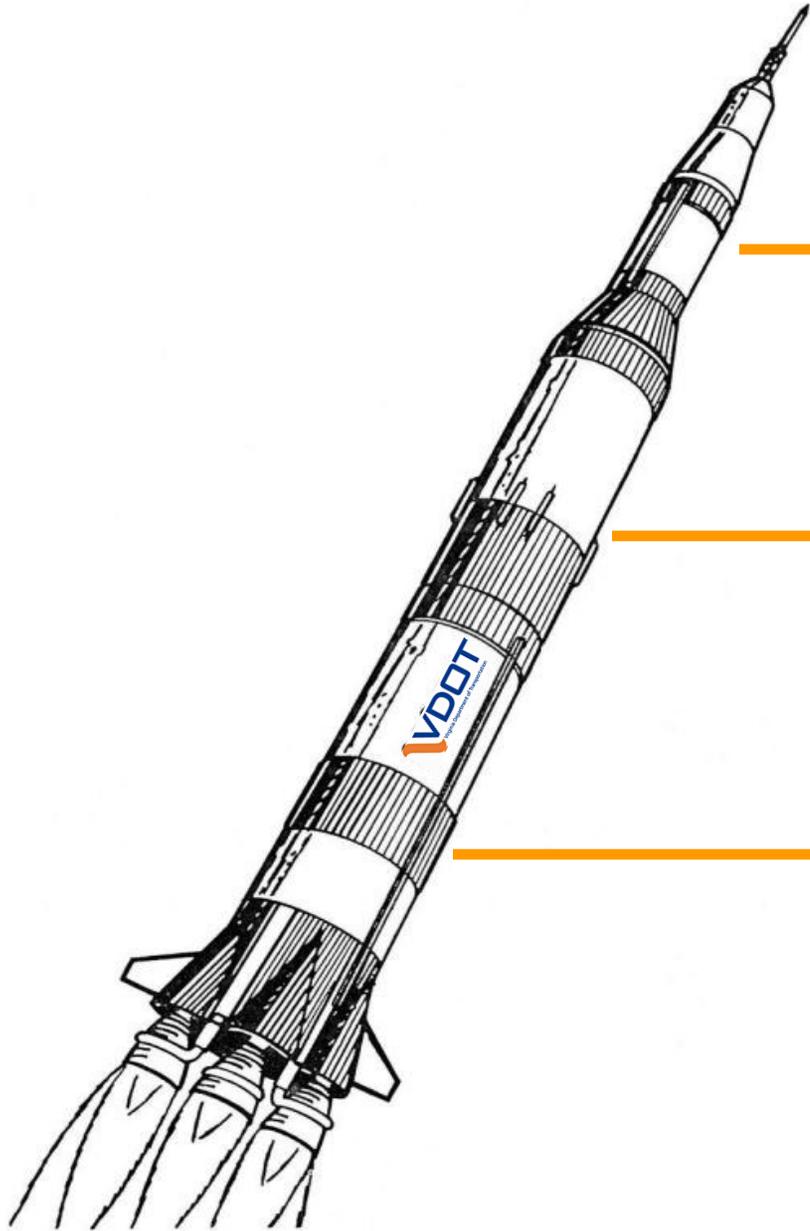
VDOT Rocket : Prioritize Improvements

Stage III (36+ months)
TIP with ROW

Stage II (12-36 months)
HSIP / CMAQ / TE Projects with no ROW

Stage I (0-12 months)
Signal Optimization / Maintenance Fix

Fuel =
Crash Analysis / RSA
Turning Movement Counts / Traffic Signal
Model
