## **High Tension Cable Median Barrier: A Scanning Tour Report**

A report prepared by  
**Traffic Operations Laboratory**  
Department of Civil and Environmental Engineering  
University of Illinois at Urbana-Champaign

Prepared for  
Illinois Department of Transportation

January 2006

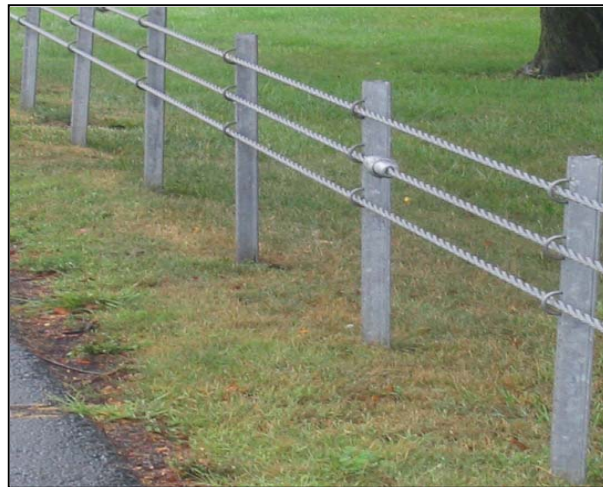
**Figure 1.** U.S. High Tension Cable System

The system is typically tensioned at 5,600 lb, and anchored with a Texas Transportation Institute's (TTI) proprietary Cable Guardrail Terminal End. TTI's end treatment was designed for rocky or hard soils, and is NCHRP 350 approved (details on TTI's end treatments can be found in acceptance letter of U.S. High Tension Cable System – FHWA website). Upper and lower cables are recommended to be located on the side of the post closest to the roadway, leaving the middle cable on the opposite side.

U.S. High Tension Cable System was installed in the median along 12 miles of I-270 by October 2004. The posts were placed at the edge of the paved shoulder and socketed in concrete foundations. Post spacing is 6.5 feet for a design deflection of 6.5 feet. More than 30 hits have been registered since installation with no fatalities or penetrations.

U.S. High Tension Cable System posts shear as a consequence of a hit, allowing cables to maintain their height. However, posts at some locations have bent, allowing the concrete foundation to be pulled out of the soil. Other posts have also sheared off at the bottom of the sleeve, particularly during the spring thaw. Installing the locking bolts in the U.S. High Tension Cable System can increase repair time, but they hold the cable at its proper height more securely than the other systems. Otherwise, the high-tension cable can cause the posts to “float” where the barrier crosses local depressions.

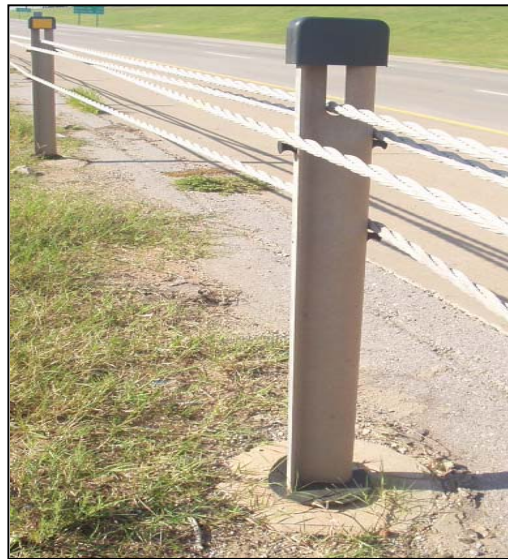
**Fence)** WRFS uses an exclusive S-shape post in its TL-3 version. The manufacturer recommends only pre-stretched cables.

**Figure 2.** Brifen Wire Rope Safety Fence System

Posts are installed in concrete foundations with a minimum strength of 3,500 PSI or can be driven using a post with a soil plate. In the four-cable system, the three lower cables are interwoven around the posts and the upper cable is placed in a slot on the top of each post. The end treatment is a customary part of the design and extends 19 posts in total: 4 posts for the Wire Rope Gating Terminal (WRGT), and 15 posts for the transition to the line posts.

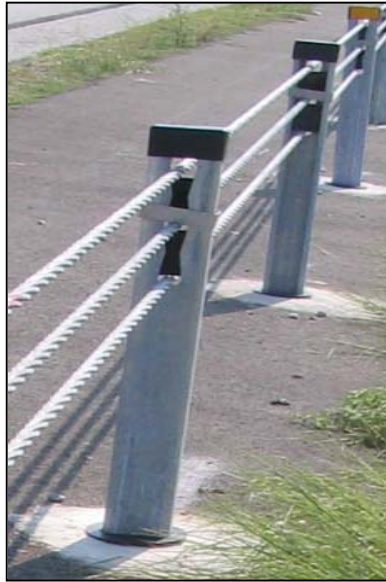
**CASS (Cable Safety System)** is a three-cable system by Trinity Industries, Inc. It uses pre-stretched cable, and the posts have an opening in the upper part to accept the cables, which are kept in correct position by wider slot sections at specified cable heights, a plastic cap on the top of the post, plastic spacer blocks, and a steel strap. Posts are installed in steel sockets that can be either driven directly into the soil, or cast in concrete cylinders. TTI's Cable Guardrail Terminal Ends are used to anchor the system.

**Figure 3. CASS System**

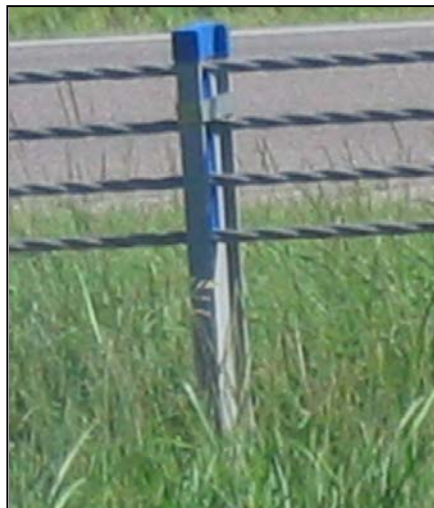
Safence is a 4-cable WRSF system originally developed in Sweden by Blue Systems AB in 1993. Cables in the Safence system are factory pre-stretched. It uses I-section or C-section posts, which can be driven directly in the soil or installed in concrete cylinders. Spacers are placed between the cables to maintain adequate separation. Up to date, crashworthy end terminals have not been developed and tested.

**Figure 4. Safence System**
