# Ohio Department of Transportation

## Cable Barrier Systems

OTEC Presentation

Dean Focke, ODOT  
Standards Engineer

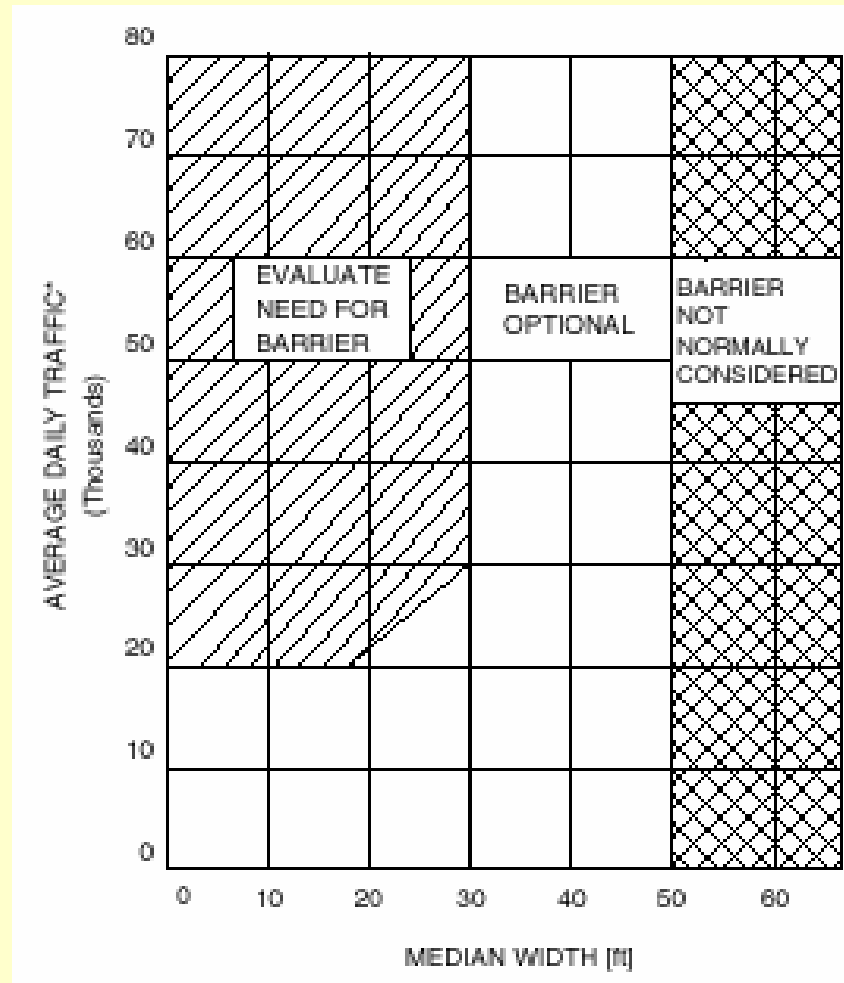
# AASHTO Roadside Design Guide

## Median Barrier Warrants

Source: *Roadside Design Guide*  
(AASHTO, 2002)

# AASHTO Warrants

- Based on two older studies
  - Graf, V. D. and N. C. Winegerd, 1968
  - Ross, H. E., Jr., 1974
- Warrants based on
  - Before/After Accident Data Analysis
  - Low-Moderate Traffic Volumes
  - Attempt to Minimize Serious Injury/Fatal Crashes

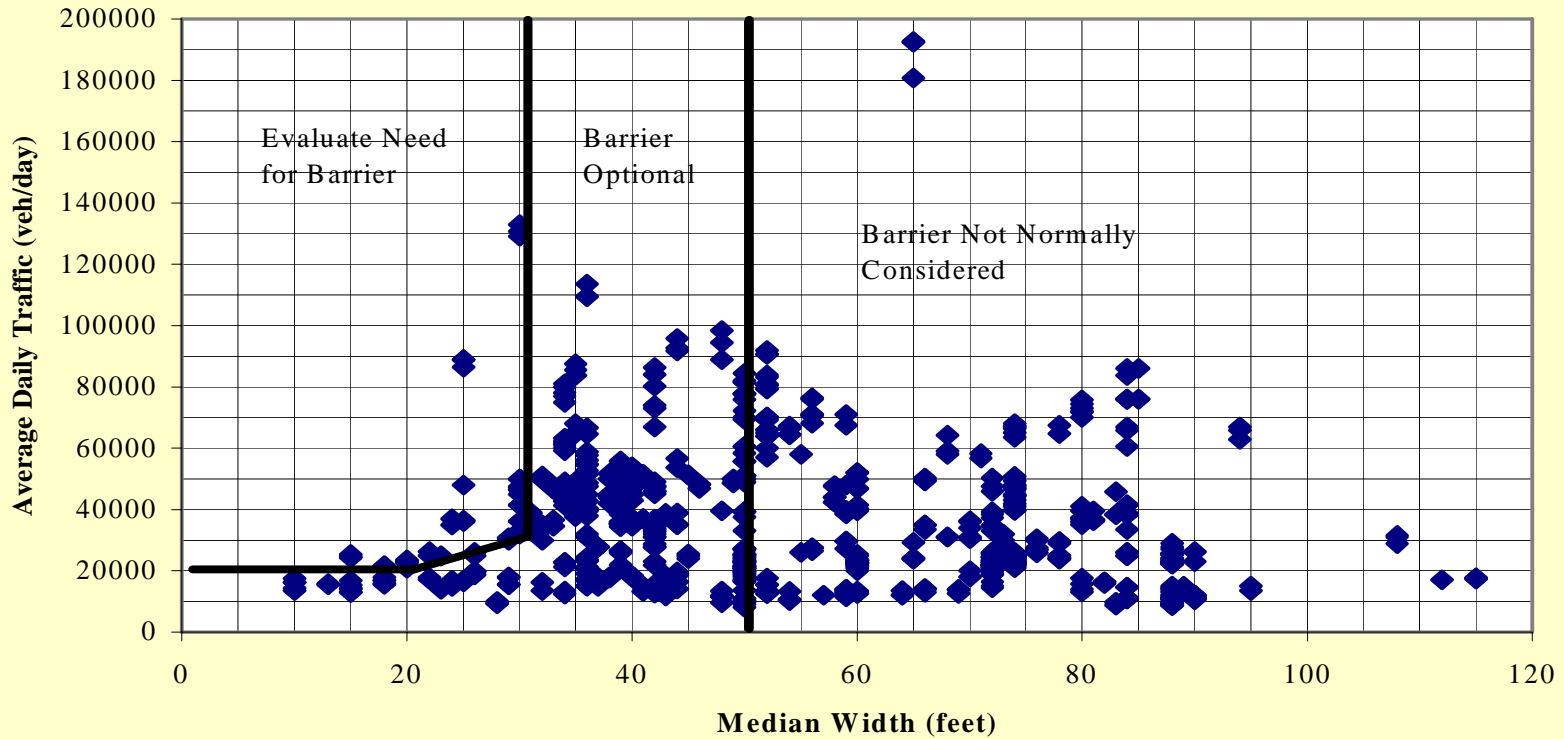
# CA Median-involved Crashes

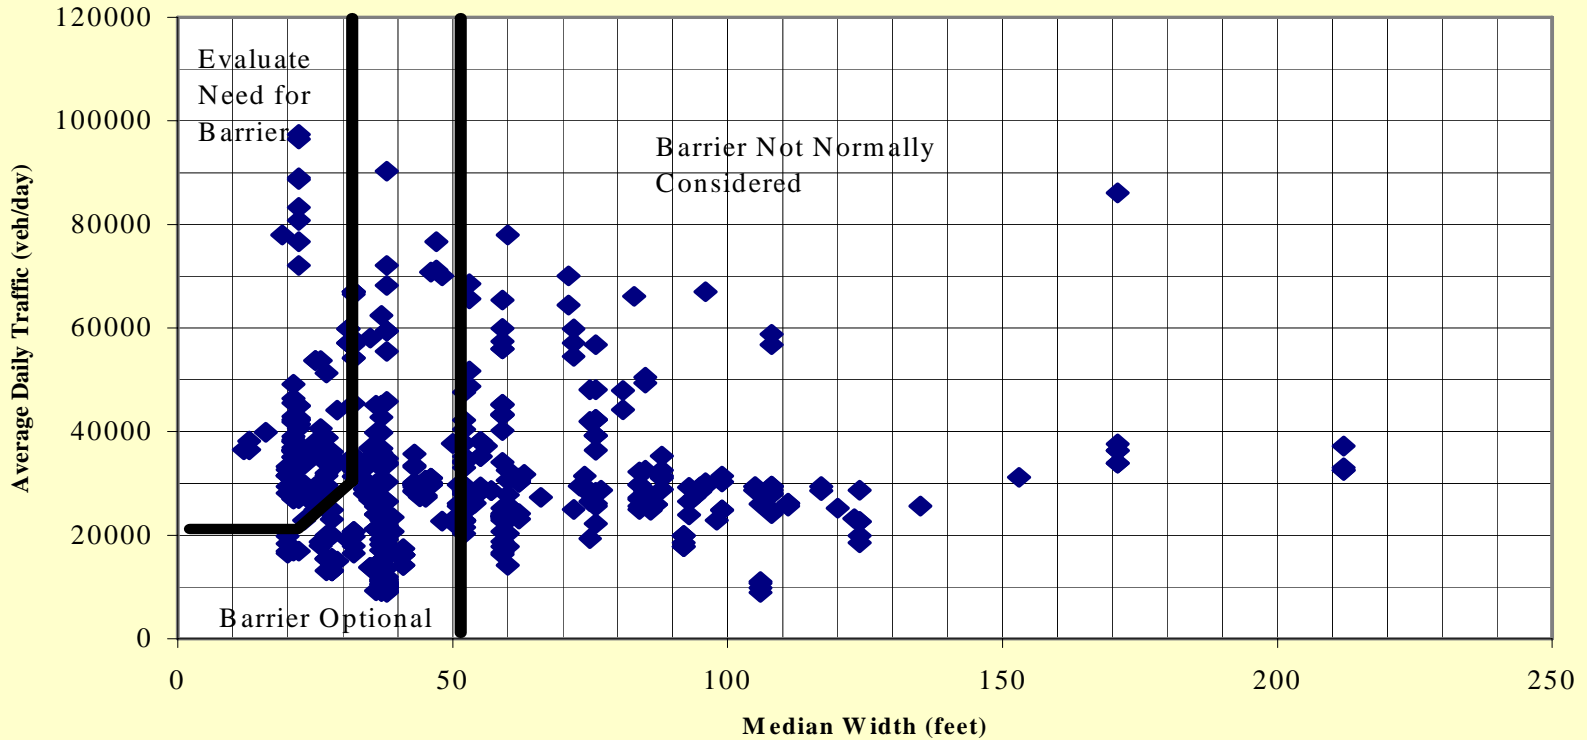
# NC Median-involved Crashes

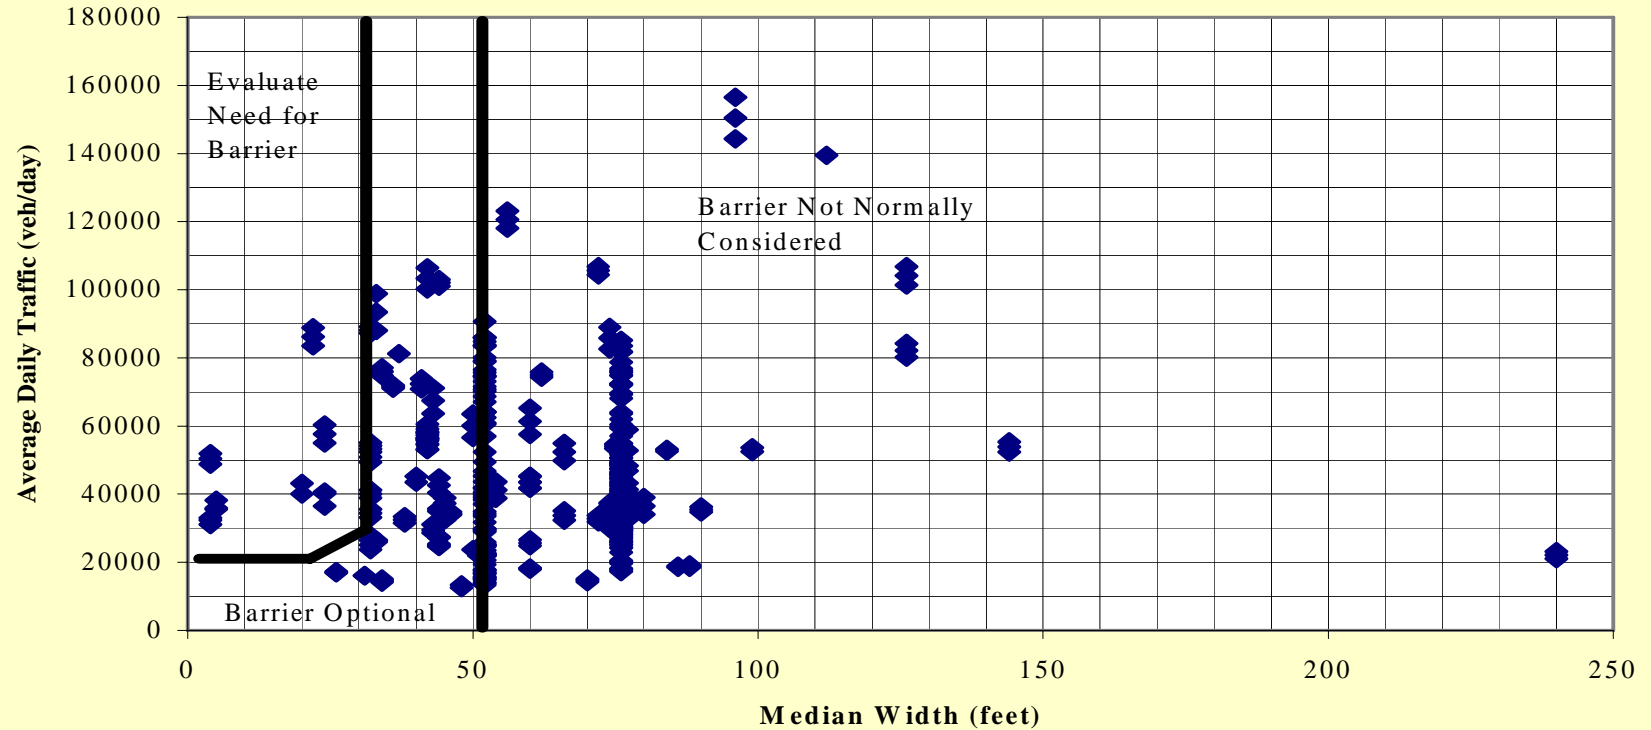
# OH Median-involved Crashes

- Median-involved crash frequency decreases as median width increases.
- Average daily traffic volume has greatest influence on median-involved crashes.
- Median side slopes influence median-involved crash frequency.
- NC CMC crash severity is greatest when median width is less than 70-ft.

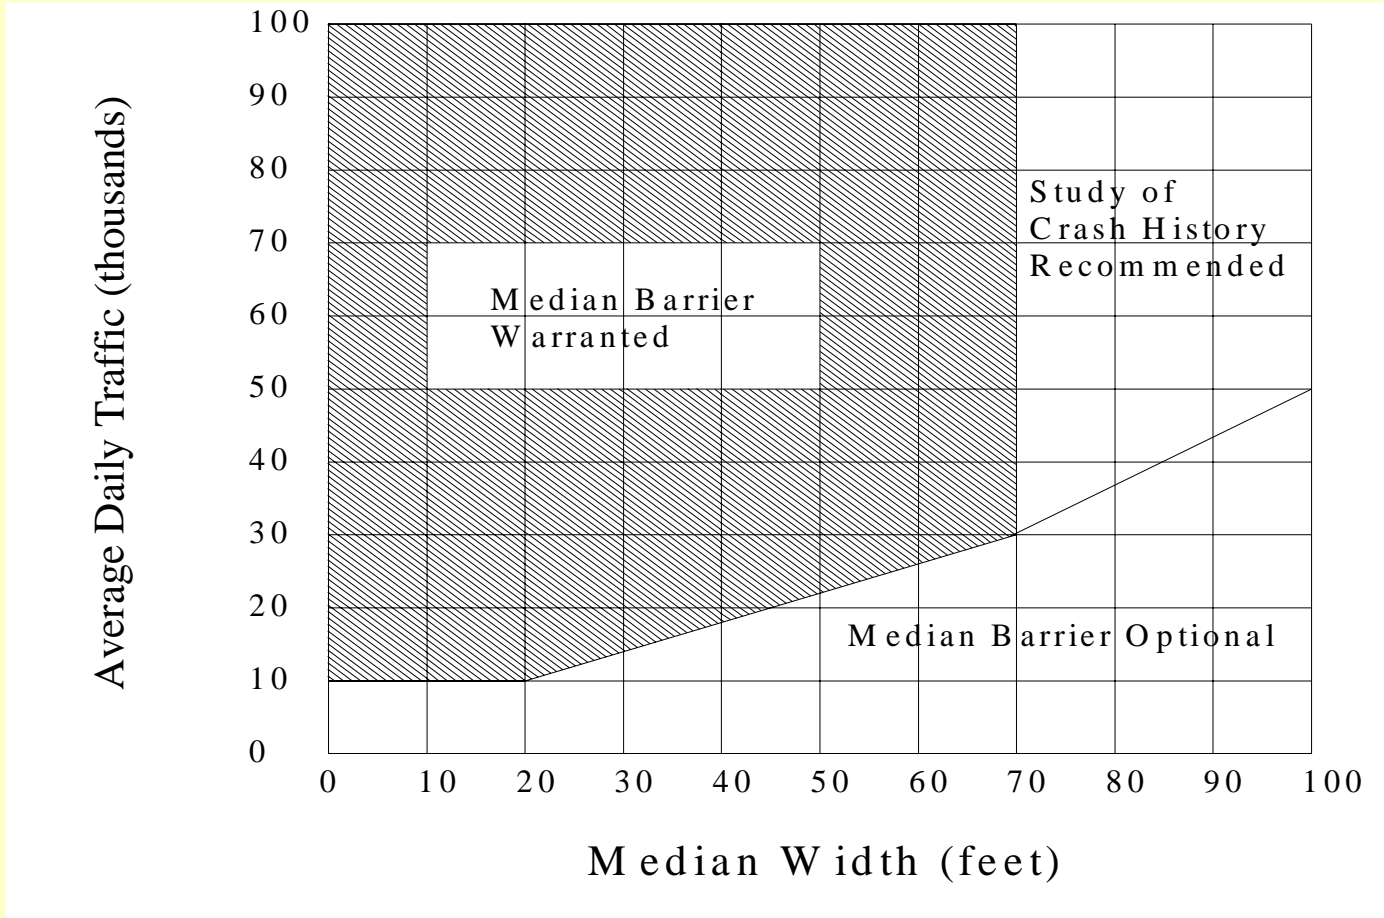
# NCHRP Project 17-14 Recommended Median Barrier Warrants

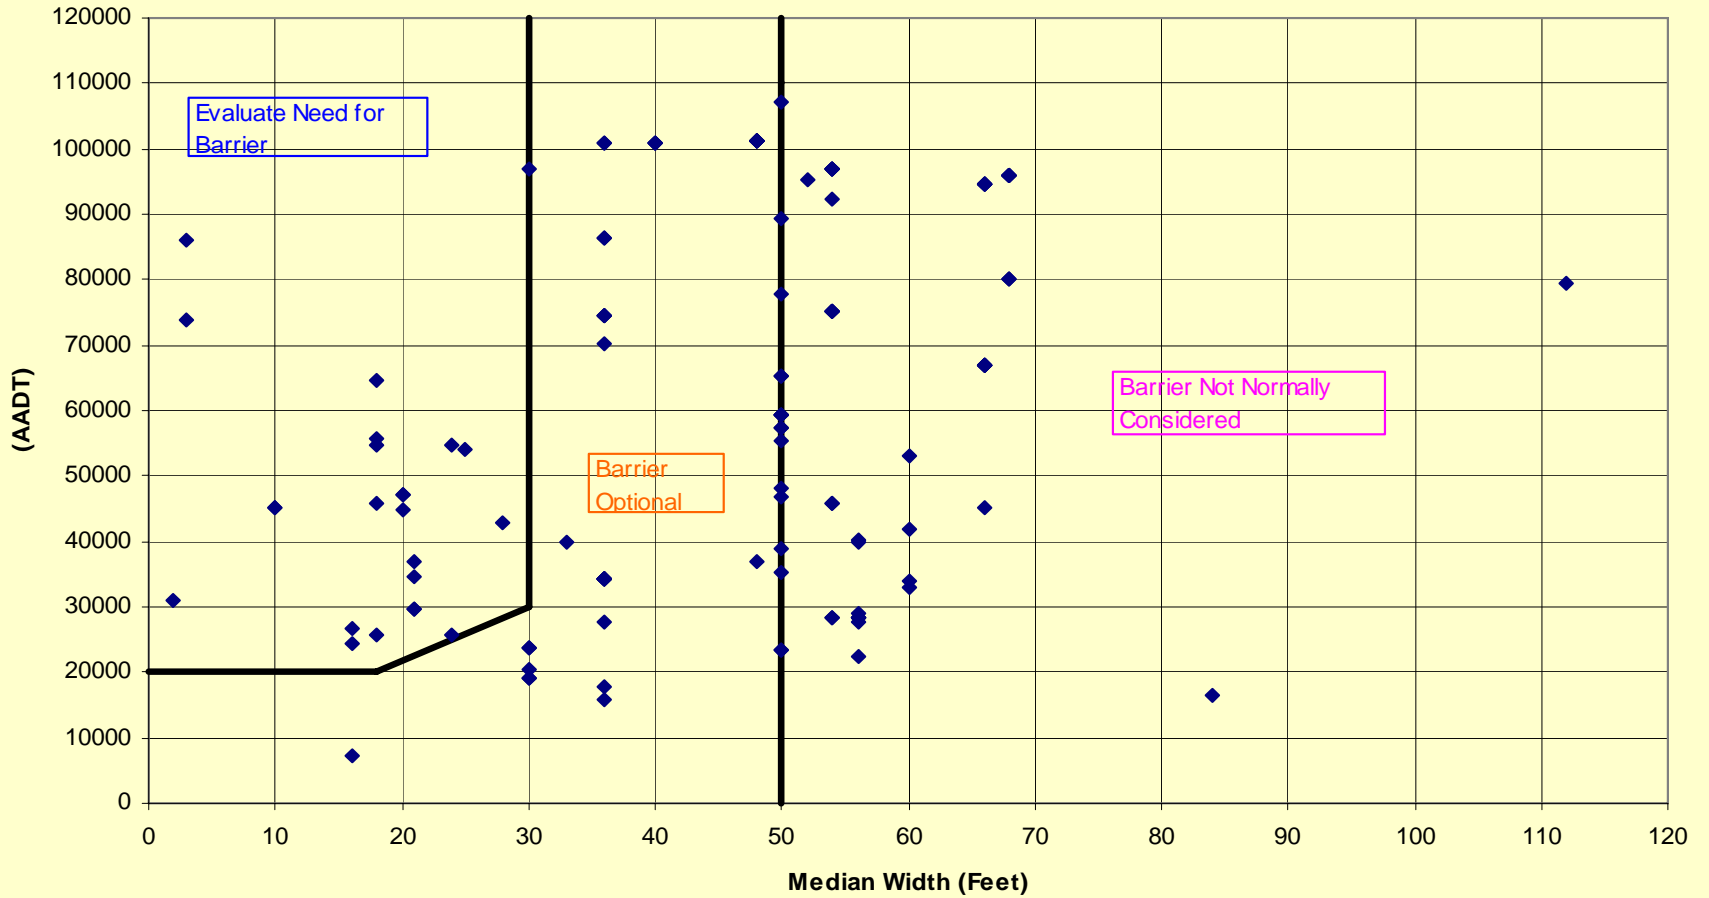
**MEDIAN BARRIER WARRANT  
(AASHTO 2002 Figure 6.1)  
1999-2002 NJ Median Cross Over Crashes**

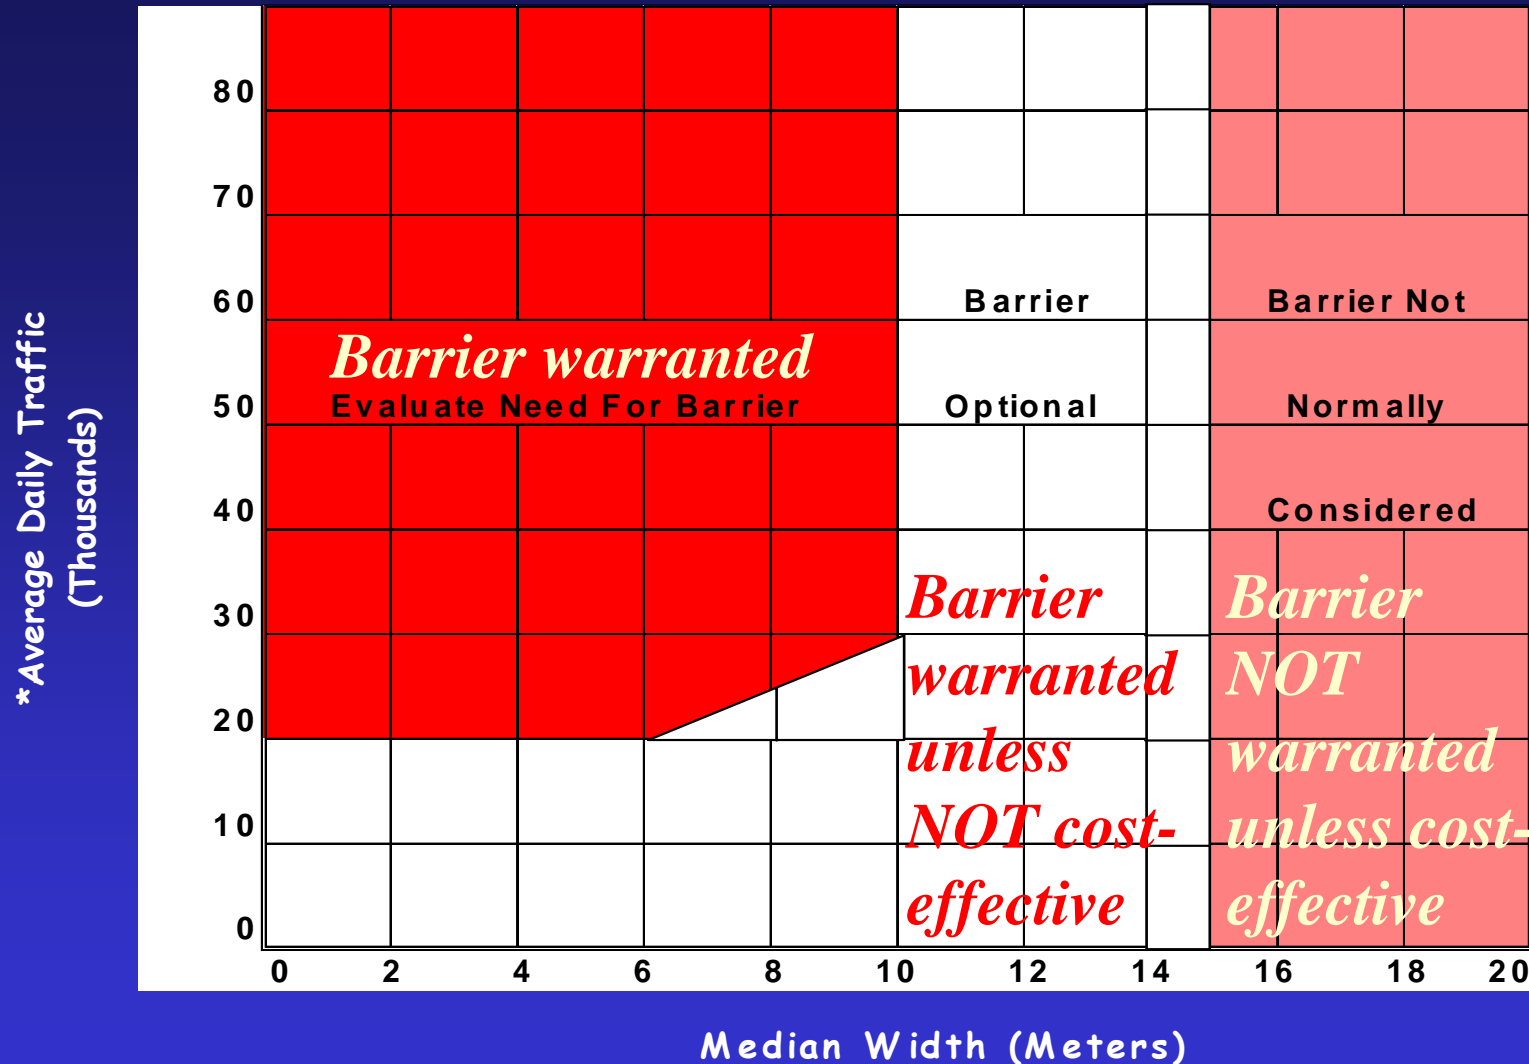
Figure 6.1

# FHWA's proposal....

\*Based on a 5-Year Projection

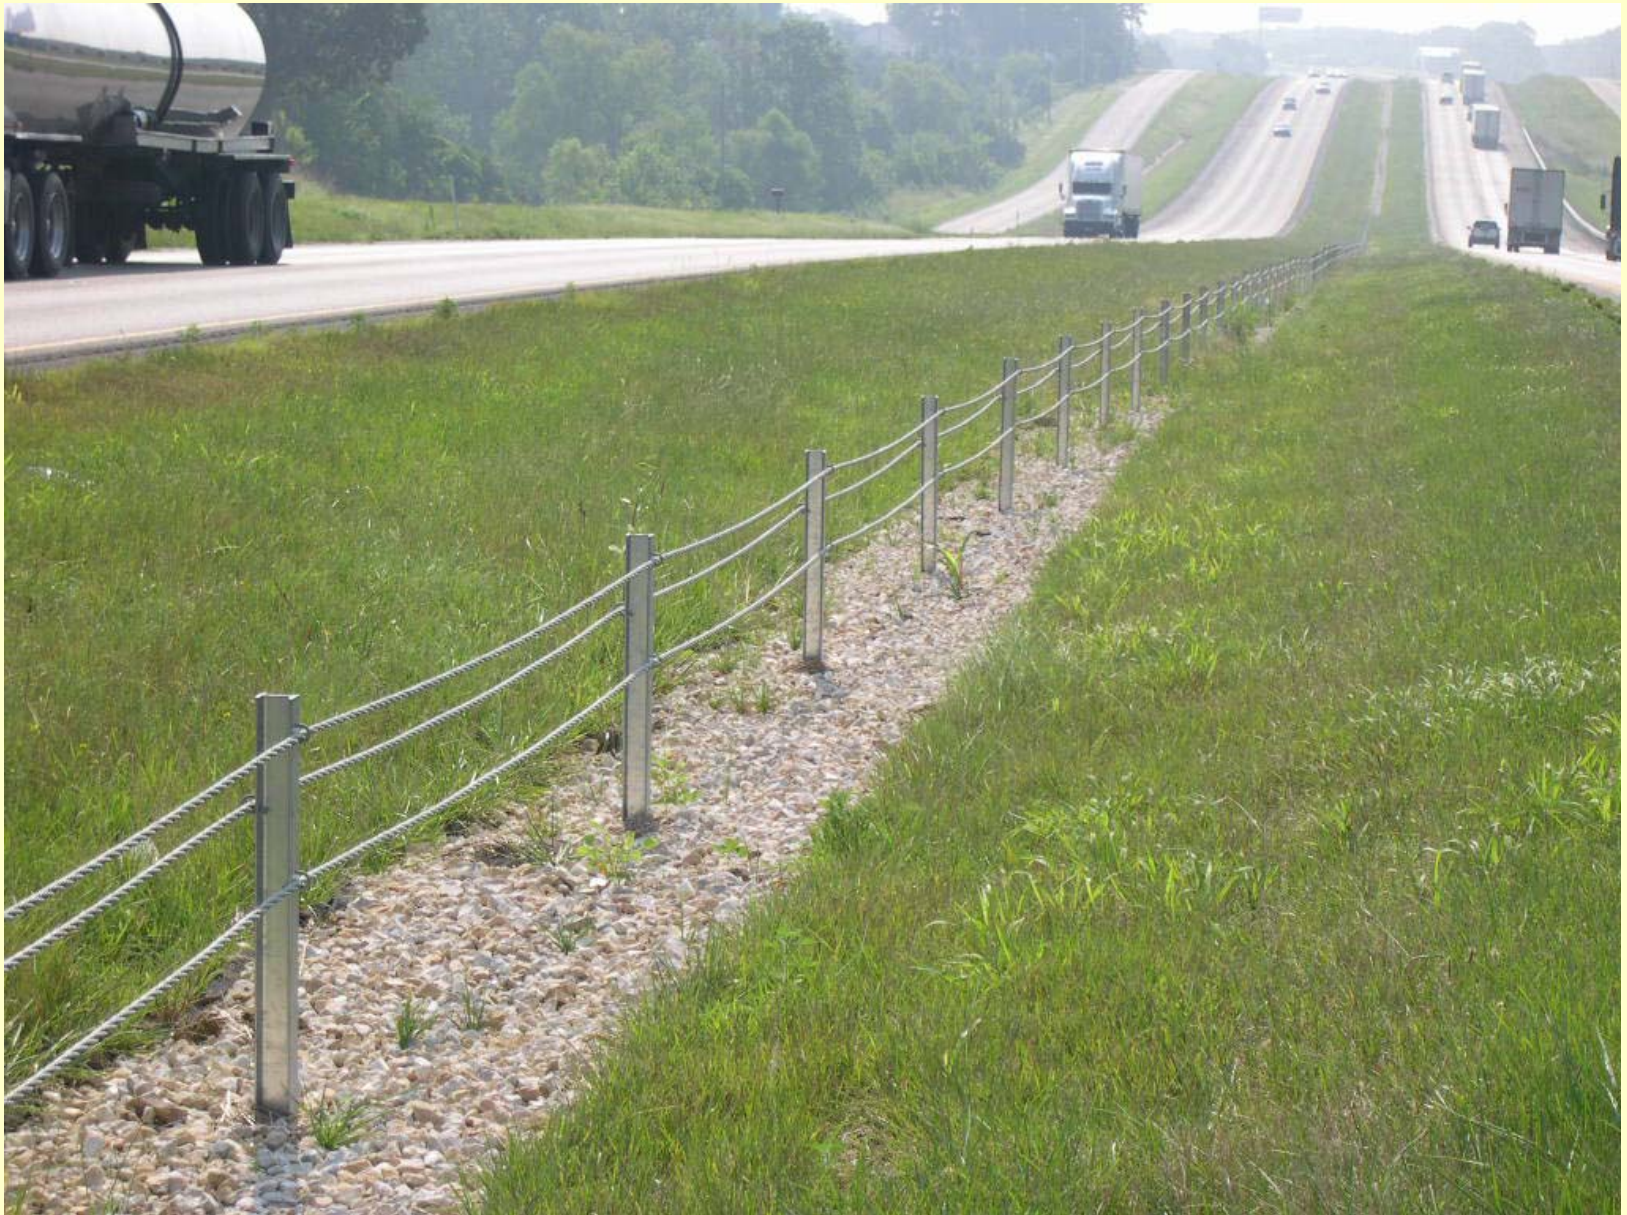
3/8" DIA. HOLE DELIN. MOUNTING  
(SEE REFLECTOR MOUNT DETAIL)

**DOUBLE FACE GUIDERAIL POST  
HOLE PLACEMENT DETAIL  
INTERMEDIATE POST**

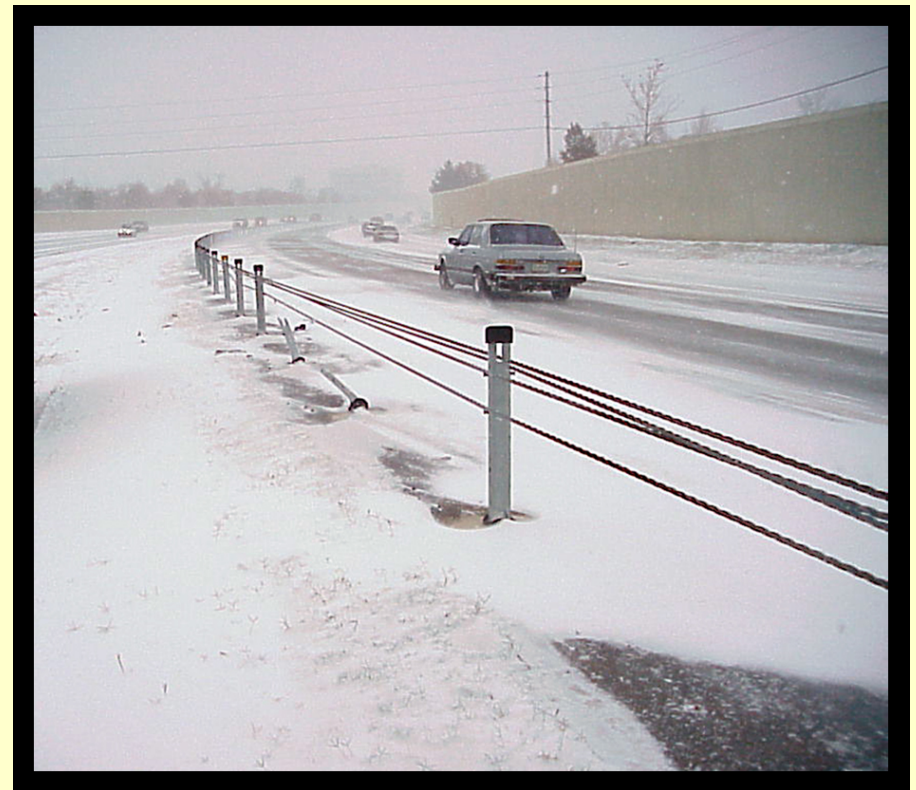
## Interwoven High Tensioned Ropes

- Reduced length of barrier damaged in crash
- Ropes typically stay up & can handle additional hits before repairs

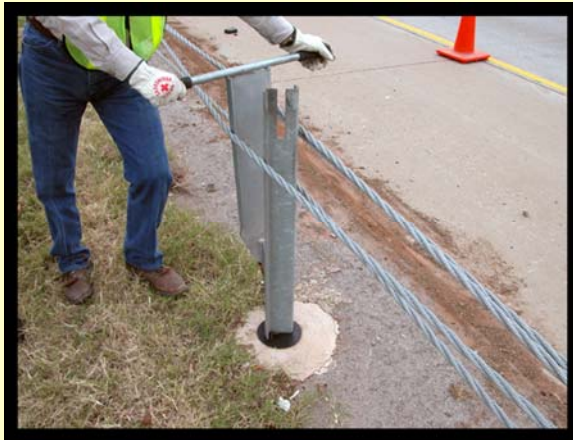
# Repair

- Typical repair time under 30 minutes
- Only one person required
- Inexpensive – normally just a few posts

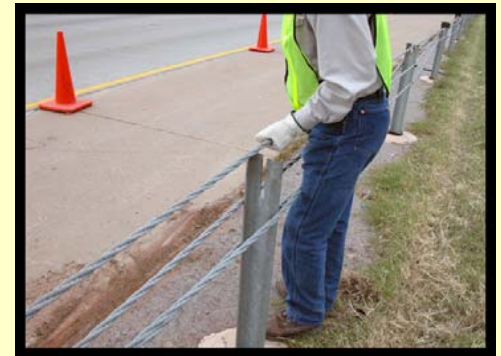
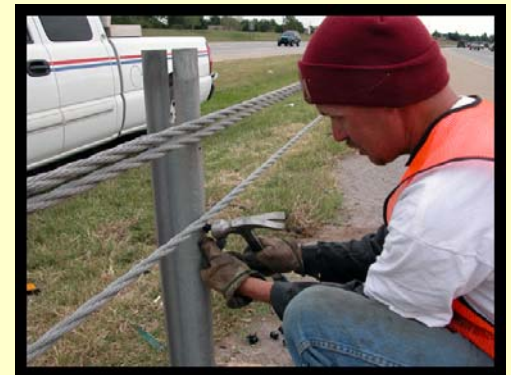
## Repair

- No lane closures required for heavy equipment
- No specialized tools (except tension meter on occasion)
- Ropes and rigging screws not damaged during impact

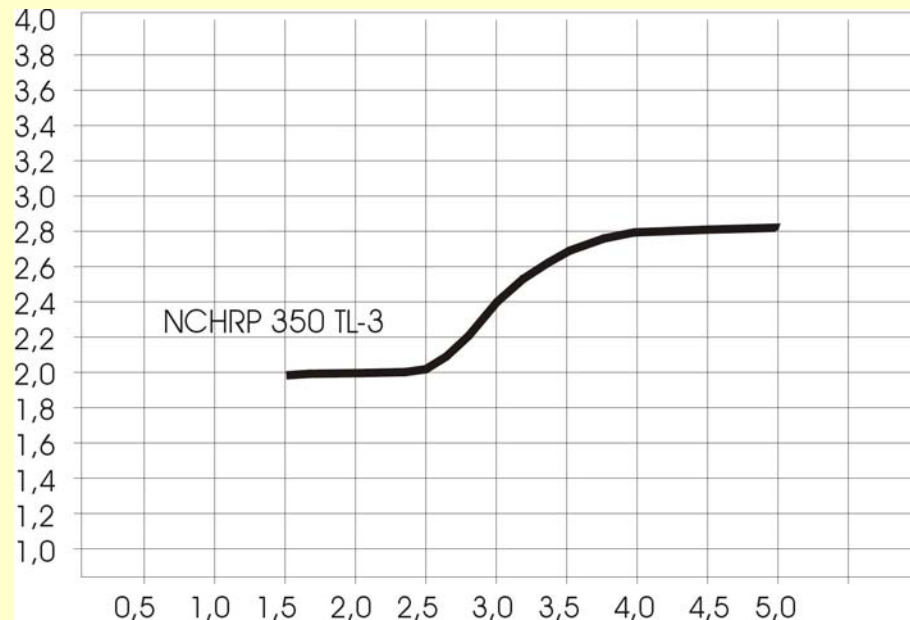
Designed by deflection (2.0 - 2.8 meters or 6'9" - 9'2")

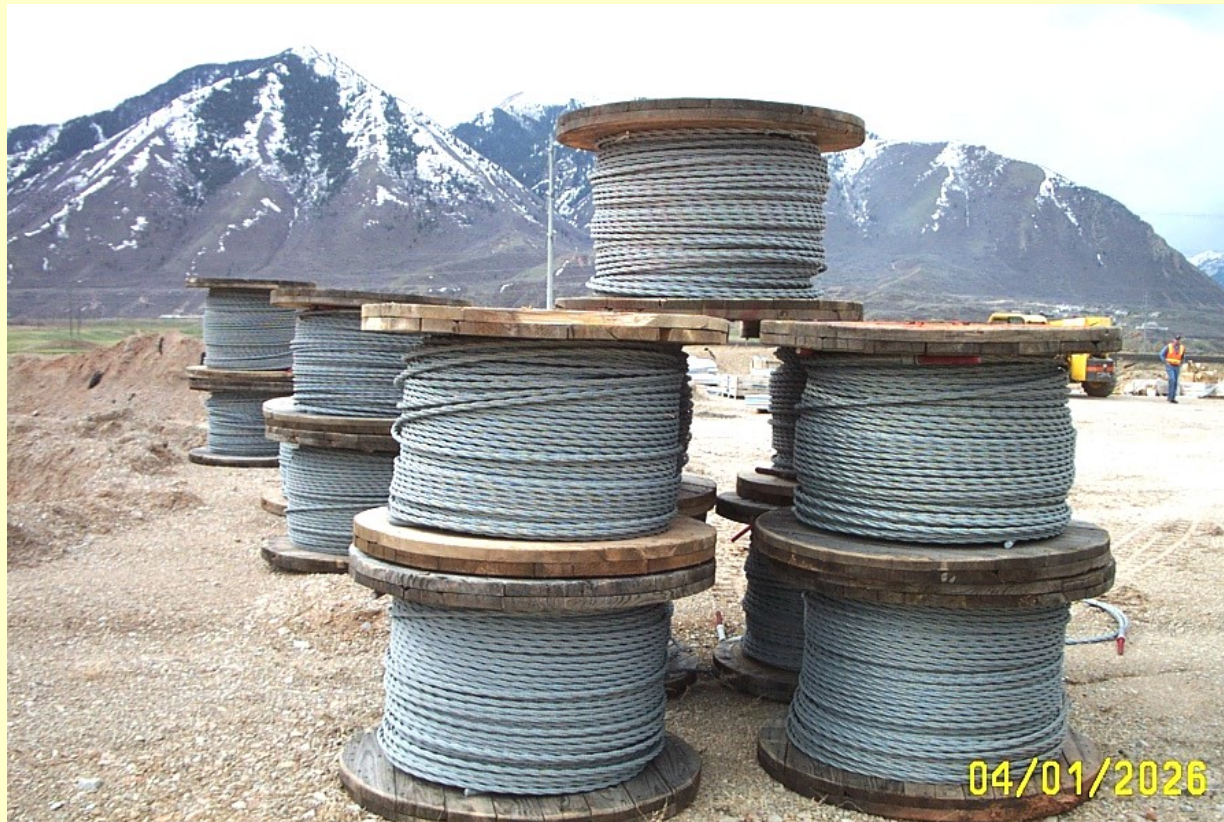
Stacks of  
Cable in  
Staging  
Area

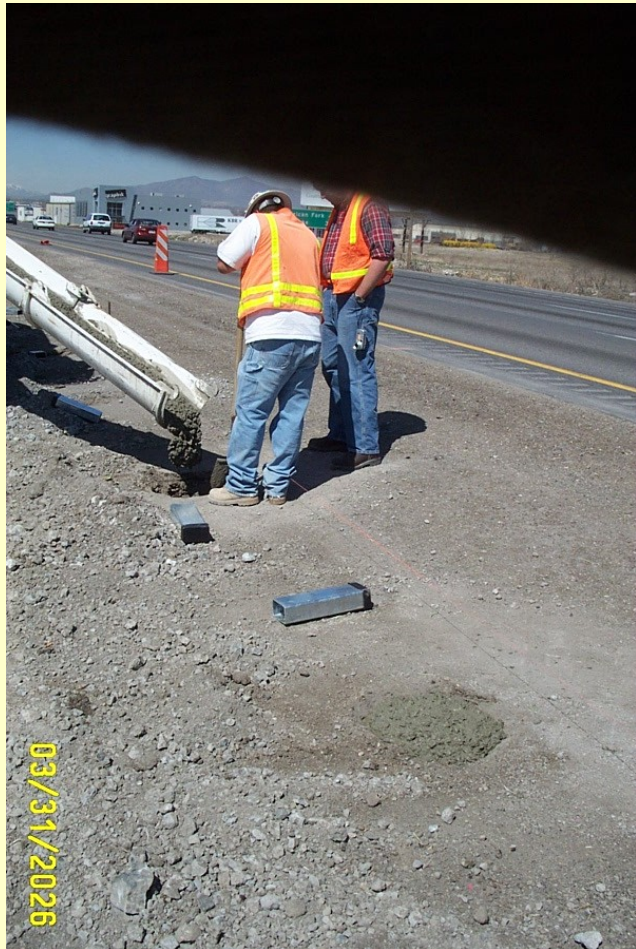
Filling holes for  
concrete/sleeves...

Contractor able to get 75 to  
100 holes per 10 yd truckload  
in most areas, using  
4000lb/sq. in. strength  
concrete.

(Some areas, poor substrate  
created enlarged holes, only  
50 per load possible there.)

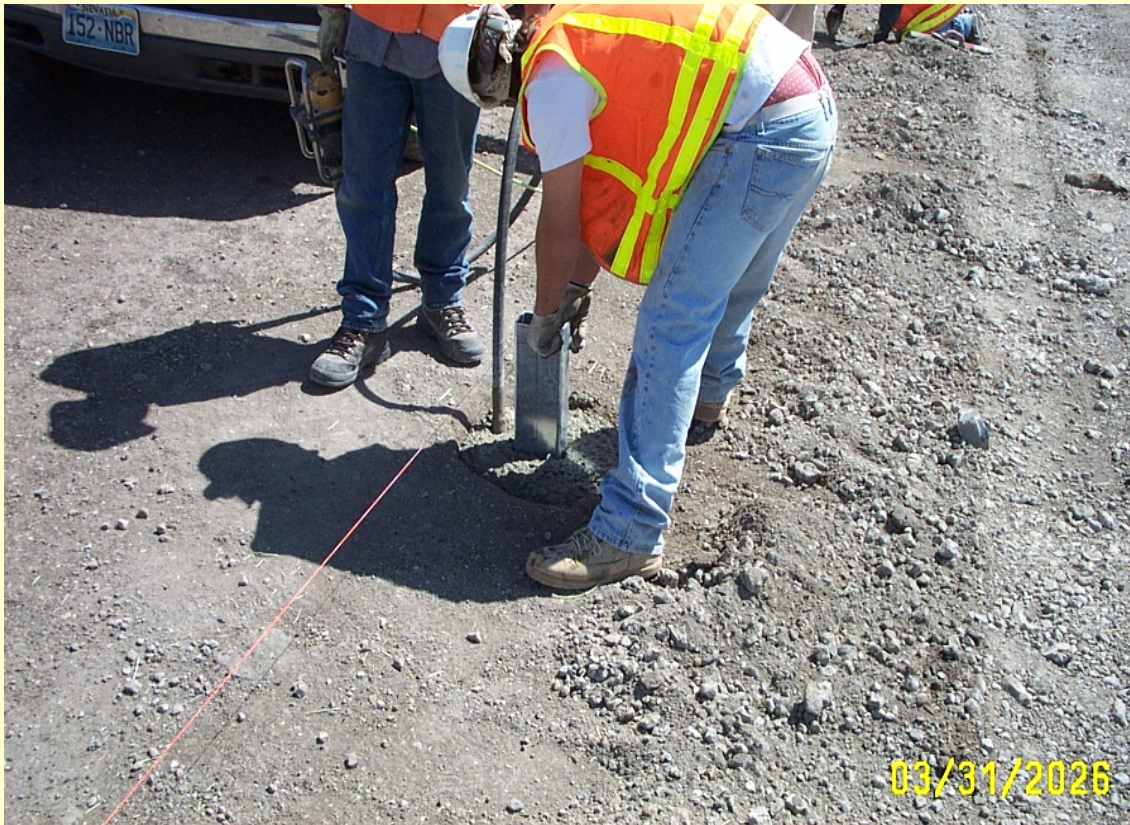
Inserting Sleeve  
Contractor used vibrator to make this easier and to settle the concrete.

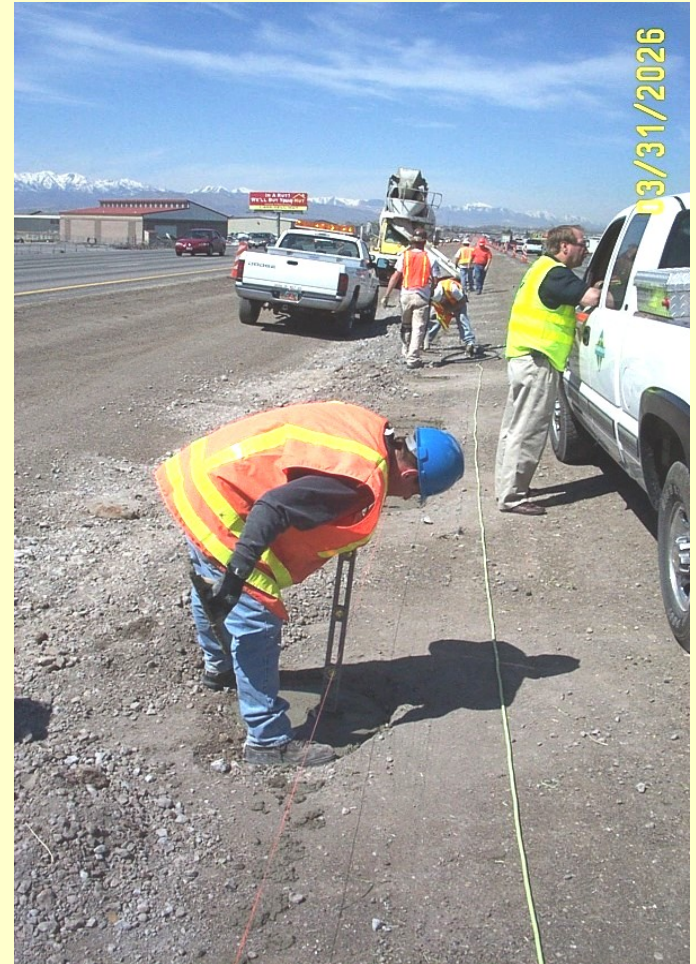
Foreman later double-checks the alignment of each sleeve.

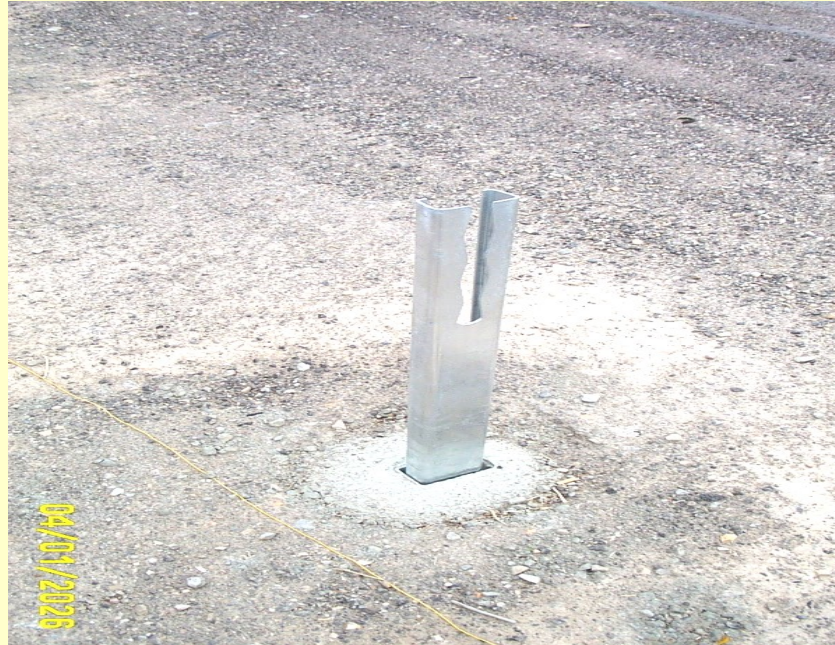
In a day or so, posts can be inserted. Note good finish nearly level with ground.

(Sleeve cover not shown.)

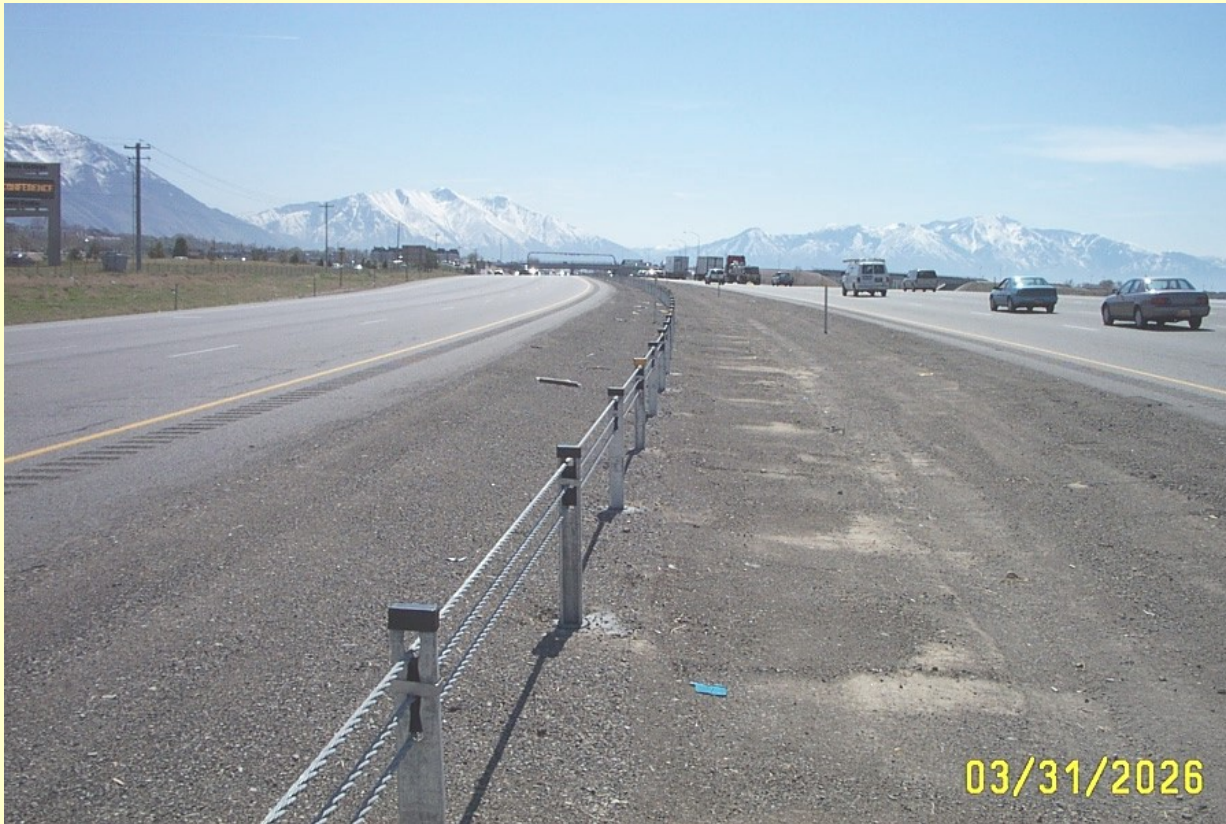
Finished  
installation

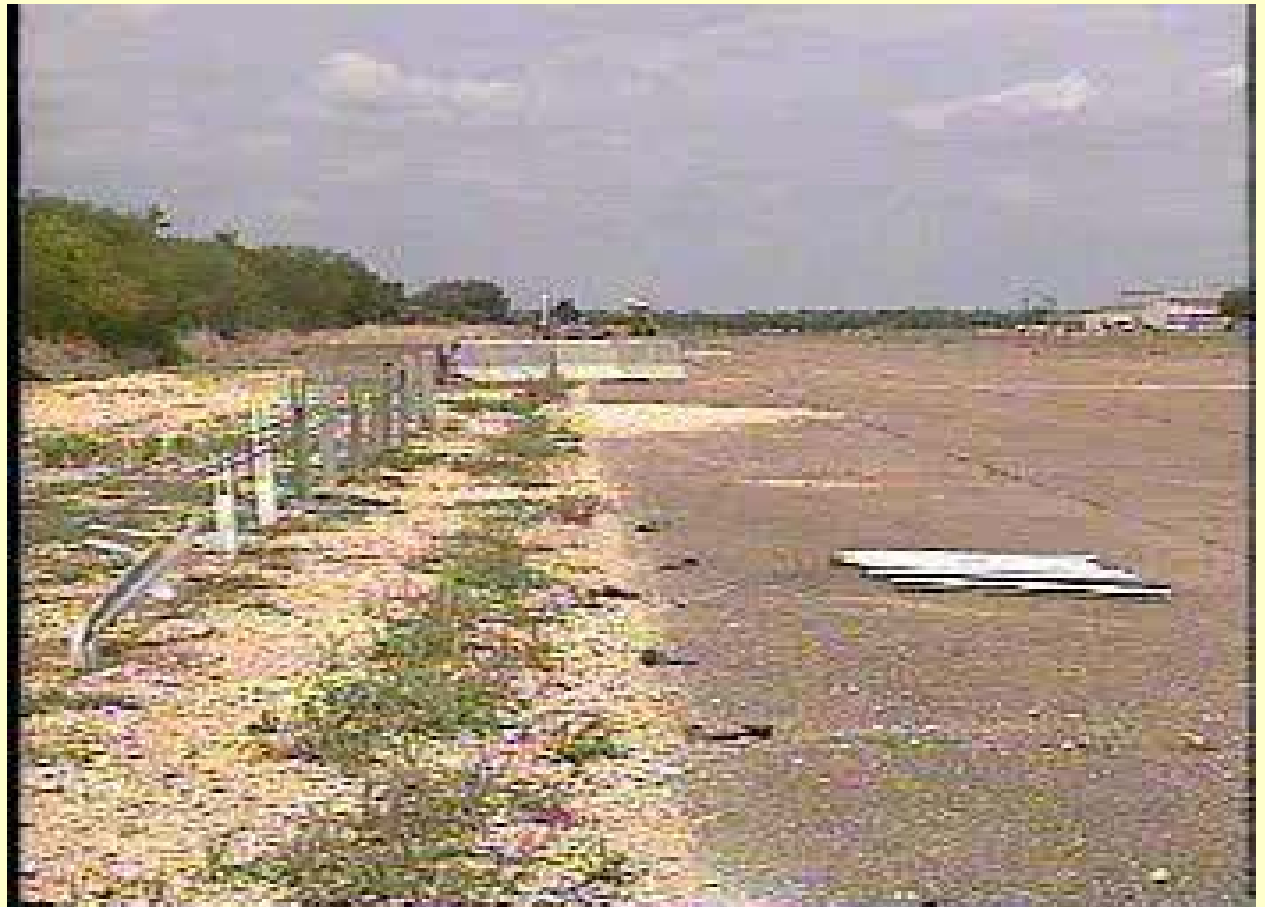
1) Removing  
Damaged  
Posts

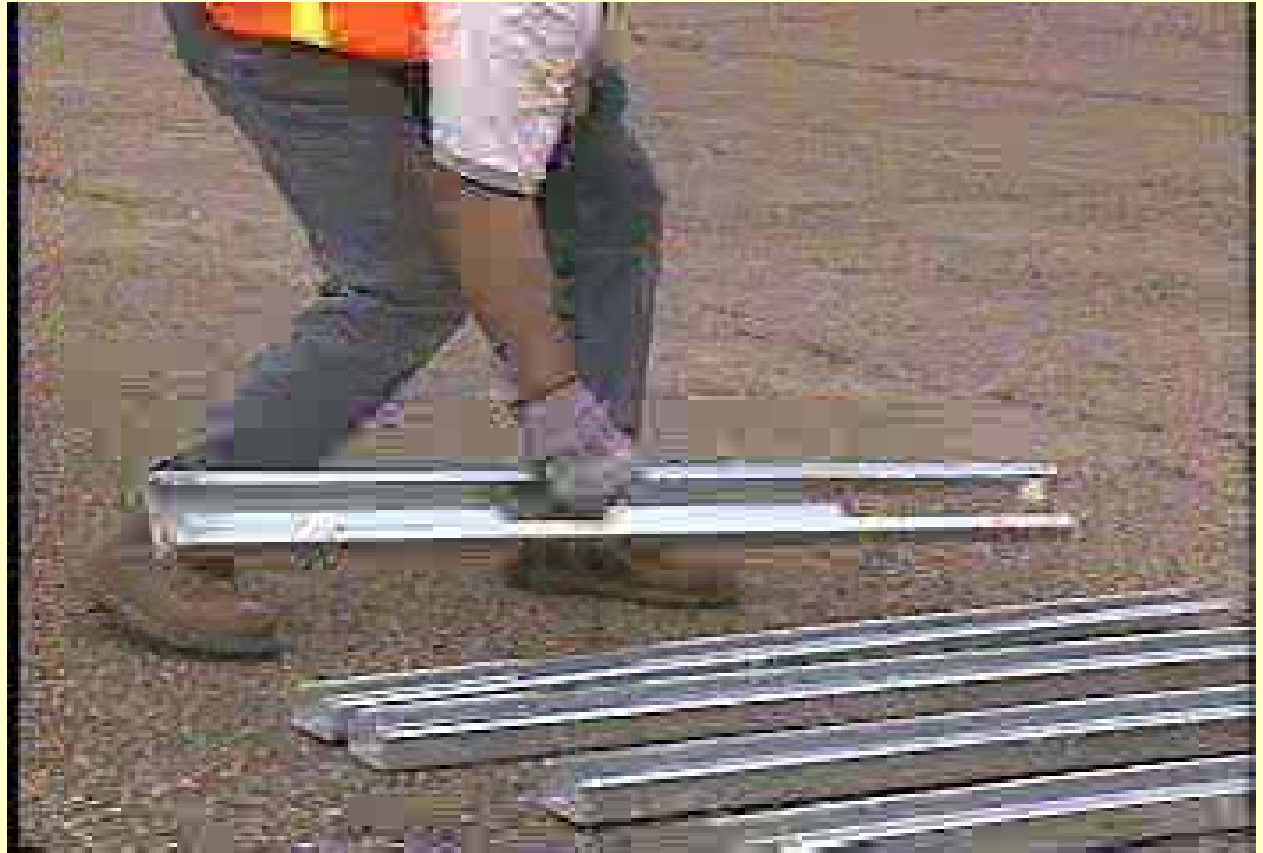
2) Setting  
New Posts

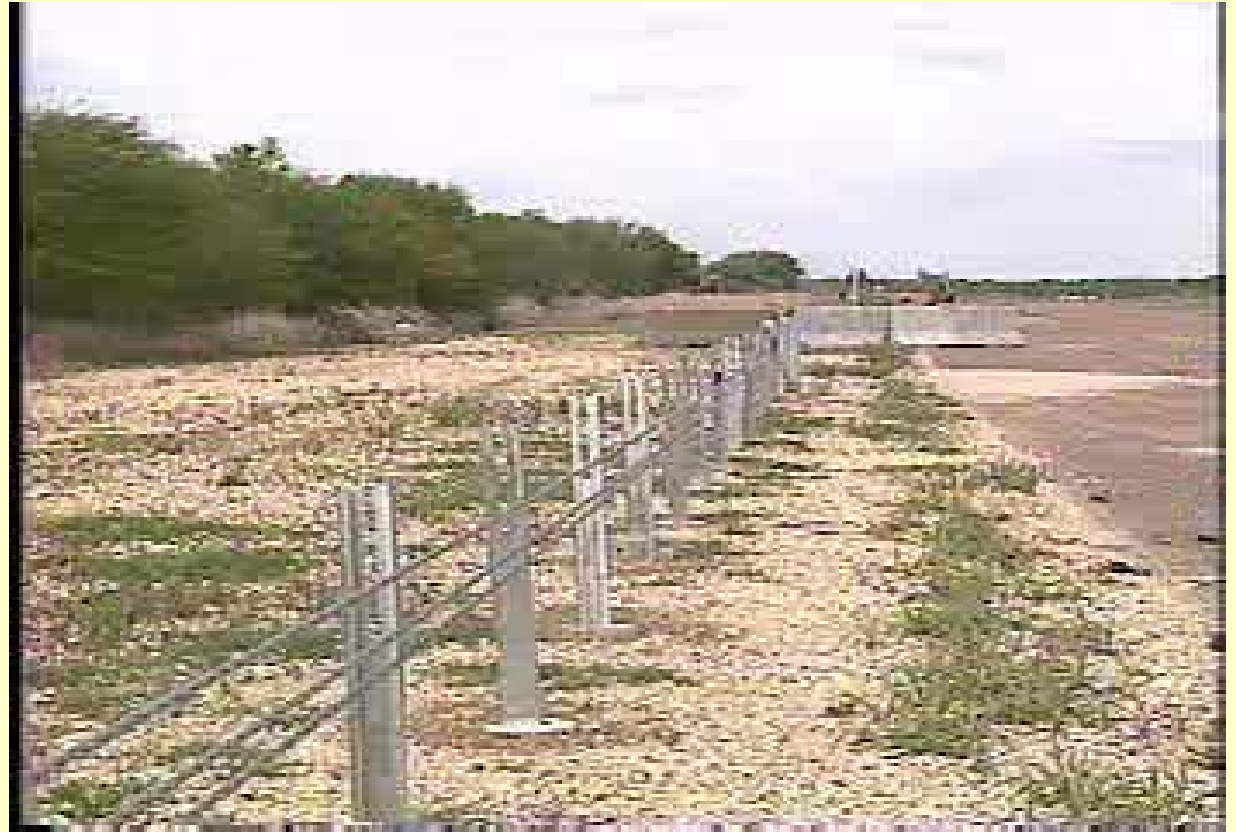
3) Cable  
Placement

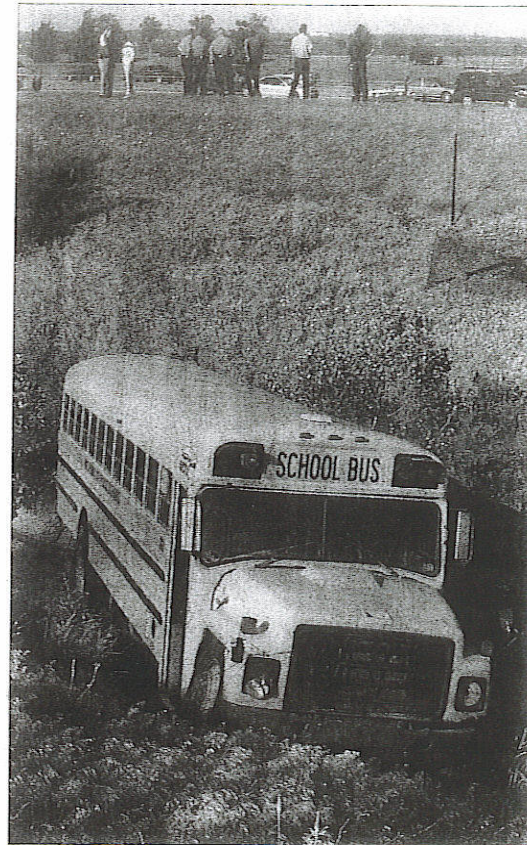
An Oklahoma City School District bus sits Wednesday morning in a drainage ditch on the east side of Lake Hefner Parkway. The driver, Woodrow Commander, apparently suffered a heart attack while driving, crashing the bus. No students were on board at the time.

The bus bounced off the cable barrier device and crossed over all the northbound lanes, running off the east side of the road, Phillips said.
