Improving Highway Safety: Cable Median Barrier

January 2004

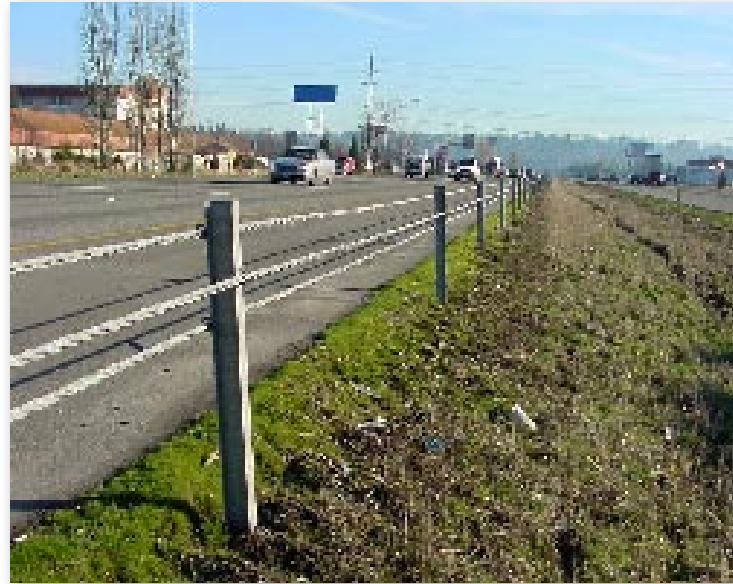
Typical cable median barrier installation and details

Cable barriers have been used on the nation's highways since the 1930's or before. The modern system, which uses 3 cables supported by weak steel posts was developed in the 1960's and has been used significantly by several states. Since 1989, the American Association of State Highway and Transportation Engineers (AASHTO) *Roadside Design Guide (1)* has contained information on a cable median barrier design that mounts the middle cable on the back side of the posts so that it can contain and redirect vehicles that strike the system from either side. Cable median barrier has been tested in accordance with NCHRP Report 350 Test Level 3 (3, 4). However, there have been only a few studies published about the in-service performance of this system. The WSDOT conducted a study of this barrier performance (5) and the results are summarized as follows:
