**RSA Program**  
**in**  
**Collier County, Florida**

Robert Register, P.E., PTOE  
Transportation Services Division

National Peer Exchange on Road Safety Audits

May 22-23, 2007

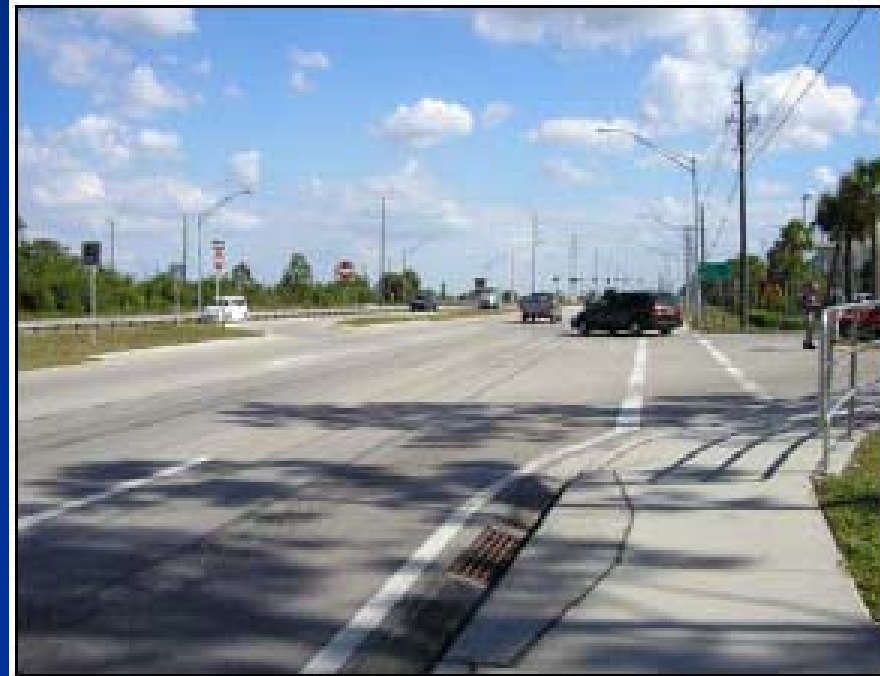
*access and left-in median break for the "Shoppes of Pebblebrooke" shopping mall*

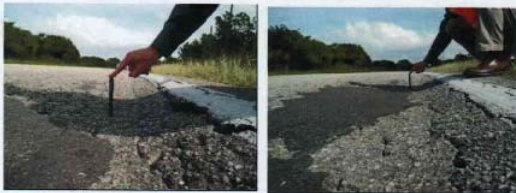
*Location:* West of Despla Blvd.

**Description of Safety Issue:** This location is in Segment 3 and is currently scheduled for the final phase of construction starting late 2008 or early 2010. The roadway was overtopped during the summer of 2006 causing rutting of the existing lanes. Some ruts were measured to be 4 inches or greater. This area has extensive pavement and base failure and the ruts allow the opportunity for the collection of water during rainfall events. The primary safety issues are the poor riding surface and potential to lose control of the vehicle and secondly in rain/fall events the potential for hydroplaning. The roadway is currently signed but bagged saying "Caution Road Under Water" with flasher.

**Recommendation:** Advance this section in the work program to be constructed with the initial set of projects. If this is not possible conduct a milling and resurfacing project to repair the roadway surface. This will also require some base failure repair. Under the current construction schedule this section would have about 4 to 5 years of use before

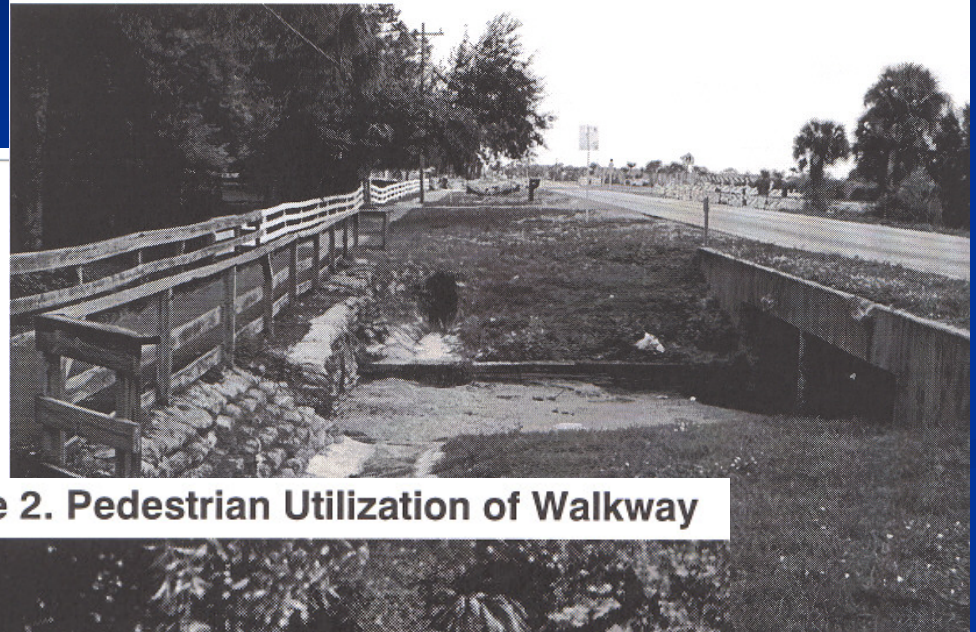
Figure 1. Fish Branch Creek Crossing with Pedestrian Walkway

Fish Branch Creek Crossing  
Lake Trafford Road

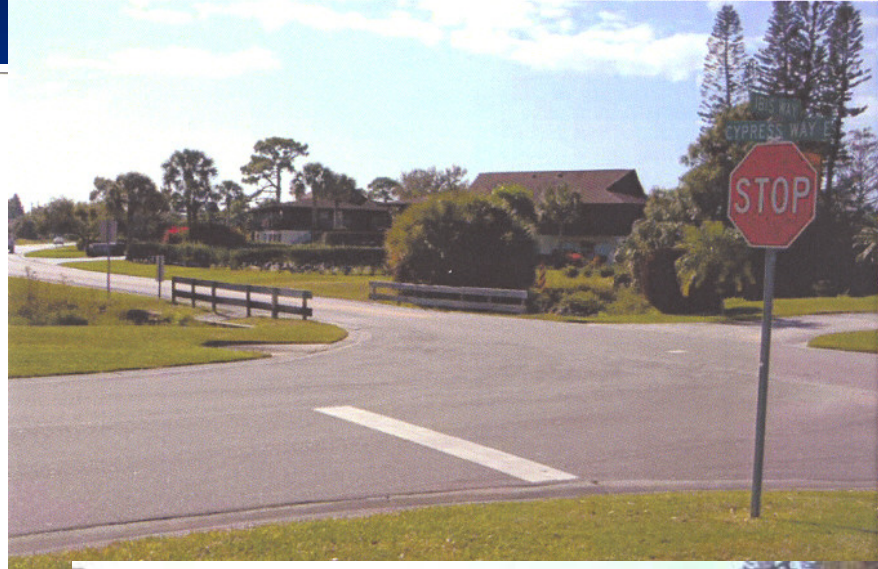
Figure 1. Culvert at Intersection of Cypress Way East and Ibis Way

Cypress Way East and Ibis Way  
Drainage Improvements
