Washington State Cable Median Barrier

Richard B. Albin

AASHTO TIG

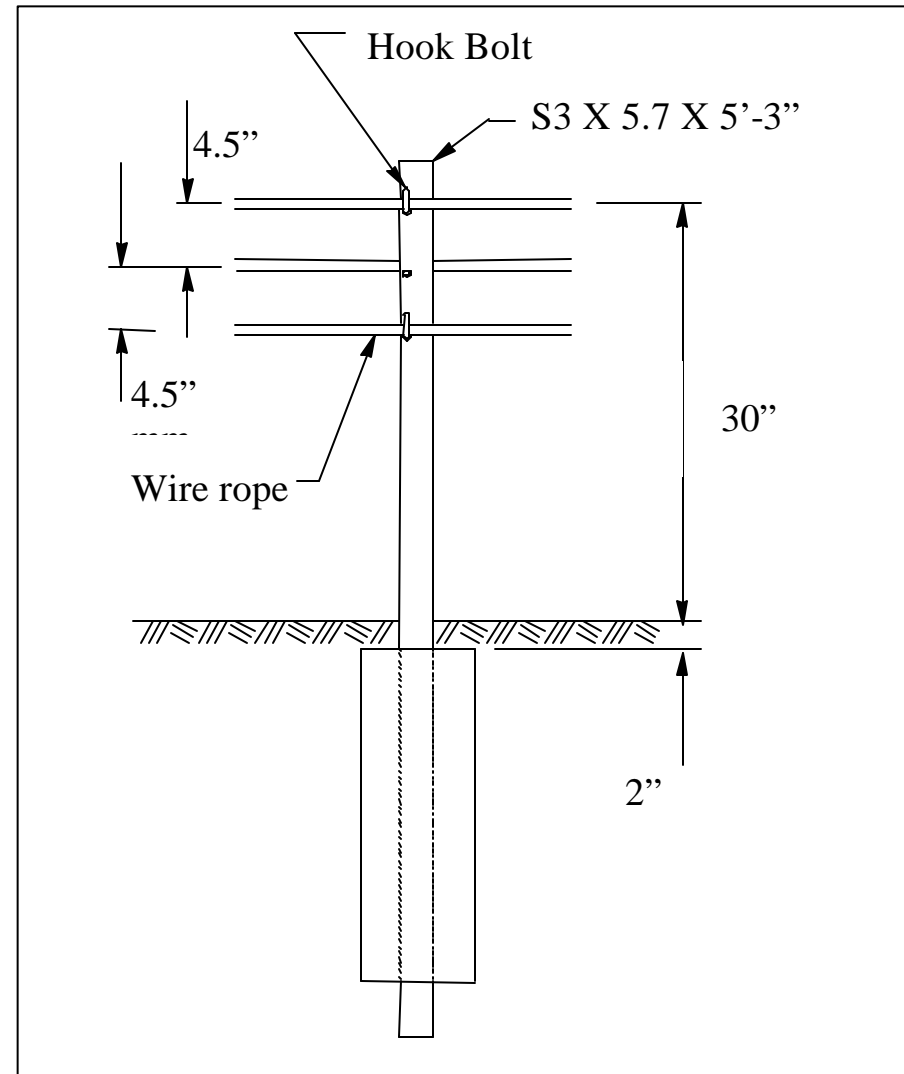
Barrier Design

- Cable heights
 - Top – 30"
 - Middle – 25.5"
 - Bottom – 21"
- Middle cable of opposite side of posts

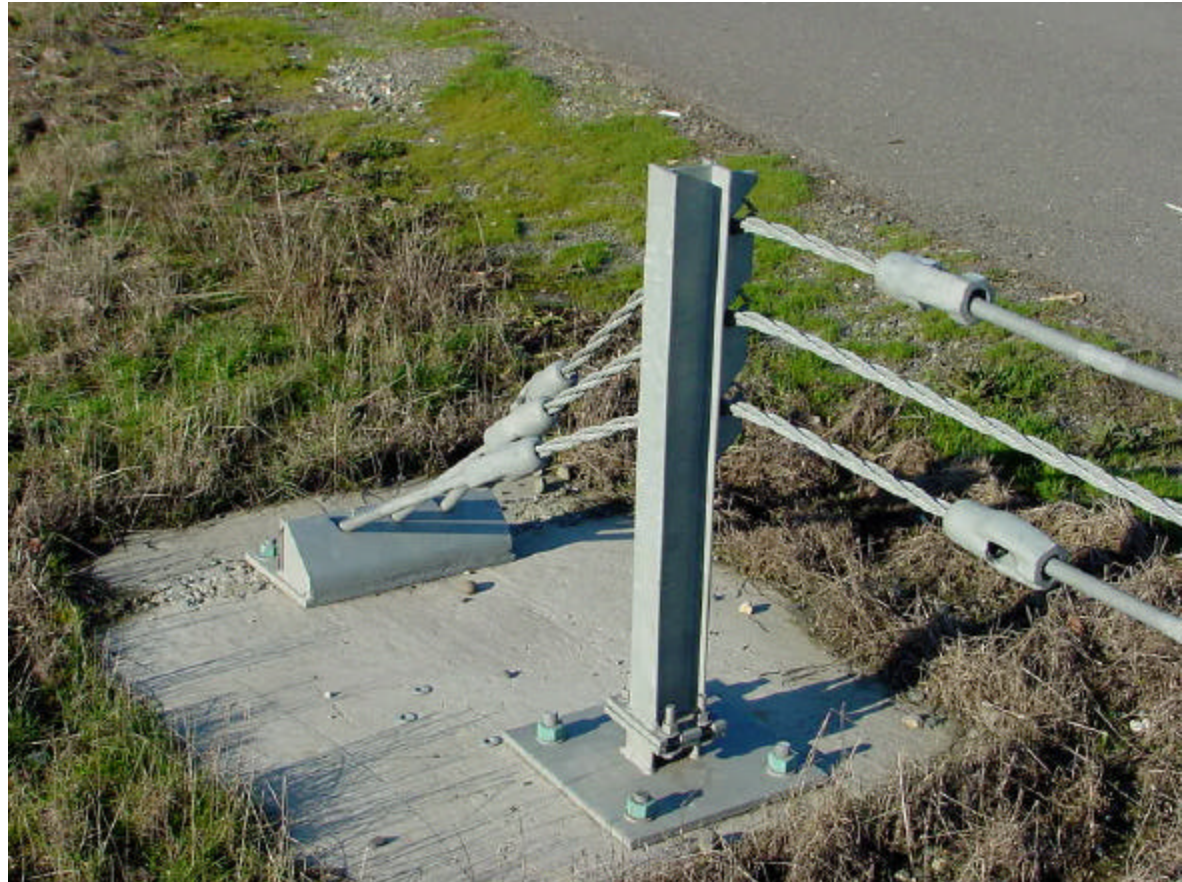
Barrier Design

- WSDOT uses a terminal design based on one tested by New York DOT

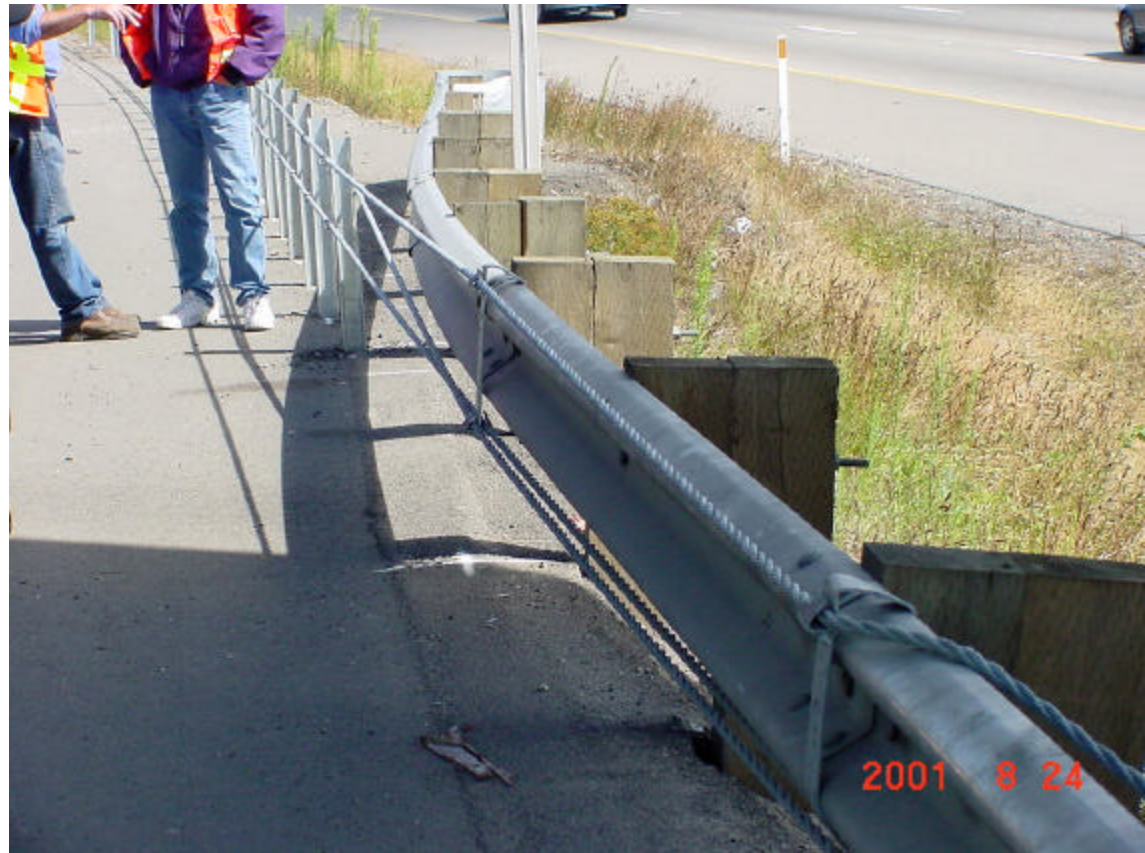
Barrier Design

- WSDOT uses a transition to W-Beam that was developed by South Dakota DOT

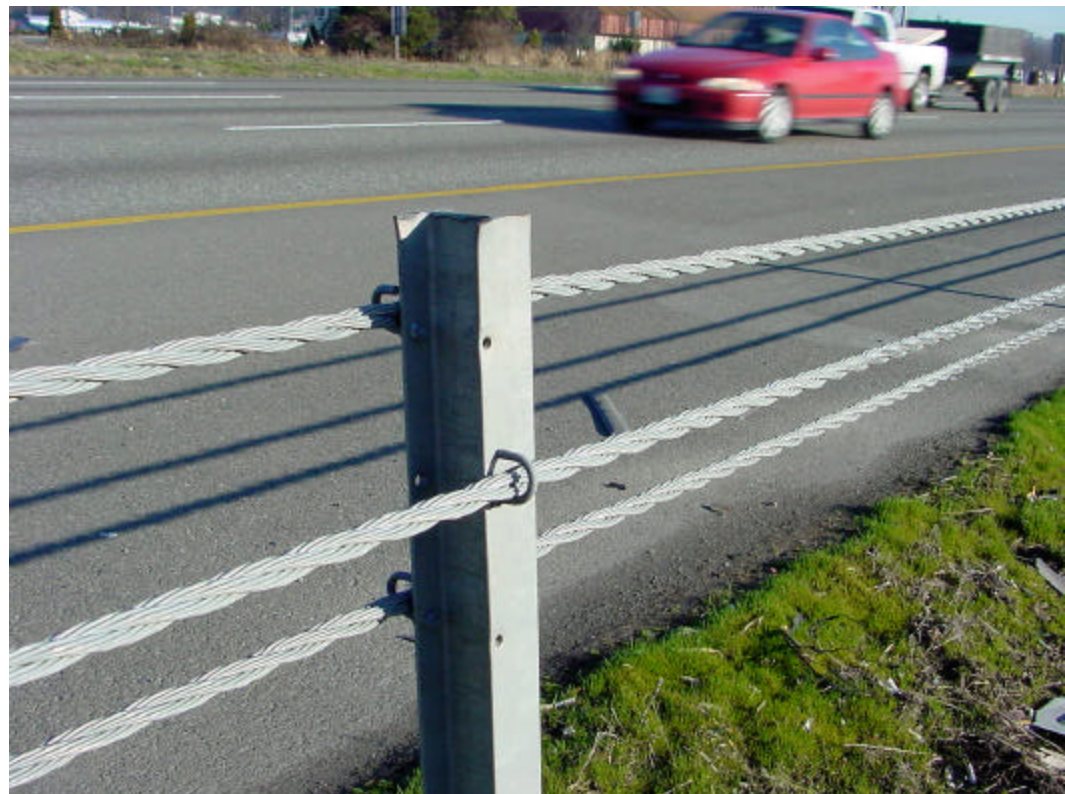
Crash Testing

- Cable median barrier has been crash tested in accordance with NCHRP 350, Test Level 3 criteria
- Testing was performed with impact on the side with only one cable

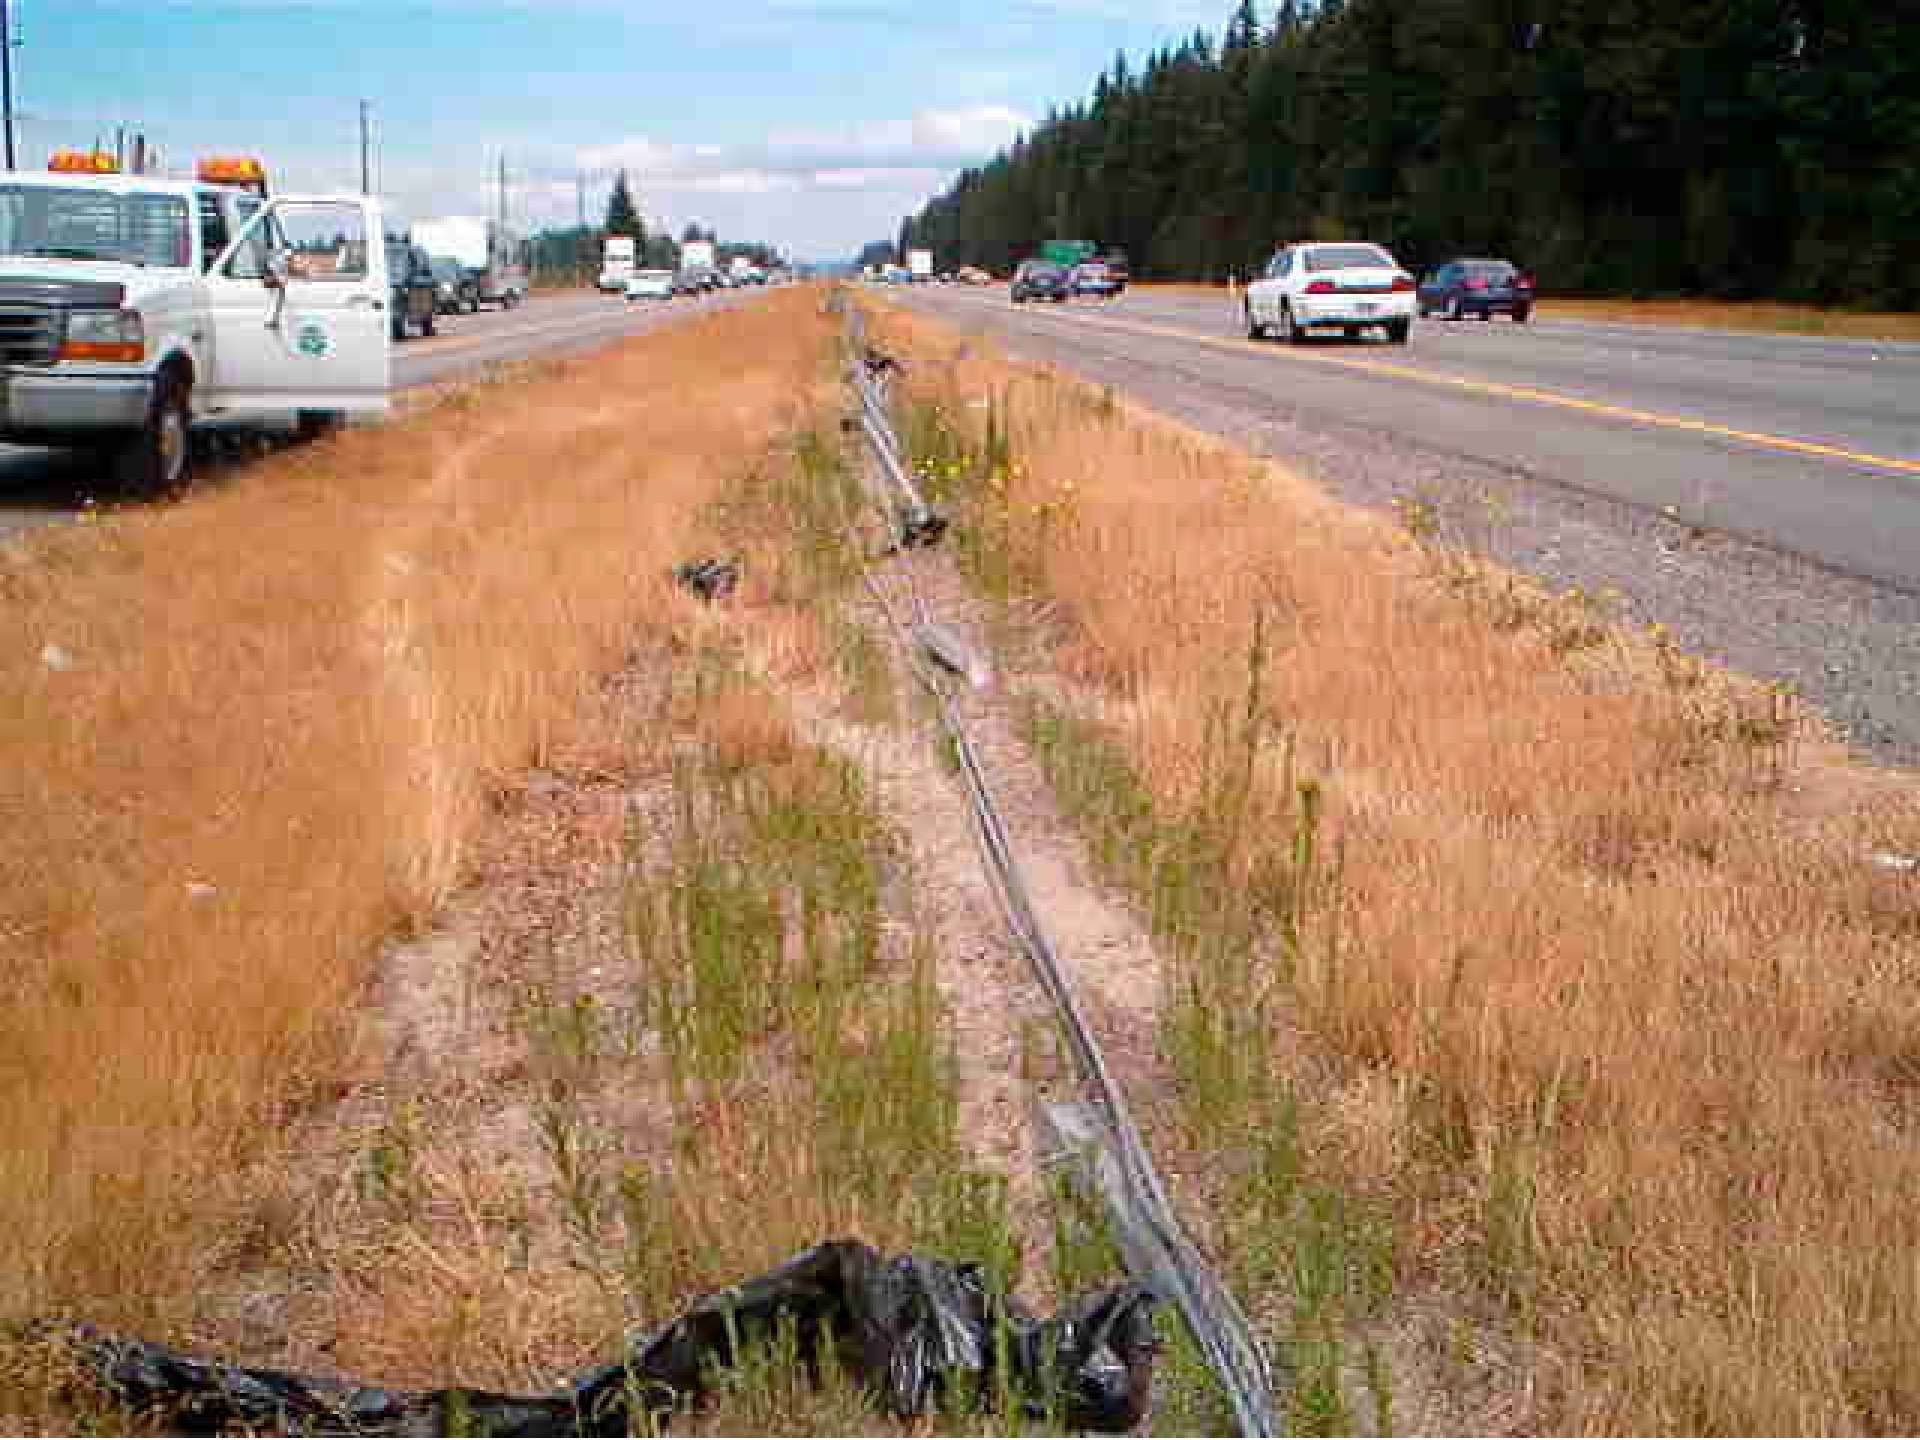
Maintenance Costs

- Data is based on 141 maintenance repairs

Max.	Min.	Ave.
Number of posts hit:	32	1	6.7
Hours for repair:	70	1	9.4
Parts costs:	\$1,490	\$32	\$328
Total repair costs:	\$2,822	\$72	\$733

Maintenance Repair Cost/Mile/Year **\$2,570**

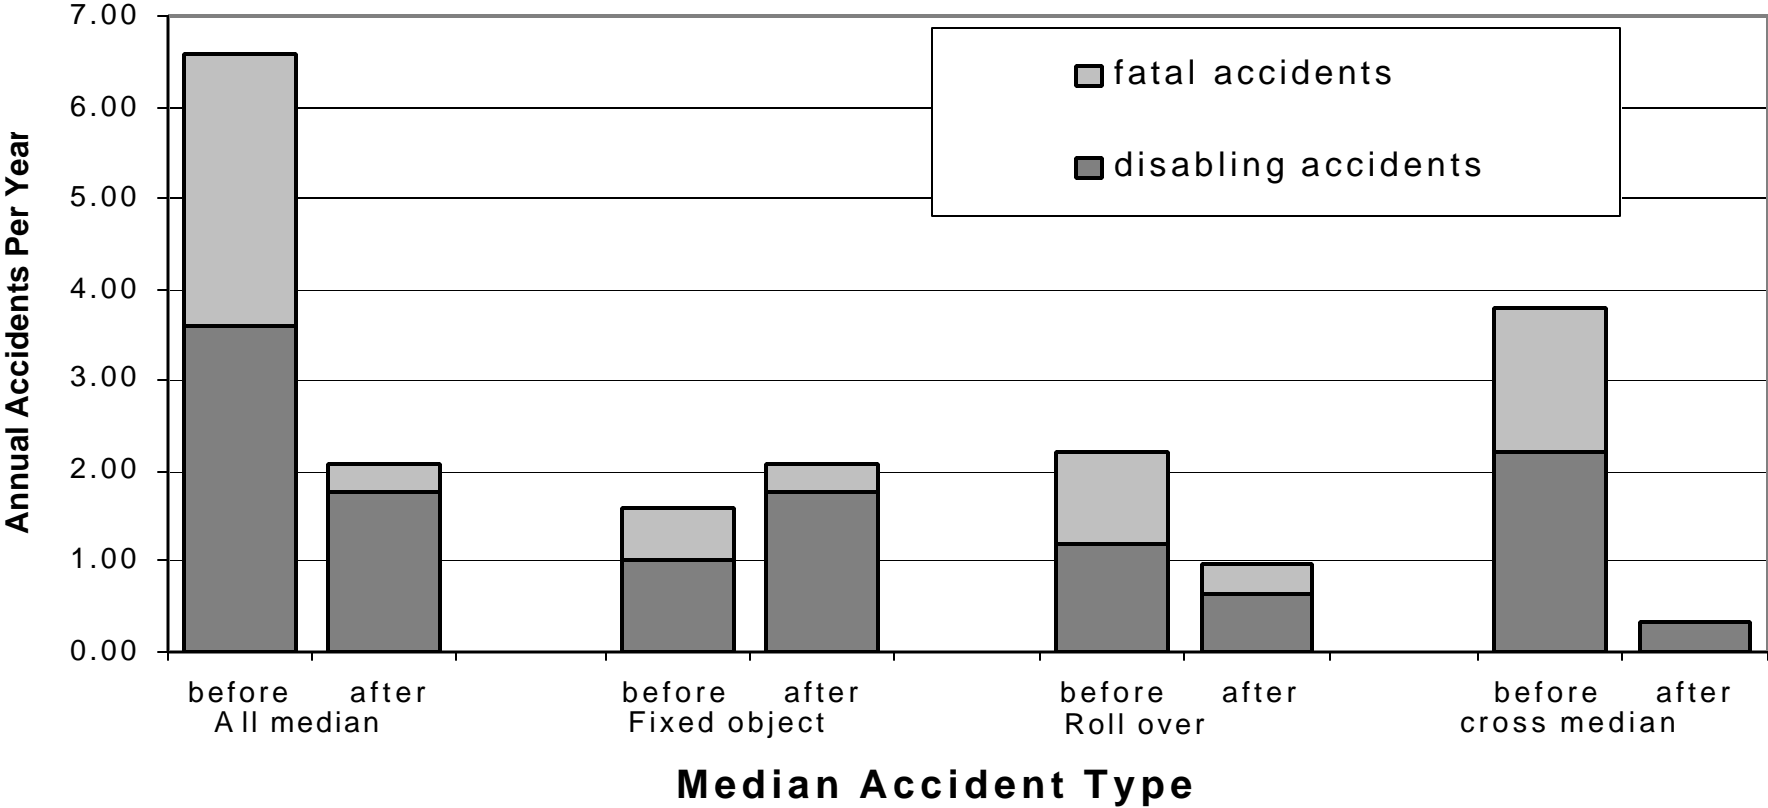
Accident Experience

Comparison of Annual Accidents Before and After Cable Median Barrier Installation

- Total accidents increased significantly after barrier installation
- Severe accidents (fatal and disabling) decreased significantly.
- This societal benefit of cable median barrier was \$420,000 per mile annually.

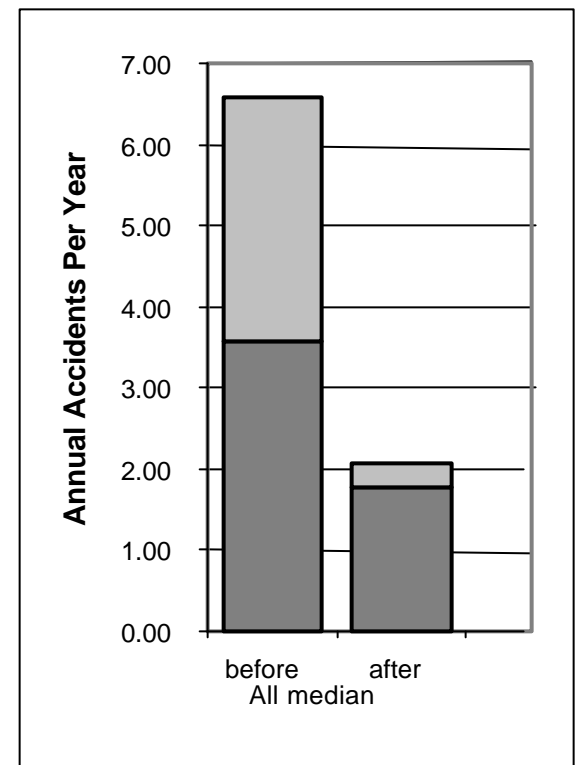
All Median Accidents

Annual Accidents	Accident Rate (per 100 MVMT)	Fatal Accidents	Disabling Accidents
Before	49	6.5	3.0	3.6
After	100	13.4	0.3	1.8

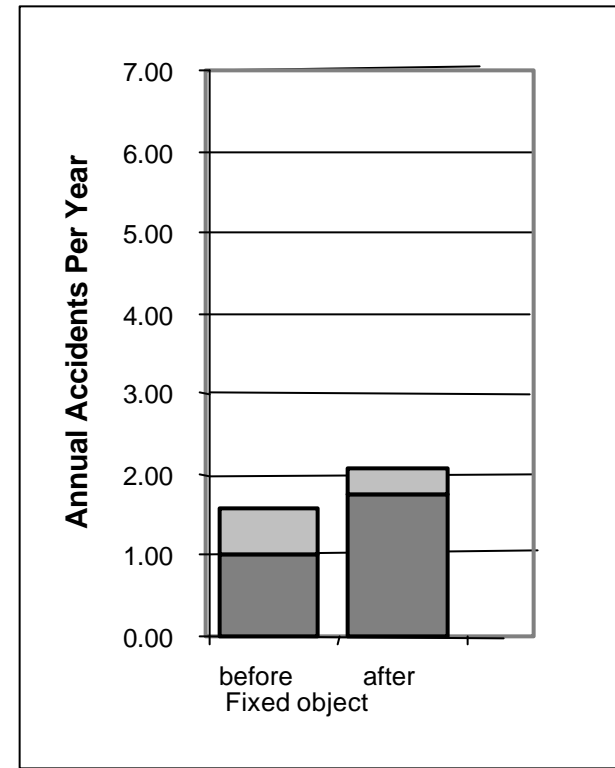
Fixed Object Accidents

*After Data includes 0.3 Fatal and 0.9
Disabling Accidents involving the Cable
barrier

Annual Accidents	Accident Rate (per 100 MVMT)	Fatal Accidents	Disabling Accidents
Before	25.6	3.4	0.6	1.0
After	91.7	12.2	0.3	1.8

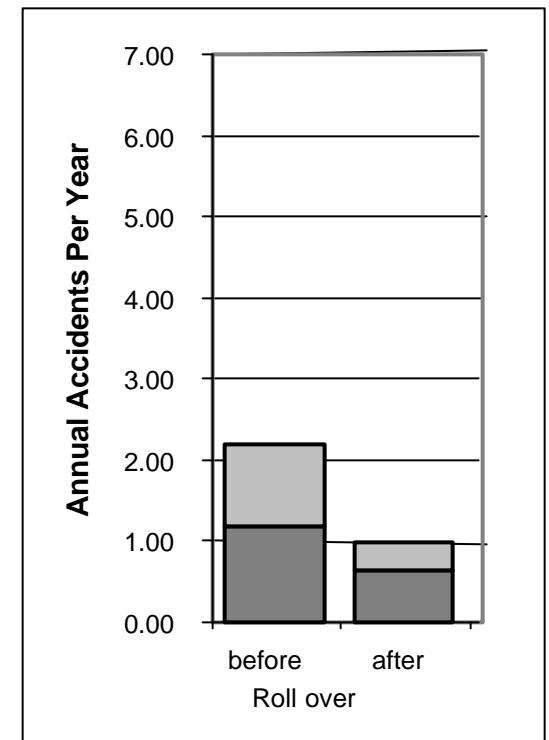
Roll Over Accidents

Annual Accidents	Accident Rate (per 100 MVMT)	Fatal Accidents	Disabling Accidents
Before	11.4	1.5	1.0	1.2
After	9.4	1.3	0.3	0.7

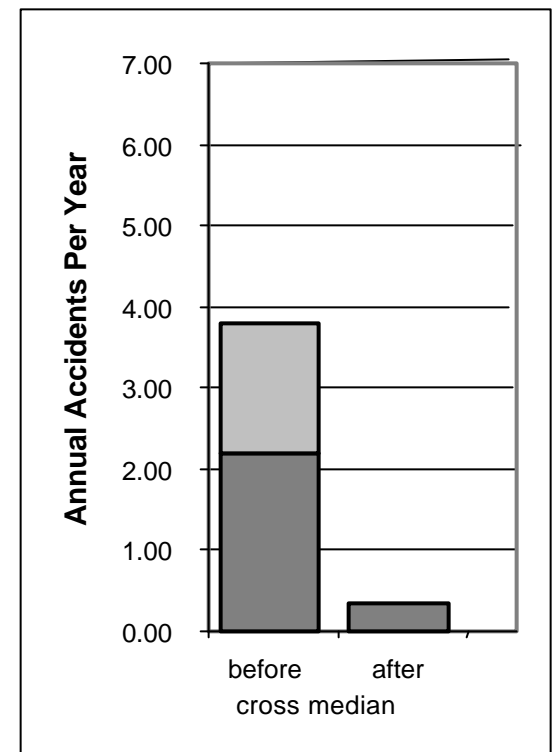
Cross Over Accidents

Annual Accidents	Accident Rate (per 100 MVMT)	Fatal Accidents	Disabling Accidents
Before	16.0	2.1	1.6	2.2
After	3.8	0.5	0	0.3

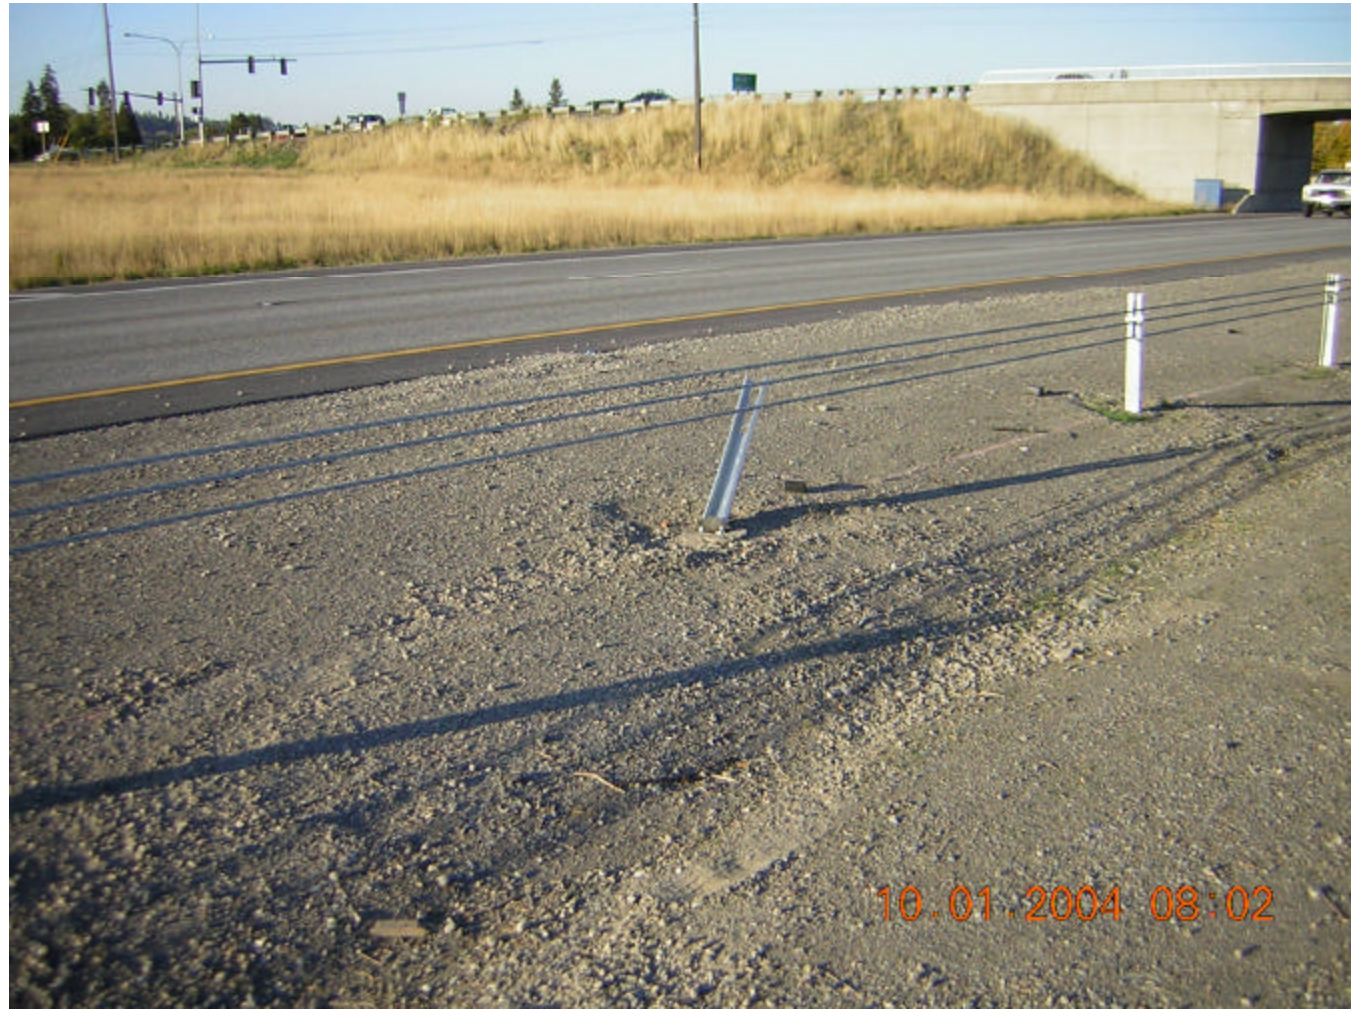
High Tension Repair

- 18 hits
- Avg # posts – 5.4
- Avg Repair Cost - \$634
