**THREE-CABLE
MEDIAN BARRIER
FINAL REPORT**

#OR-RD-99-03

Oregon Department of Transportation
Research Unit
200 Hawthorne SE, Suite B-240
Salem, OR 97310

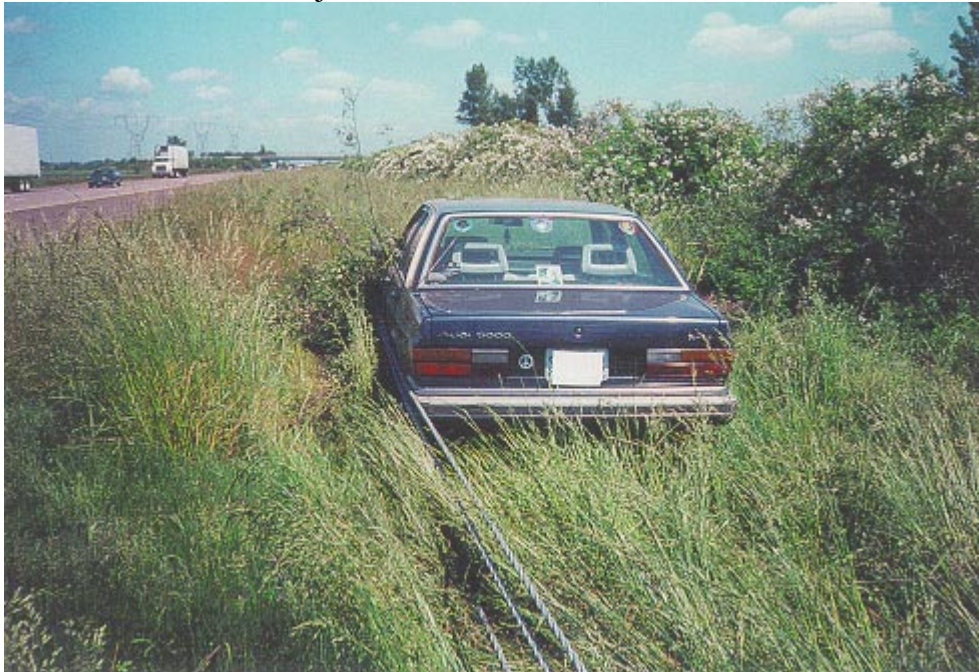
Time/Date: 0230; 6/6/97

V#1 was in the 'A' lane passing V#2. As V#1 was alongside V#2, V#2 started changing lanes from 'B' to 'A'. V#1 swerved to left to avoid V#2. V#1 then veered back to the right to avoid the median bushes, traveled into the 'B' lane in front of V#2, then swerved back to the left to avoid traffic. Ultimately V#1 went into the median at an angle and was stopped by the center median cables restraint system. Damage to approximately 60 feet of cable. ODOT notified of damage. It probably prevented a head-on collision. Due to conflicting statements by subjects involved and no independent non-partisan witnesses, no action was taken. No injuries.

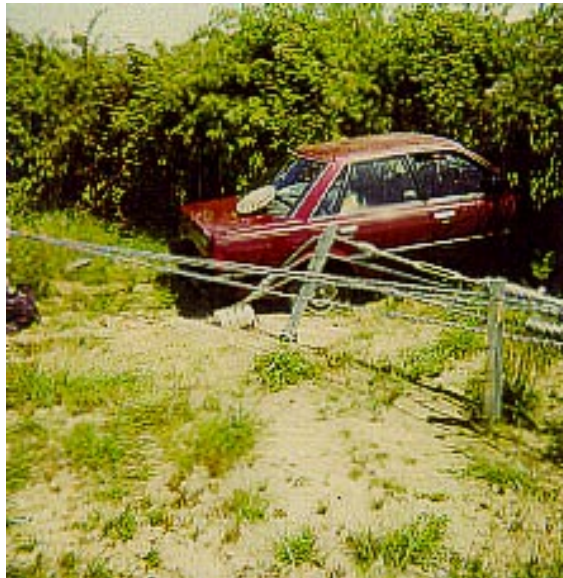
Time/Date: 2020; 7/17/97

V#1 was S lane 'B'. V#2 was S lane 'C'. OP #1 looked down for a second and when OP#1 looked up V#1 swerved a little, OP#1 overcorrected back, tapped V#2 causing minor damage to V#2. V#1 left roadway, struck 3-cable restraint system, passed through cables and stopped. Cables tore hood off V#1 and crushed windshield. V#1 stopped in median. Non-injury.

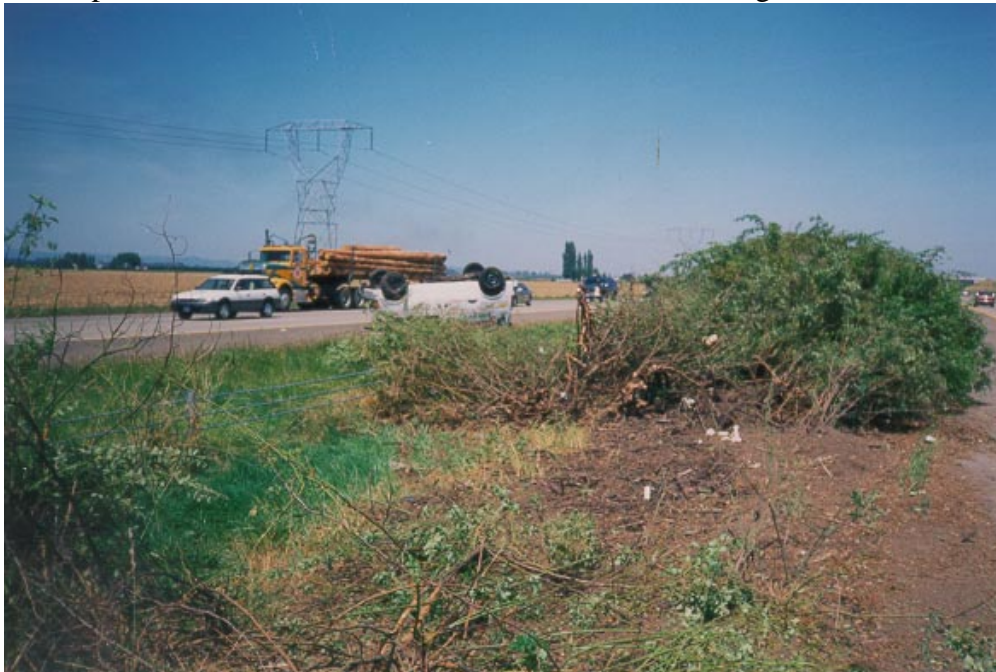
Time/Date: 0400; 7/24/97

V#1 was I-5 N at MP 268. Witnesses said V#1 was following too close. A vehicle in front braked. OP#1 slammed on the brakes and lost control. OP#1 hit the median 3-cable system and flipped. OP#1 received minor injuries and was treated and released from hospital. OP#1 was issued a citation for careless driving.

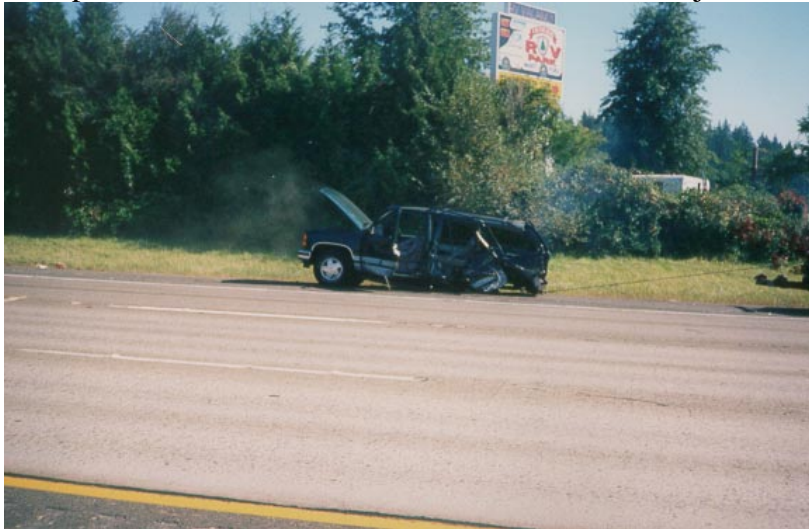
Time/Date: 1130; 9/24/97

Preliminary investigation indicates that OP#1 suffered a seizure. V#1 was S on I-5, crossed the median, broke through the cable barrier, struck V#2 and continued across the N lanes where it came to rest in a field. OP#2 received minor injuries/treated and released at hospital. V#2 totaled and towed. V#1 sustained major front-end damage.
