Curbing Wrong Way Movements onto Michigan's Freeways

Mark Bott, P.E. Engineer of Traffic & Safety Michigan DOT

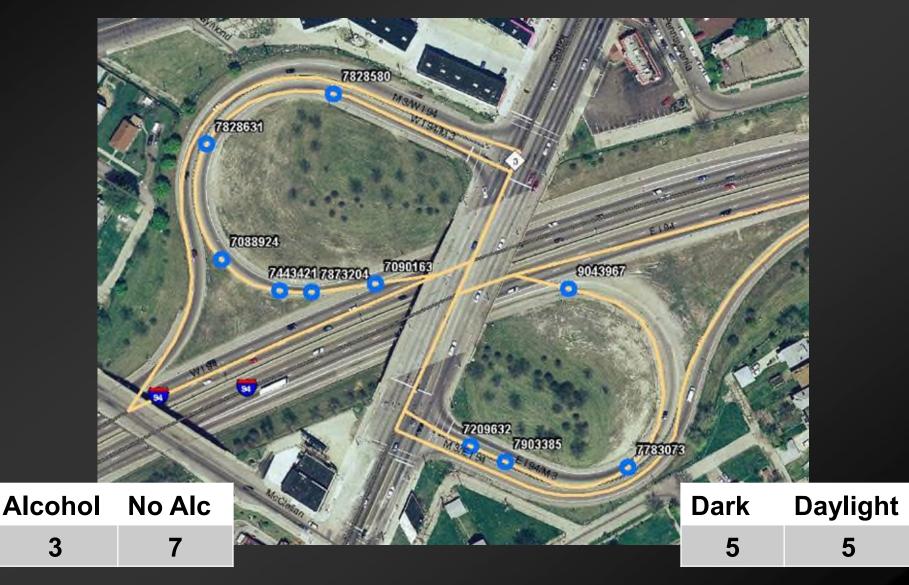
Gratiot Ave @ I-94 (Detroit)

"Video taken at the interchange indicates that drivers may be staying to the left of the barrier because they cannot see the on-ramp on the barrier's other side." Wash DOT, 2001

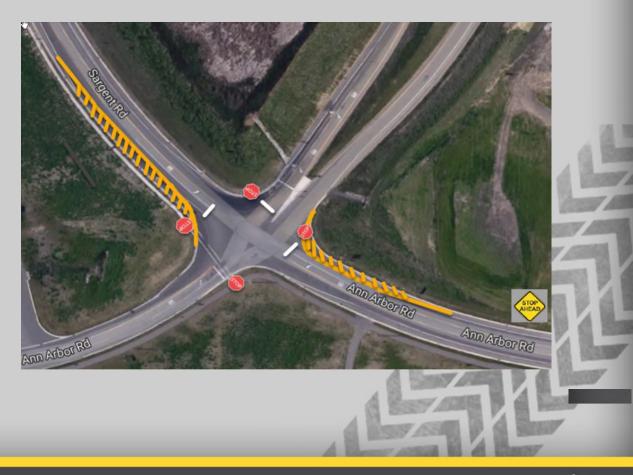
I-94 at Sargent Road

Pavement marking and signing changes completed in Fall 2017 to reduce driver confusion
