HIGH TENSION CABLE BARRIERS

OUTLINE

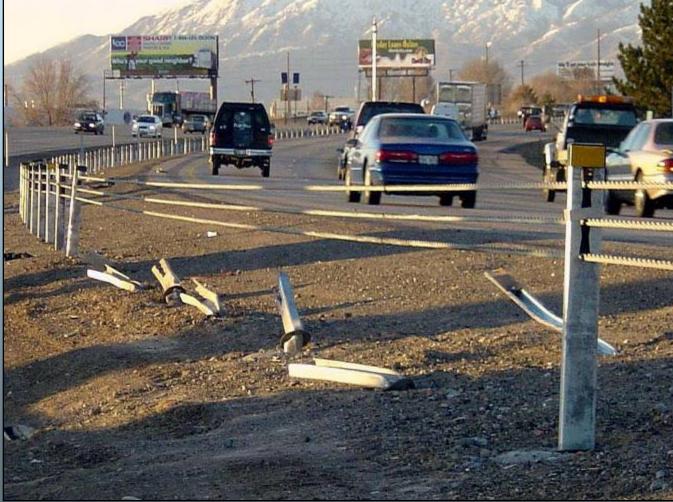
High Tension Cable After A Hit

High Tension Cable barriers can sustain hits and still remain effective

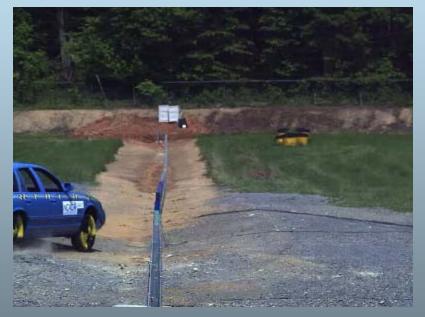
1 ft. Offset

4 ft. Offset

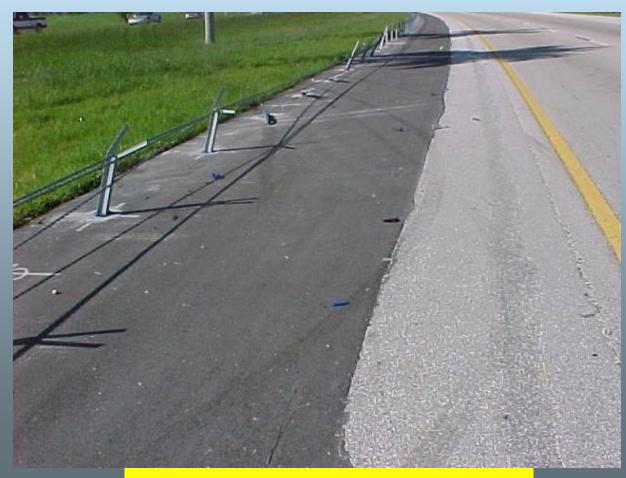
Deflection – Also affected by angle & speed

Deflection – Controlled by Post Spacing

Deflection	Post Spacing
9'3"	30.FT
9'	28.FT
8'	20.FT
7'	12.FT

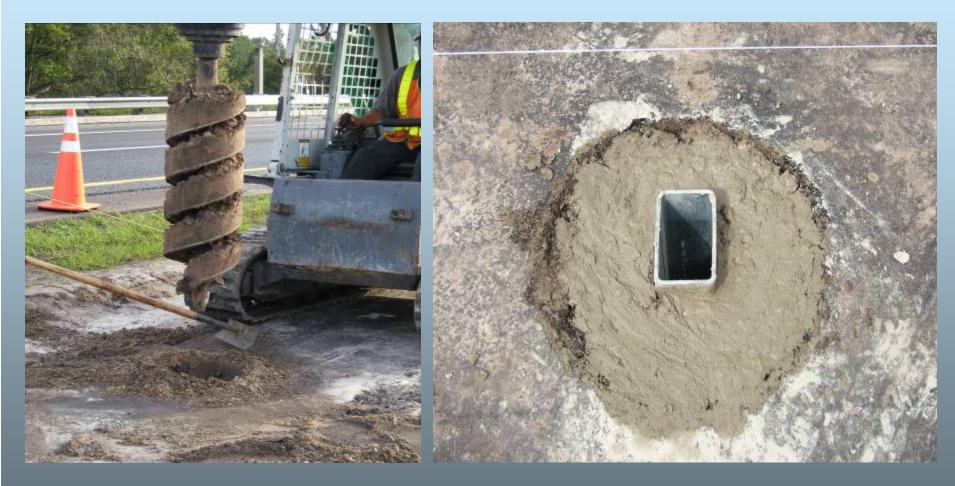
Construction Sequence Holes Drilled & Sockets Installed

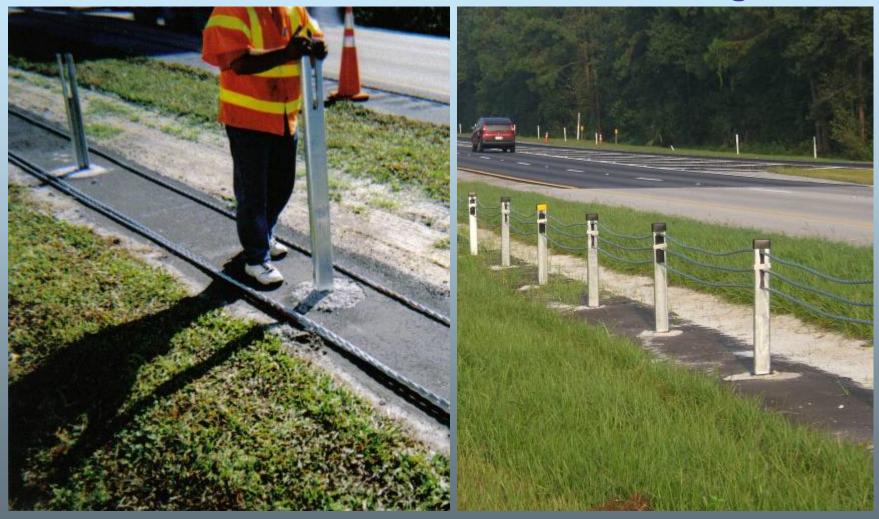
Posts Installed and Cable Strung

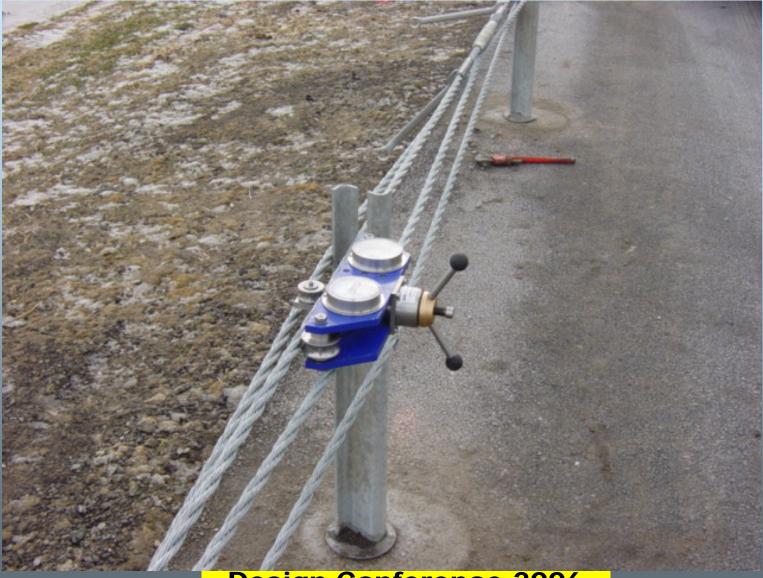
Cable Tensioned
