FAST FACTS:

Carbon Fiber Reinforced Polymer Strands

PROJECT LOCATION:	Senaca County, Ohio
AGENCY	Ohio Department of Transportation
URL:	aii.transportation.org (select <i>Carbon Fiber Reinforced Polymer Strands</i>)
PROJECT NAME:	Bridge Removal and Replacement on State Route 635
PROJECT DESCRIPTION:	This project replaced the existing bridge structure on SR 635 over Plum Run Creek with a prestressed concrete box beam with carbon fiber composite cable (CFCC) strands. New Structure File Number: 7403910.
PROJECT PURPOSE AND NEED:	The existing facility is a continuous concrete slab bridge structure with asphalt concrete wearing surface that was built in 1960. The 2017 inspection indicated that the bridge structure was in poor condition with a sufficiency rating of 60.9. The existing structure was to be replaced with a new structure with improved features to provide longer service life.
OVERALL BUDGET / COST ESTIMATE:	\$912,362.75

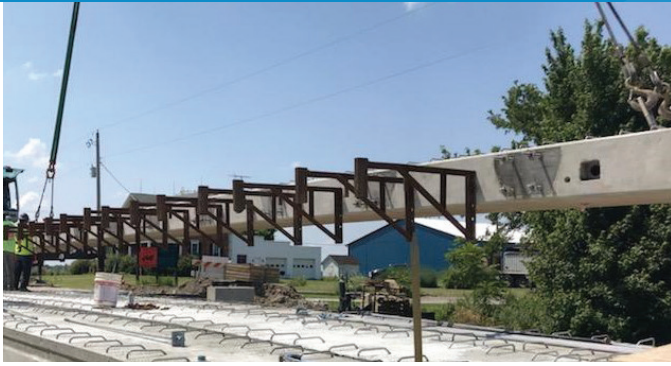
▶ An exterior box beam being launched to set onto the beam seat.

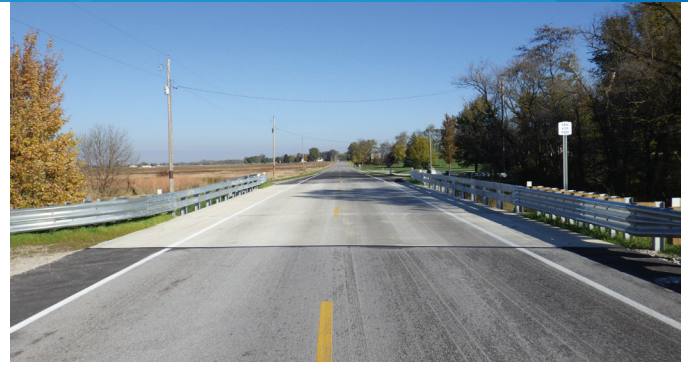
▶ Completed bridge with a view of the finished deck.

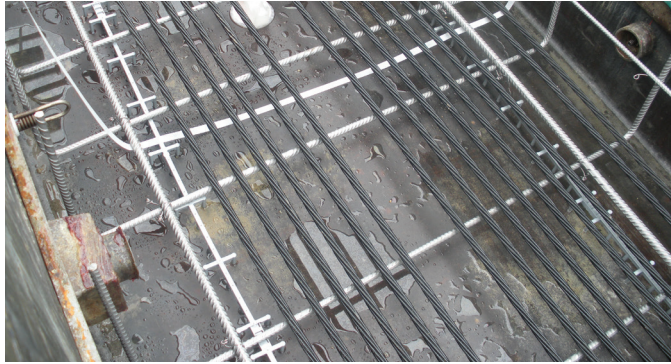
▶ Prestressed concrete box beam casting bed with the CFCC strand and the bottom stainless steel U-rebars used for shear reinforcement installed in place. Note the rectangular block out at the lower left side of the photo of the exterior beam used to run the tie rods through beams during the beam installation operation.

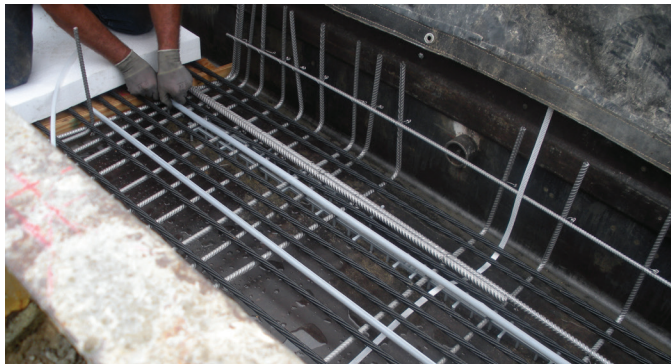
▶ Prestressed concrete box beam casting bed with the CFCC strand and the bottom stainless steel U-rebars used for shear reinforcement installed in place. Note the bond breaking plastic sleeve being installed.

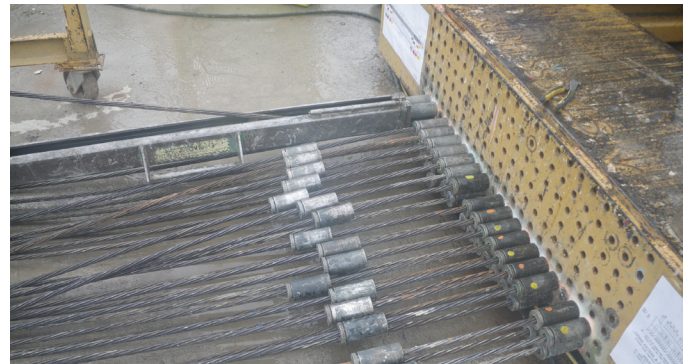
▶ Prestressed concrete box beam casting bed with the bulkhead and prestressing chucks set in place color coded for the stressing operation sequences. Note the stressing jack will fit between two chucks to normally function.

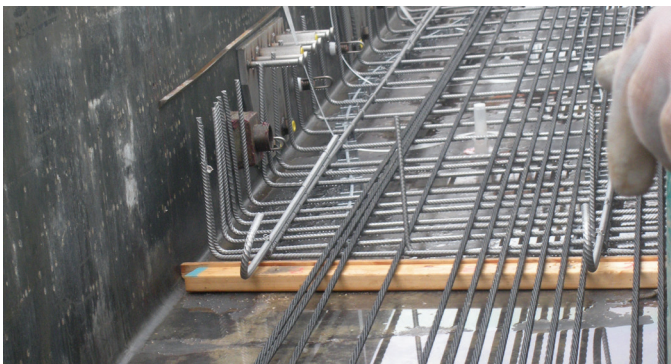
▶ Prestressed concrete box beam casting bed with the CFCC strands being set in place.

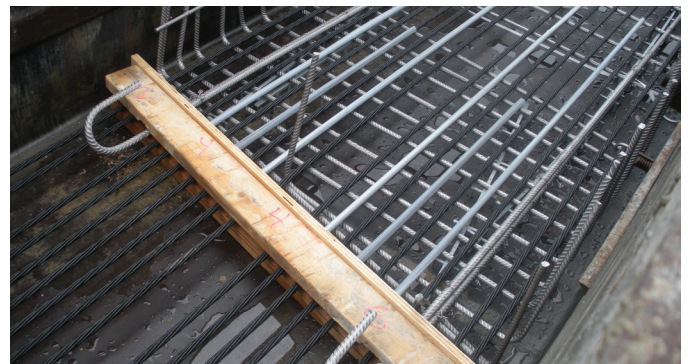
▶ Looking at beam end of the prestressed concrete box beam casting bed with the CFCC strand and the bottom stainless steel U-rebars used for shear/confinement reinforcement installed in place.
